# REPORT OF NOVA SERVICES

**Cherokee County Arts Center**  
Canton, Cherokee County, Georgia

**Subject:** Limited Environmental, Structural, and Building Enclosure  
Assessment & Consulting Services Executive Summary Report  
**Cherokee County Arts Center**  
Canton, Cherokee County, Georgia  
NOVA Project Number 10102-3022152

**Subject: Report of Limited Visual Building Envelope Condition Assessment**  
94 North Street  
Canton, Georgia 30114  
NOVA Project Number: 10102-3022152

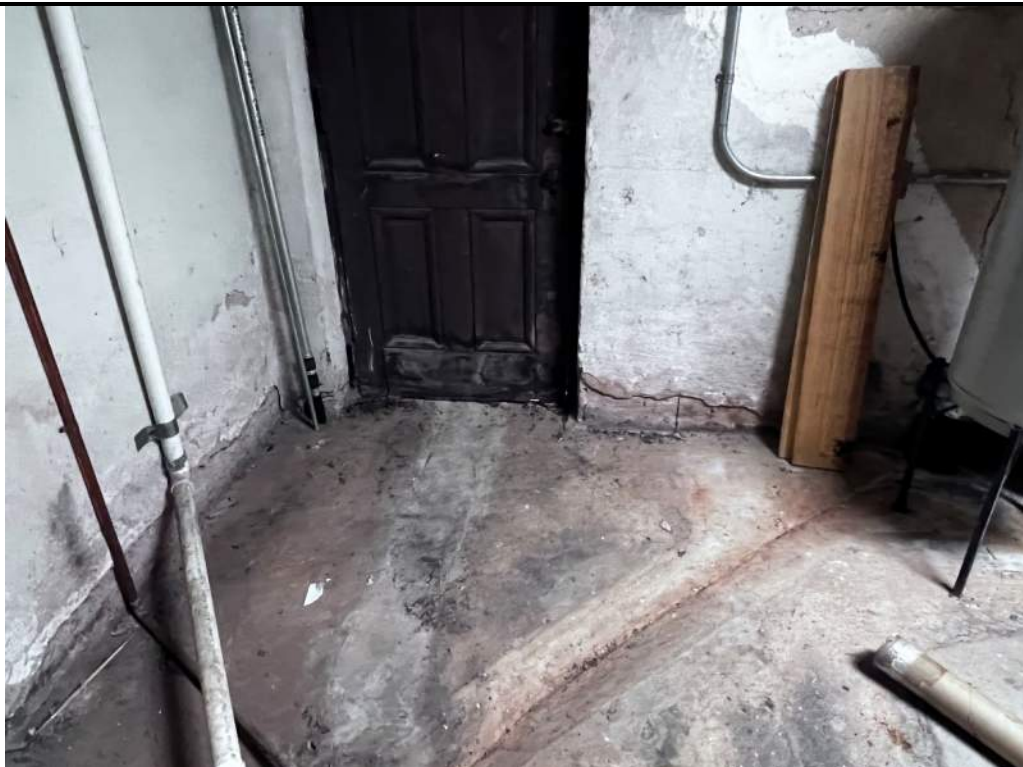
Photo 2: Interior view of mechanical room, note cracked plaster and efflorescence.

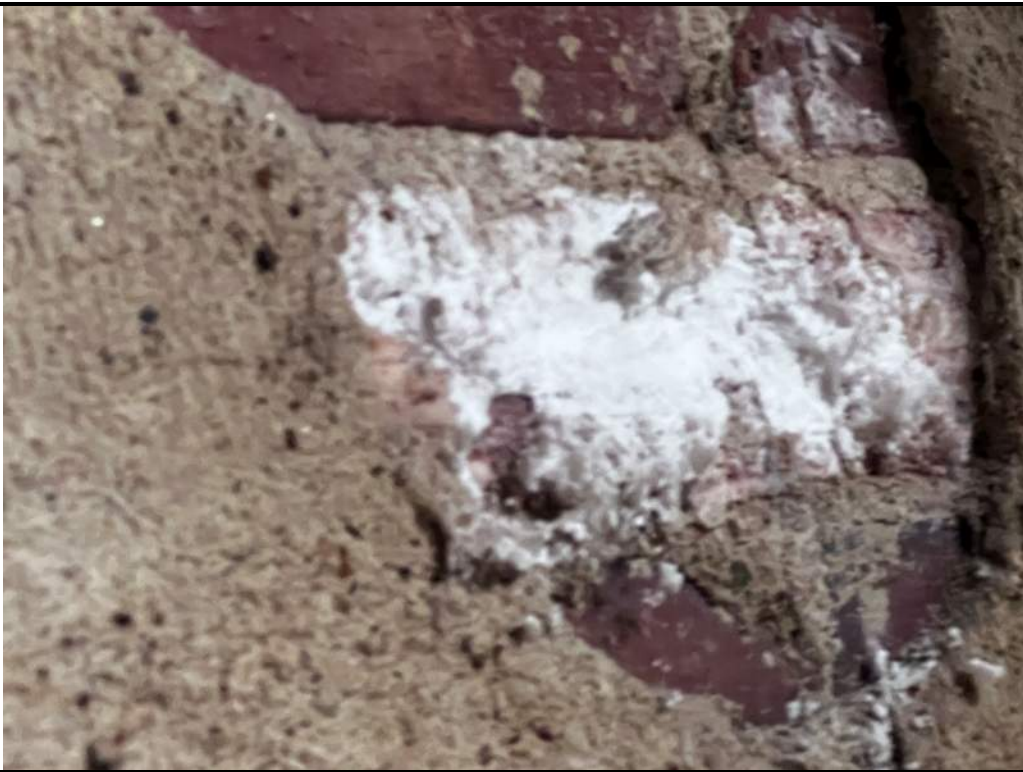
**Photo 3:** Efflorescence on interior side of exterior backed masonry wall.

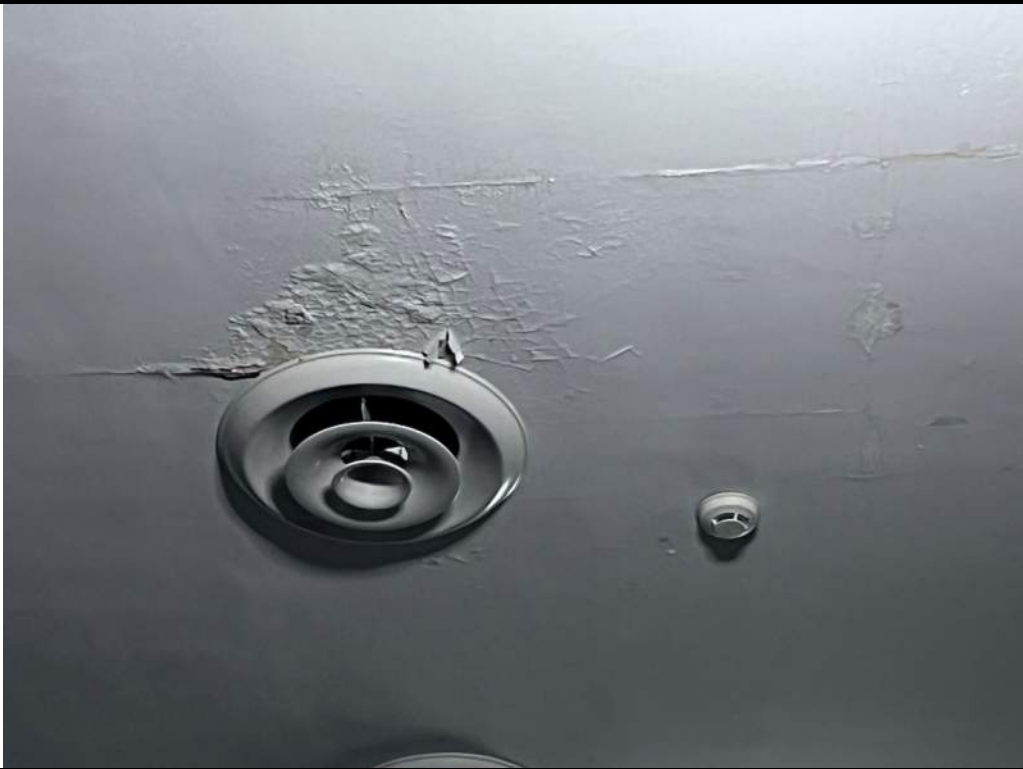
**Photo 4:** Blistered and peeling paint at suspected leak locations

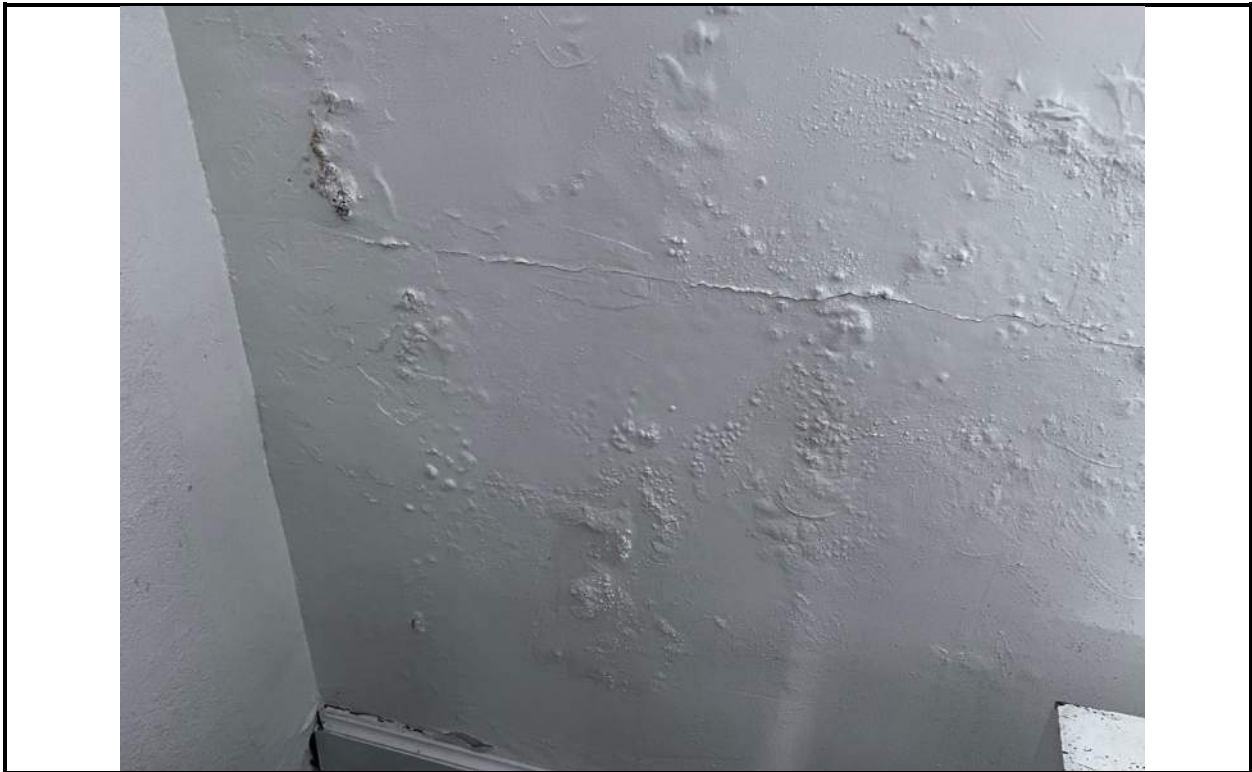
**Photo 5:** Blistered paint filled with efflorescence.

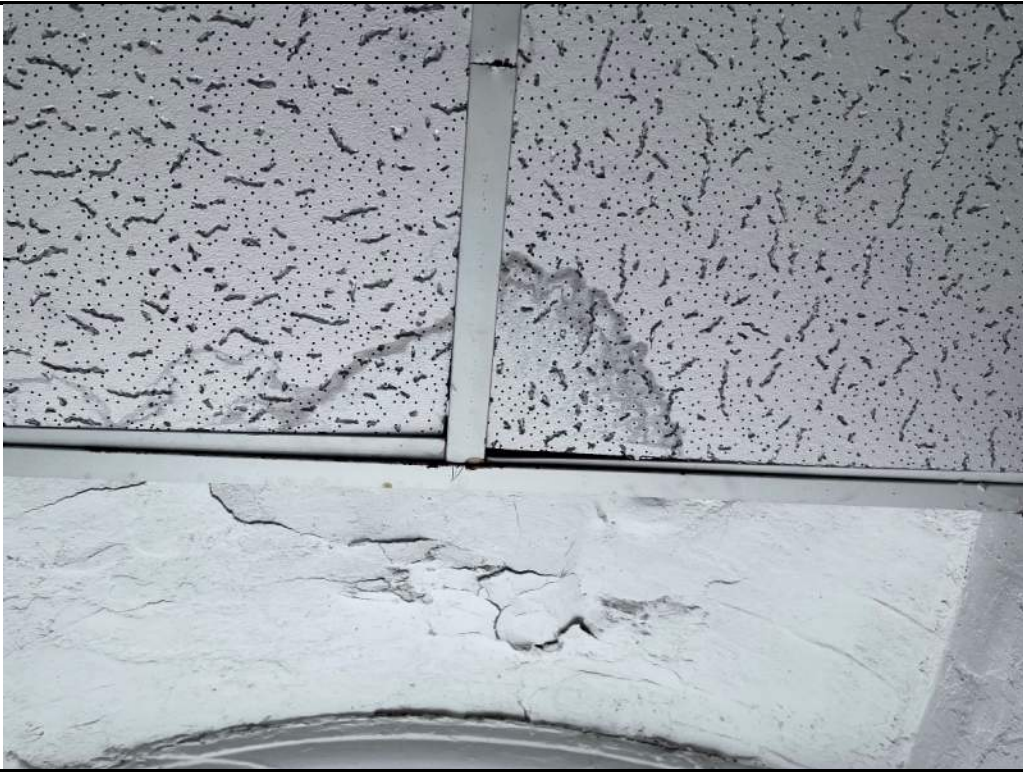
**Photo 7:** Water-stained ceiling tile

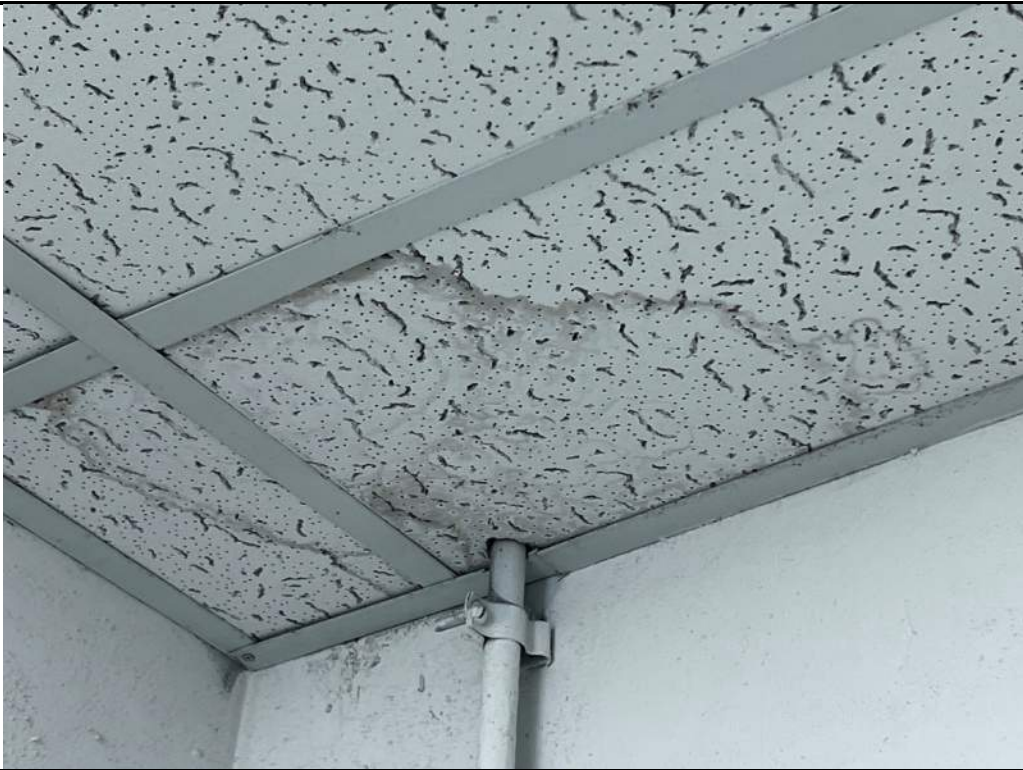
**Photo 11:** Stained ceiling tile

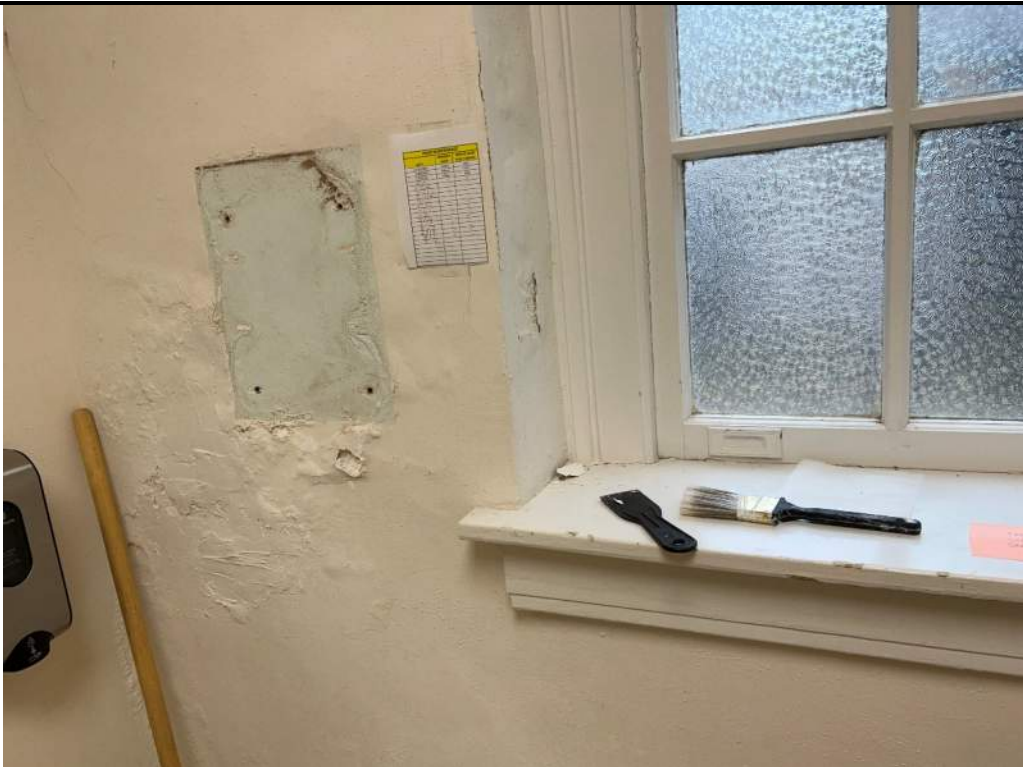
**Photo 12:** Blistered paint, efflorescence, men's restroom south side.

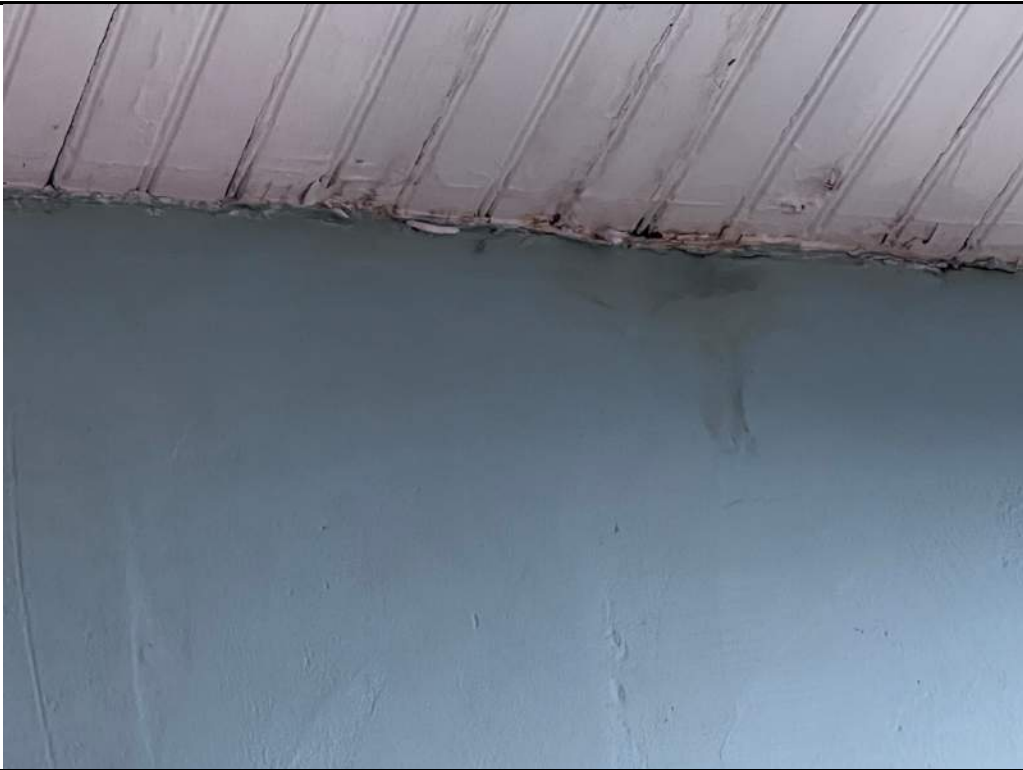
**Photo 13:** Beadboard ceiling exhibiting previous moisture damage

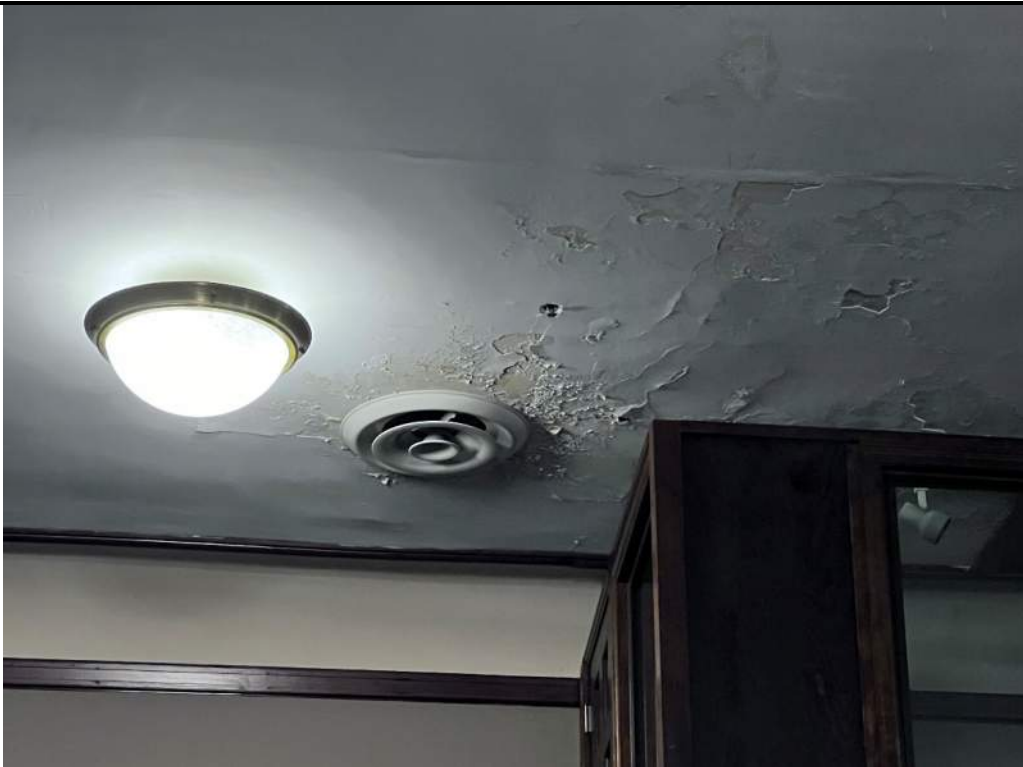
**Photo 14:** Apparent water damage above balcony.

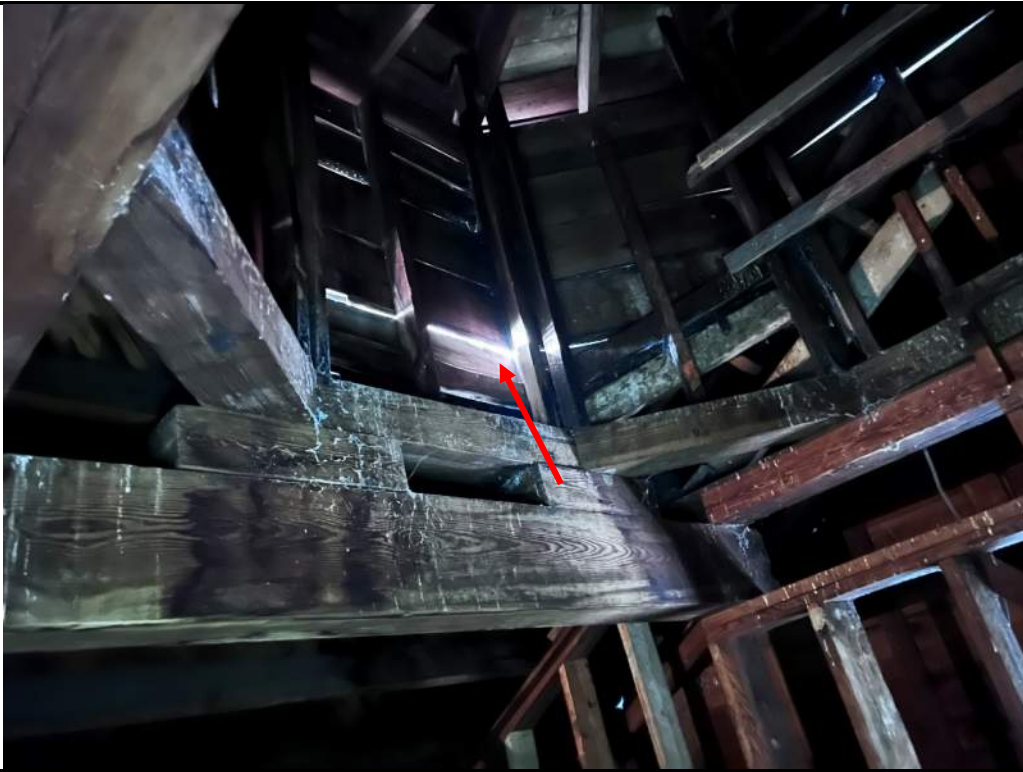
**Photo 15:** Open lap in steeple wood siding in close proximity to balcony leaks

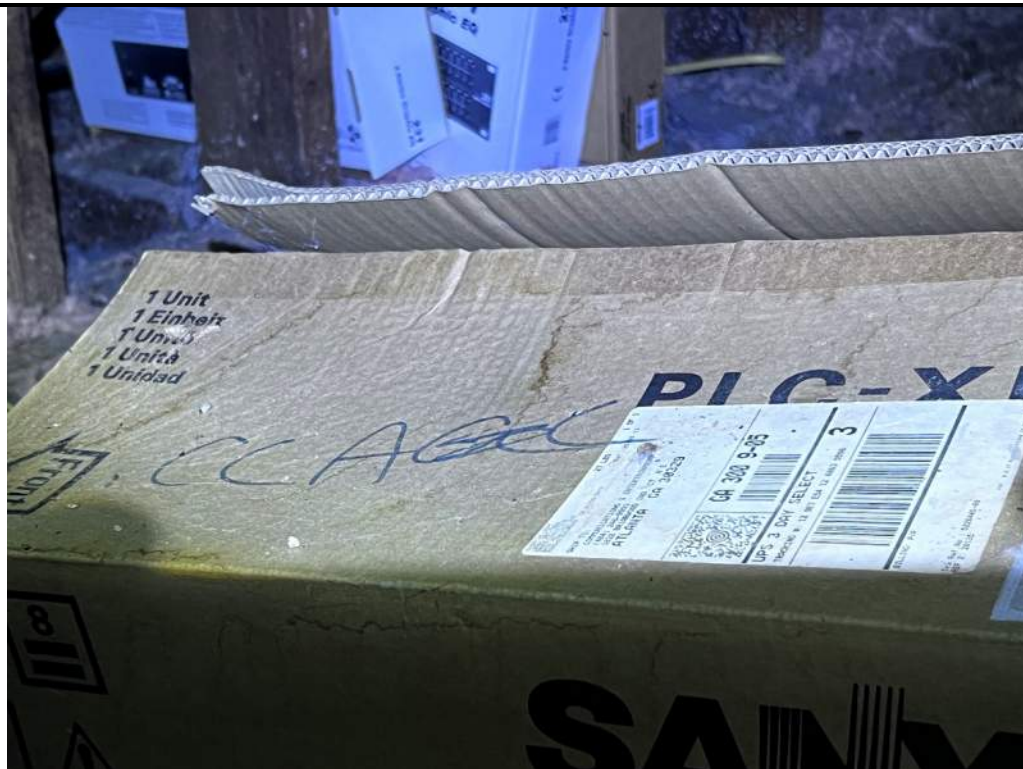
**Photo 16:** Water damaged box in vicinity of gap in wood siding

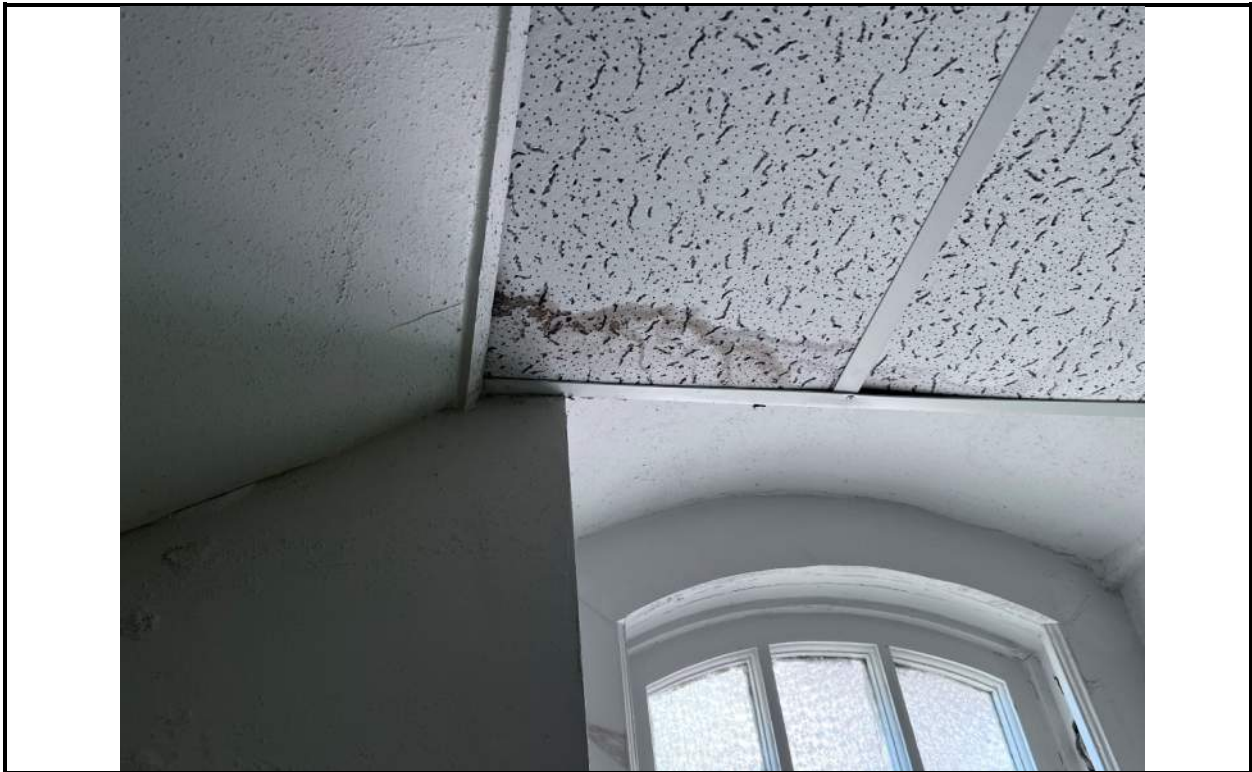
**Photo 17:** Water stained ceiling tile

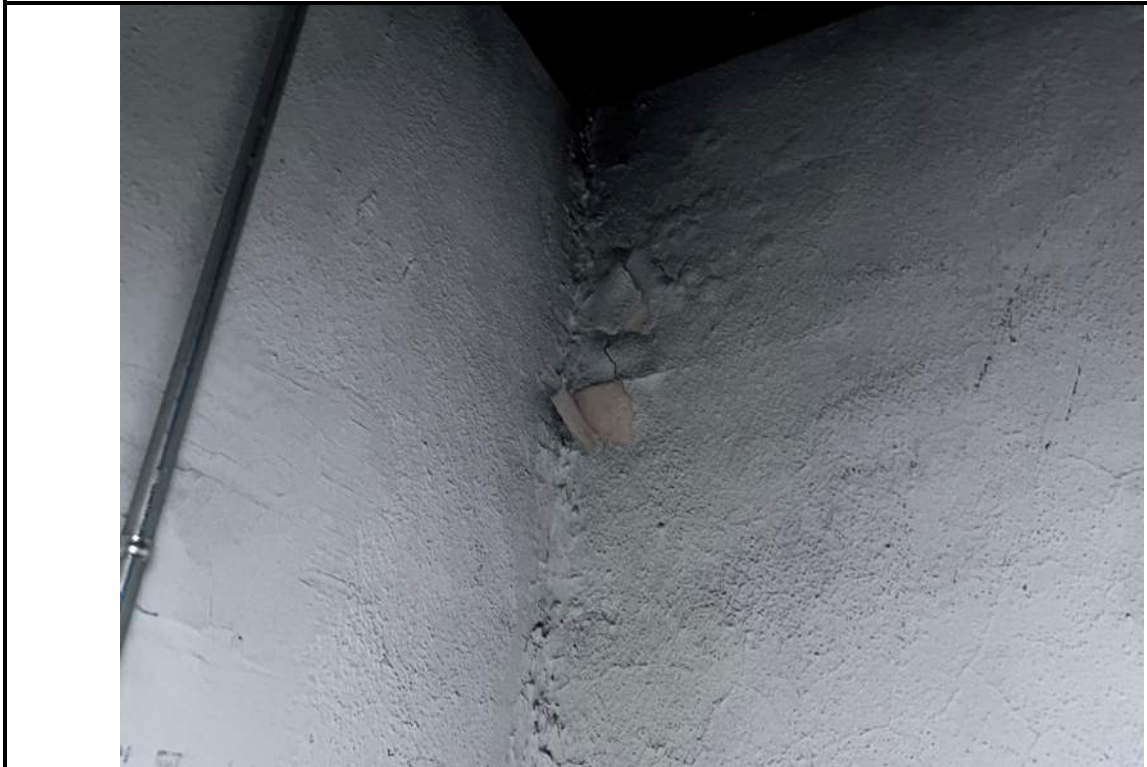
**Photo 18:** Blistered and peeling paint

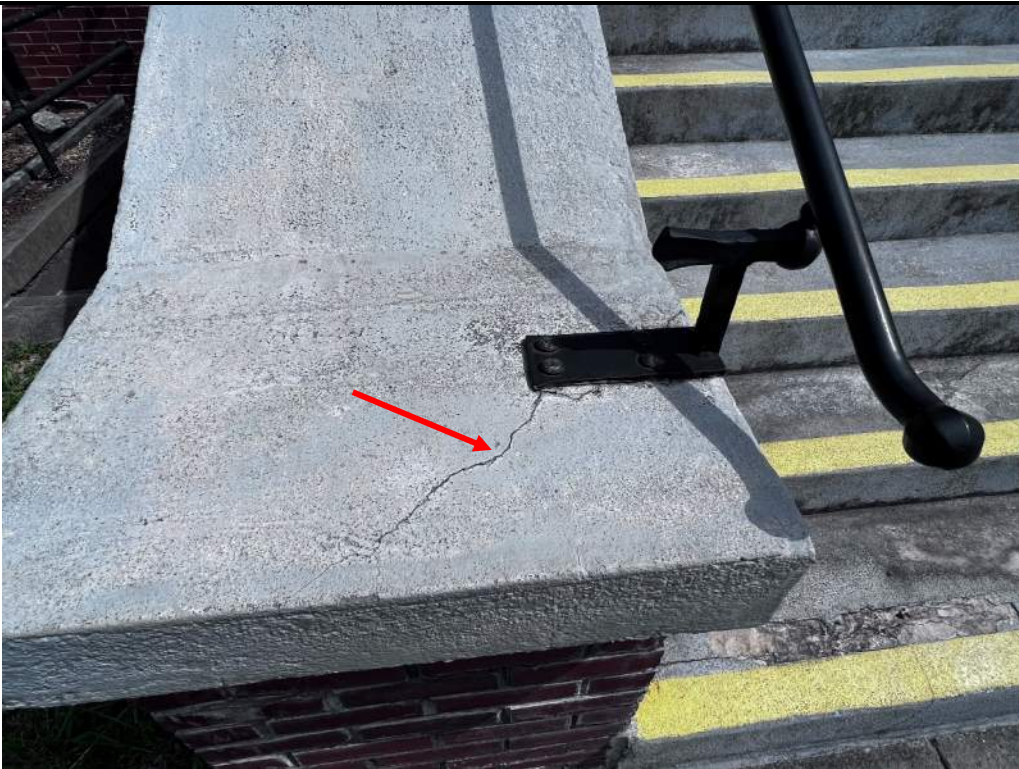
Photo 20: Cast concrete coping crack

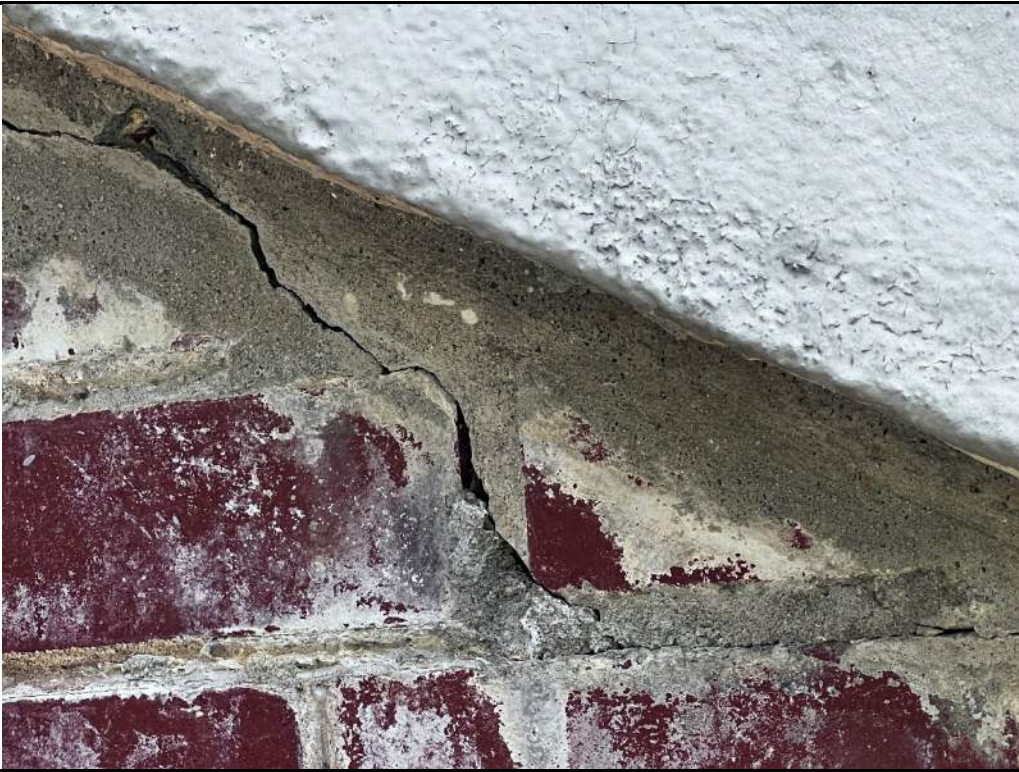
**Photo 21:** Cracked bed joint below concrete coping

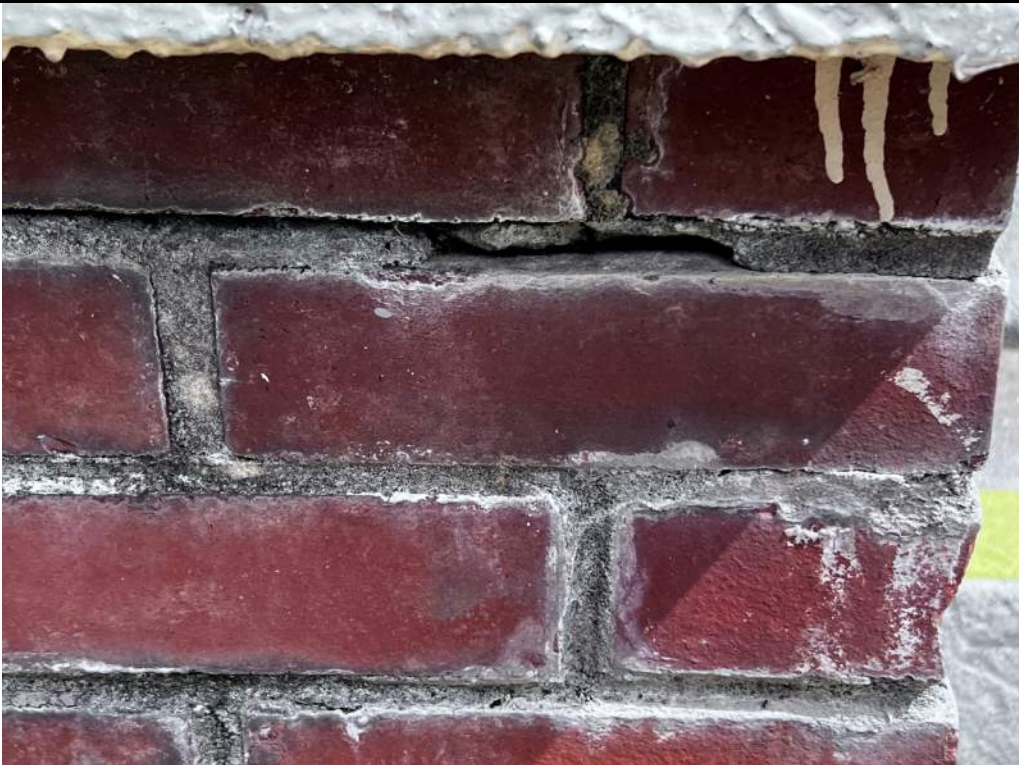
**Photo 22:** Brick mortar joint below concrete coping open

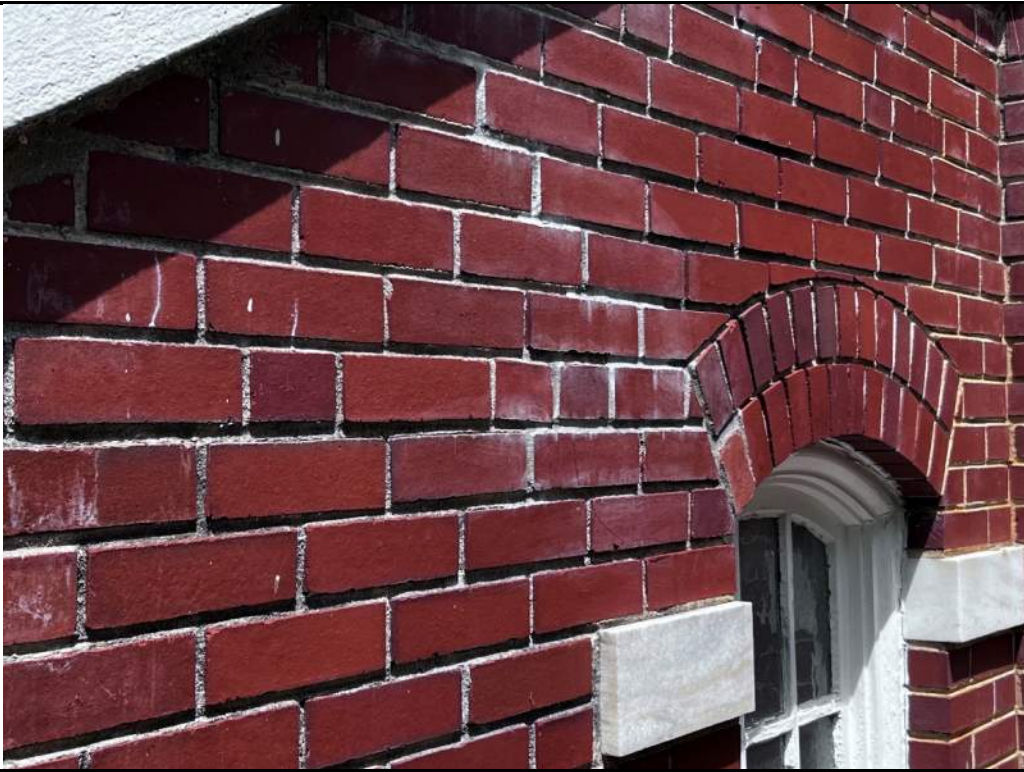
**Photo 23:** Appears to be previous mortar repair

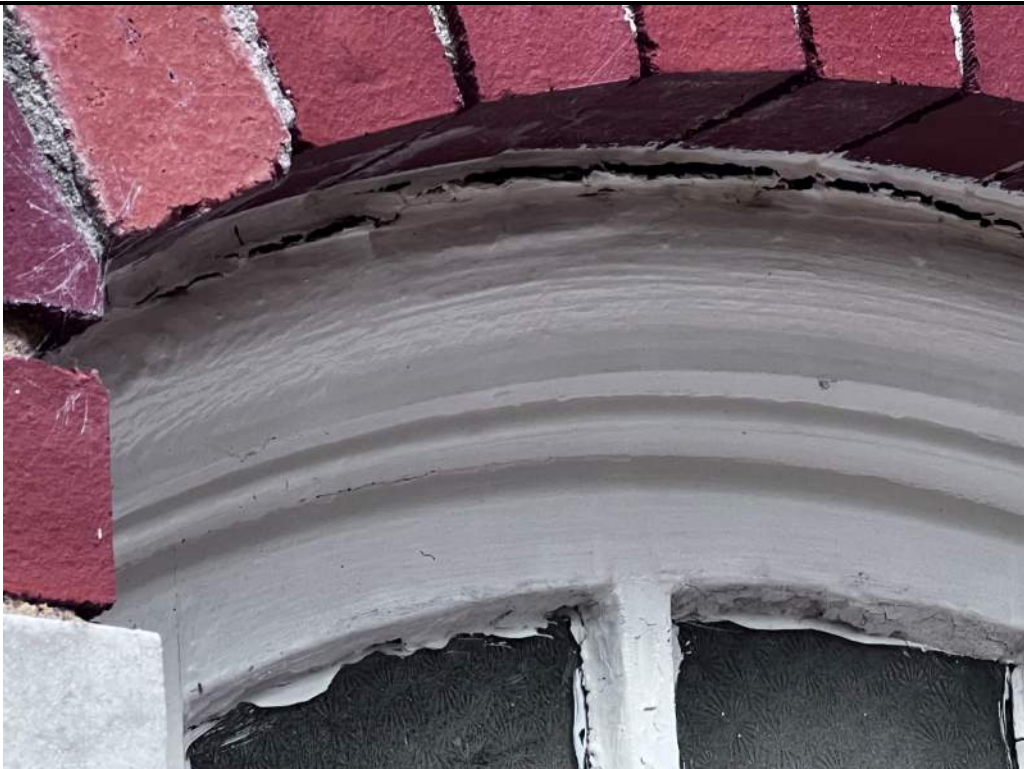
**Photo 24:** Perimeter sealant around window, poor condition

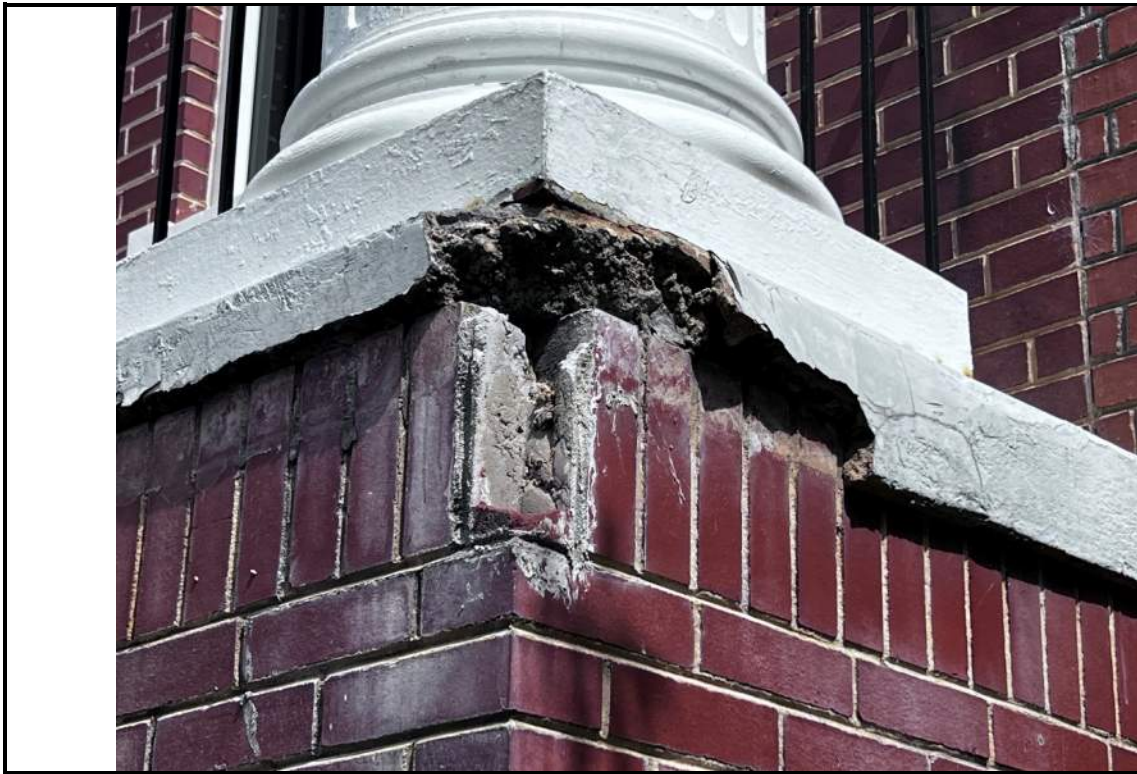
**Photo 25:** Concrete deck at entrance, above restrooms, is spalled.

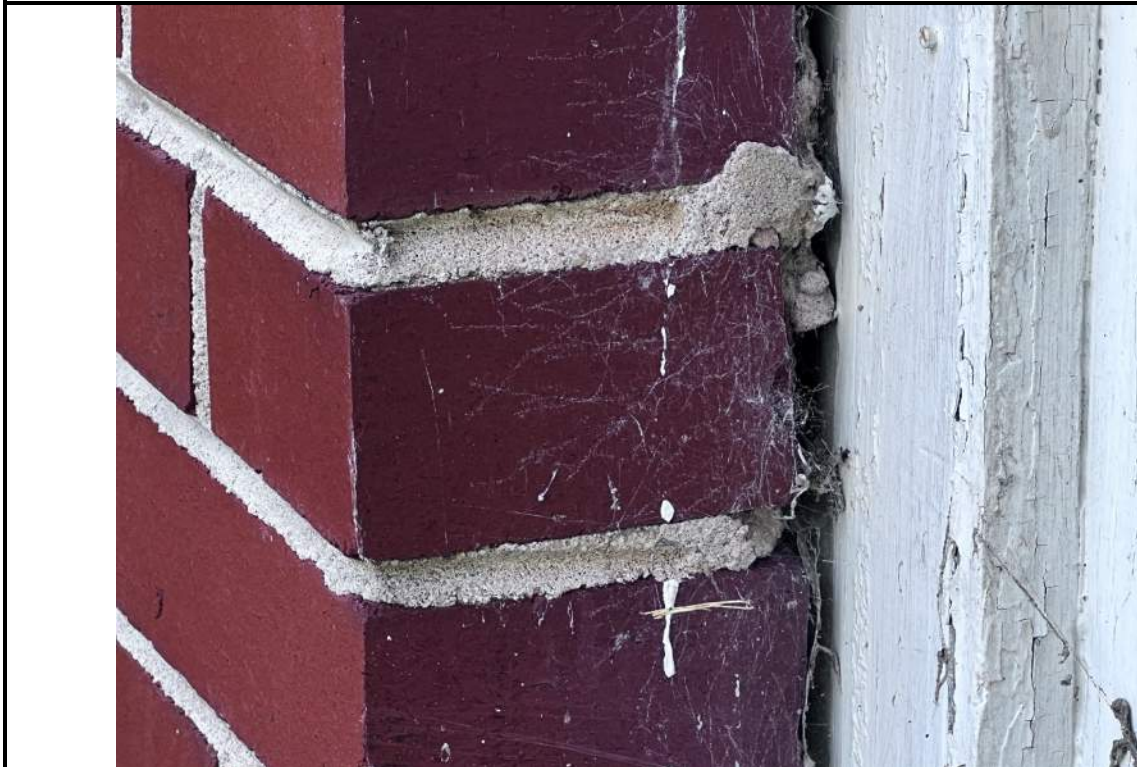
**Photo 26:** Open joint between masonry and wood window frame.

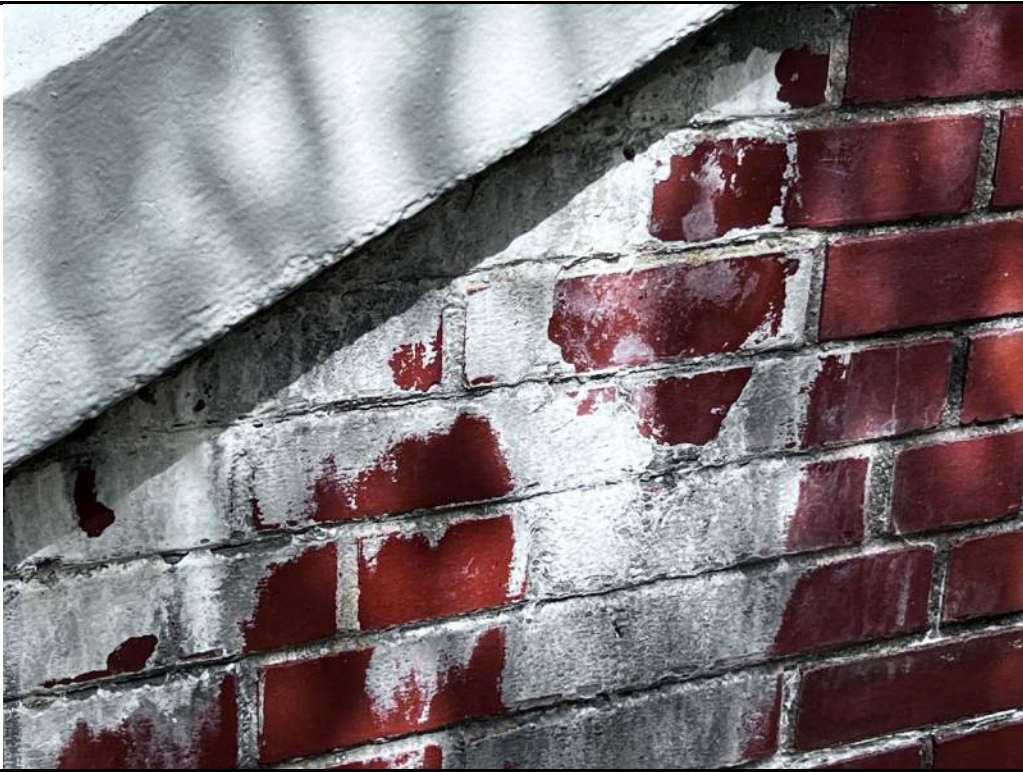
**Photo 27:** Efflorescence and lime staining on face of brick

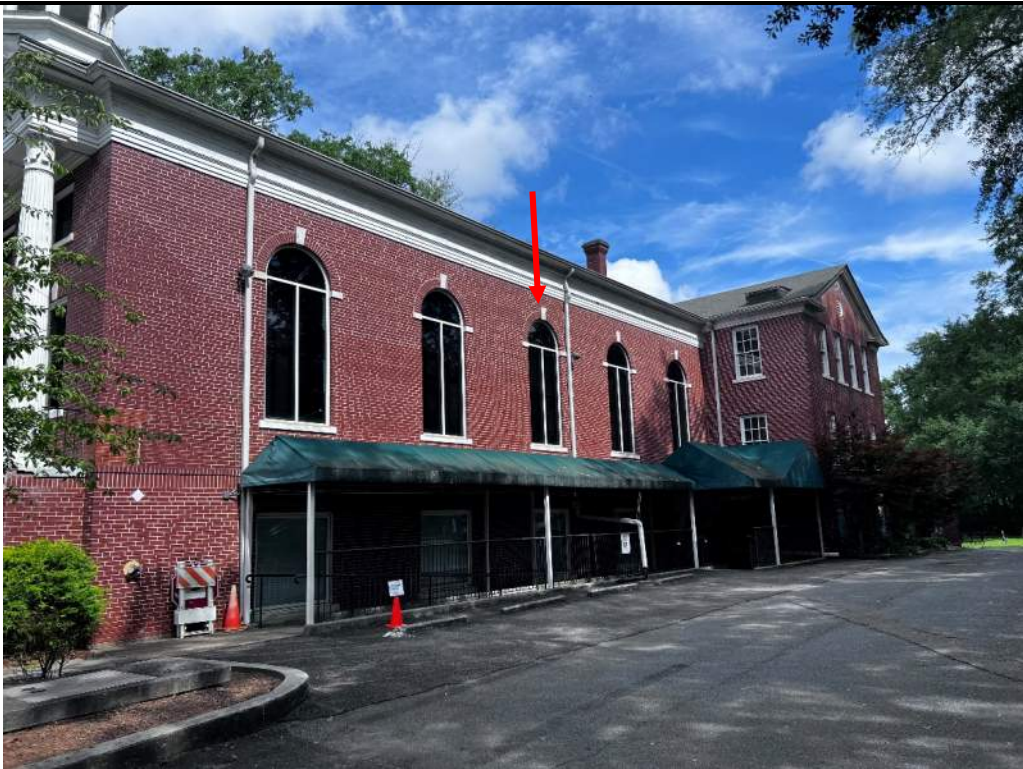
**Photo 28:** Overview east elevation, arrow points out keystone believed to be loose

- Check stability of the loose keystone located above the center of the arched window on east elevation, reattach as necessary as soon as it potentially appears to be safety issue.
- Seal up open gaps on the exterior of the steeple tongue and groove wall panels
- Low sloped shingled dormer, replace shingles with appropriate roofing system, clean, prime and repaint exposed wood trim

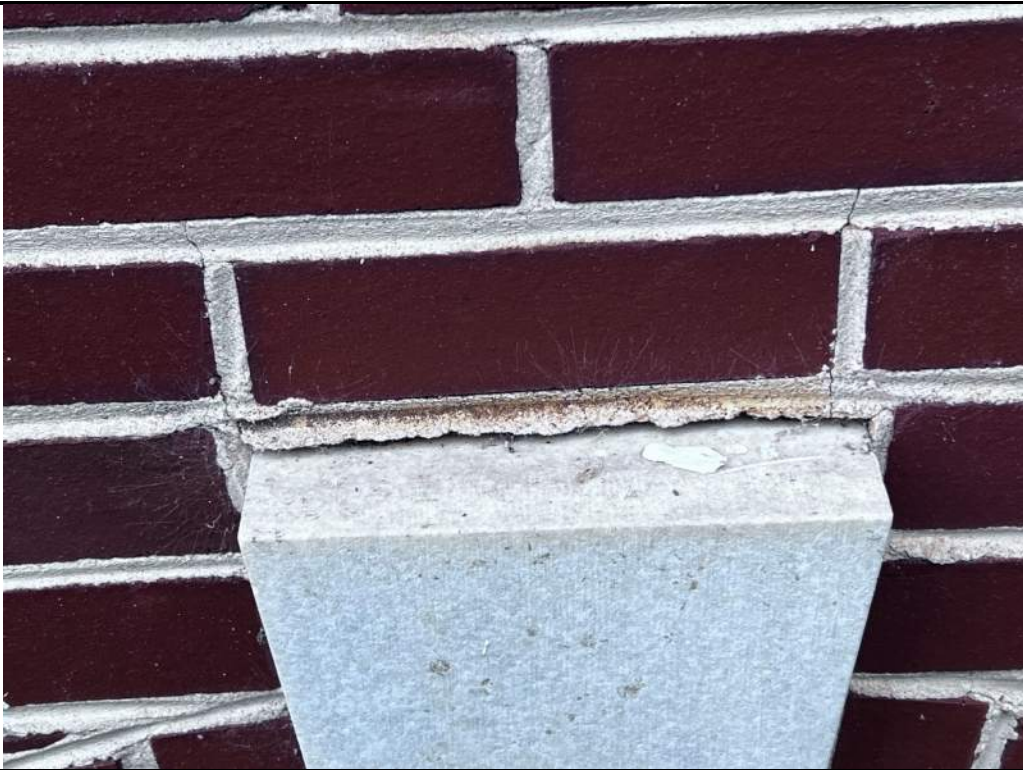
**Photo 29:** Keystone believed to be loose above aluminum framed arched window

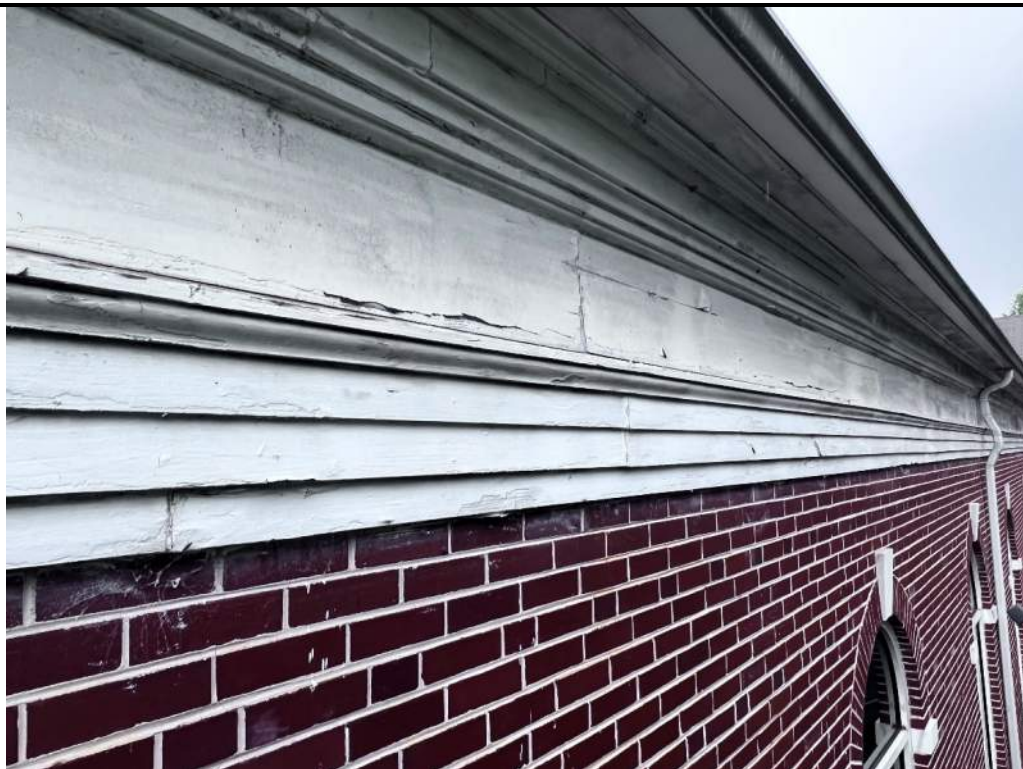
**Photo 30:** Paint peeling from wood fascia

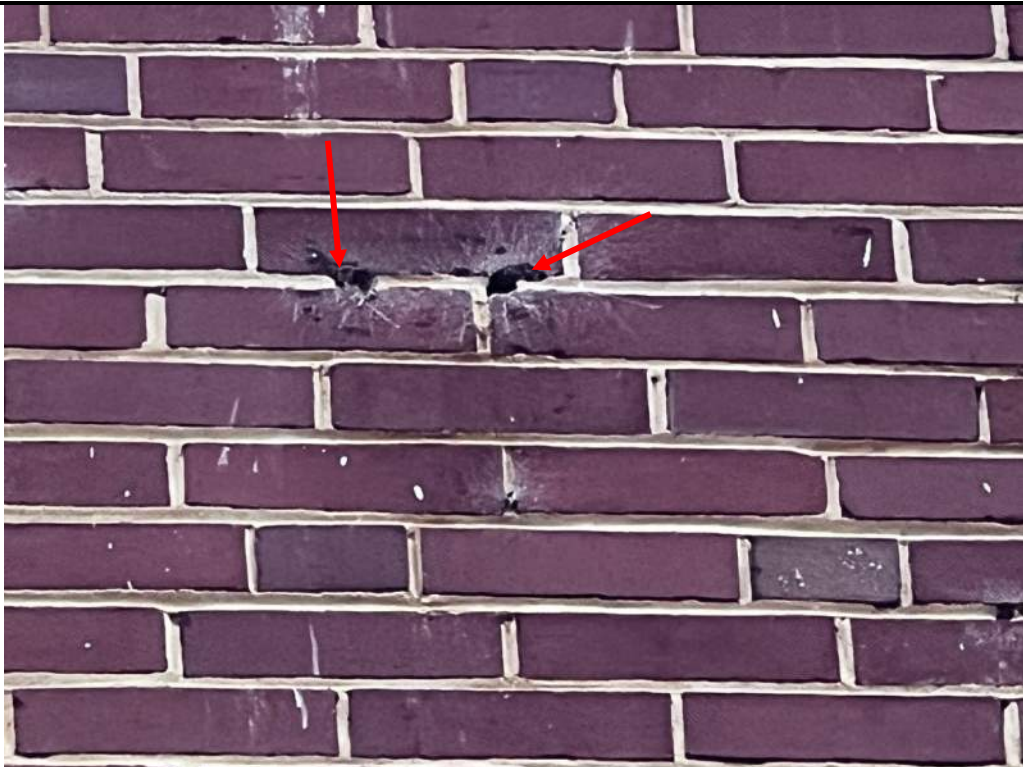
**Photo 32:** Spalled masonry brick because of performing penetrations

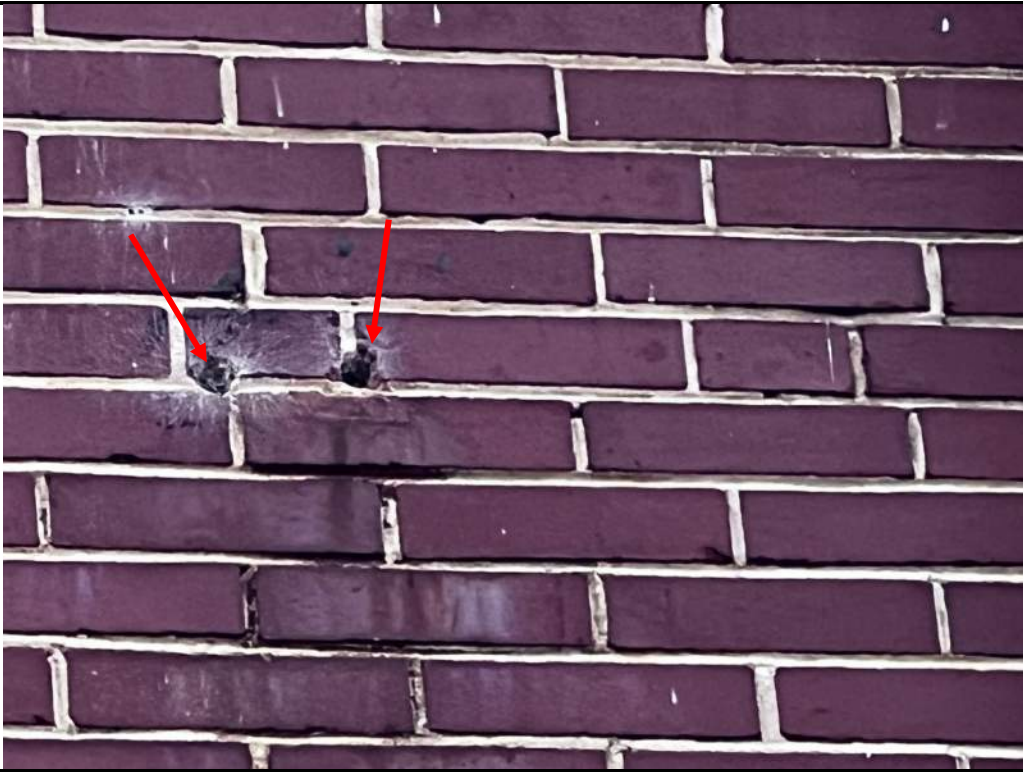
**Photo 33:** Spalled masonry brick because of performing penetrations.

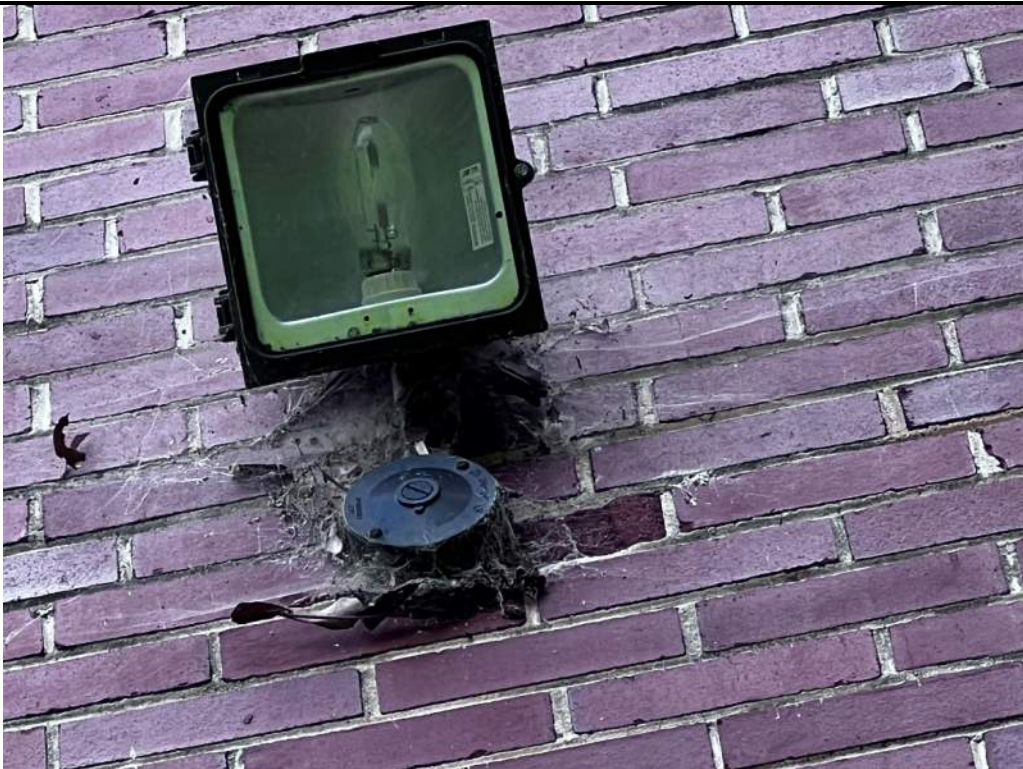
**Photo 34:** Spalled brick, possibly occurring during fixture installation.
