# REPORT OF NOVA SERVICES

**Cherokee County Arts Center**  
Canton, Cherokee County, Georgia

**Subject:** Limited Environmental, Structural, and Building Enclosure  
Assessment & Consulting Services Executive Summary Report  
**Cherokee County Arts Center**  
Canton, Cherokee County, Georgia  
NOVA Project Number 10102-3022152

**Subject: Report of Limited Visual Building Envelope Condition Assessment**  
94 North Street  
Canton, Georgia 30114  
NOVA Project Number: 10102-3022152

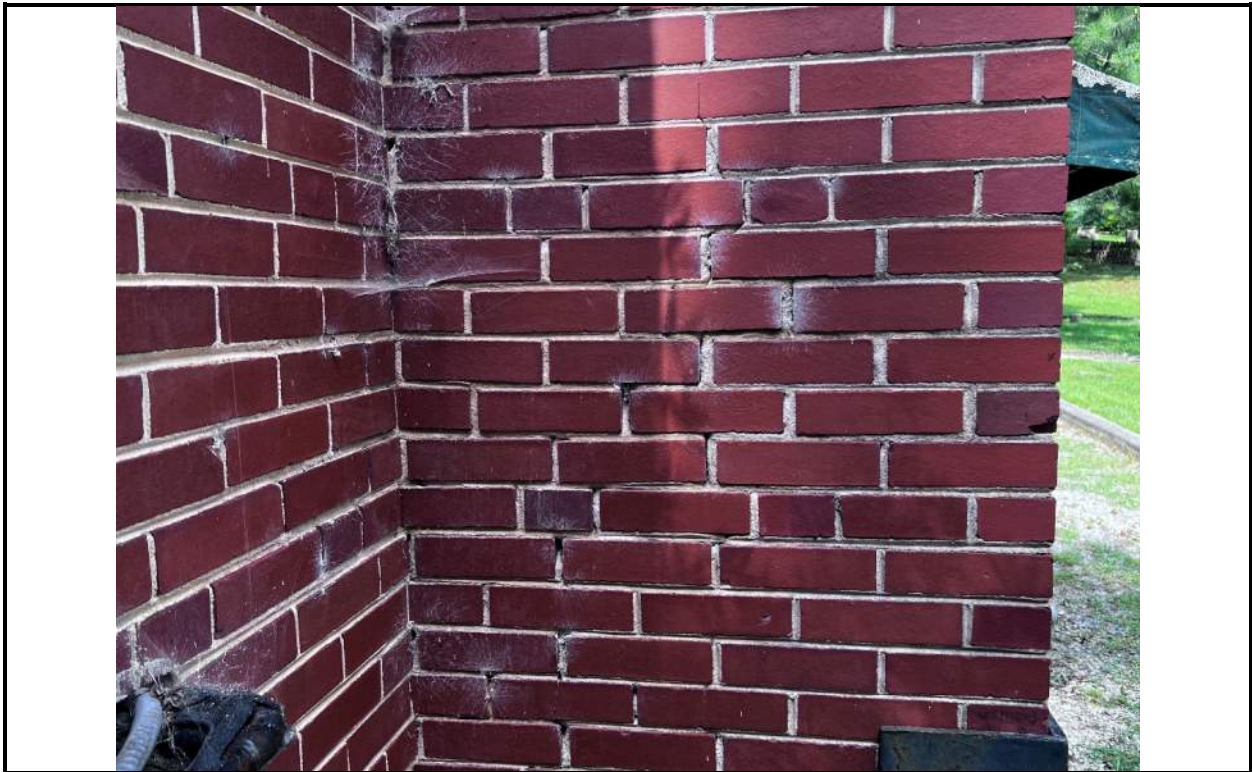
Photo 35: Deteriorating mortar

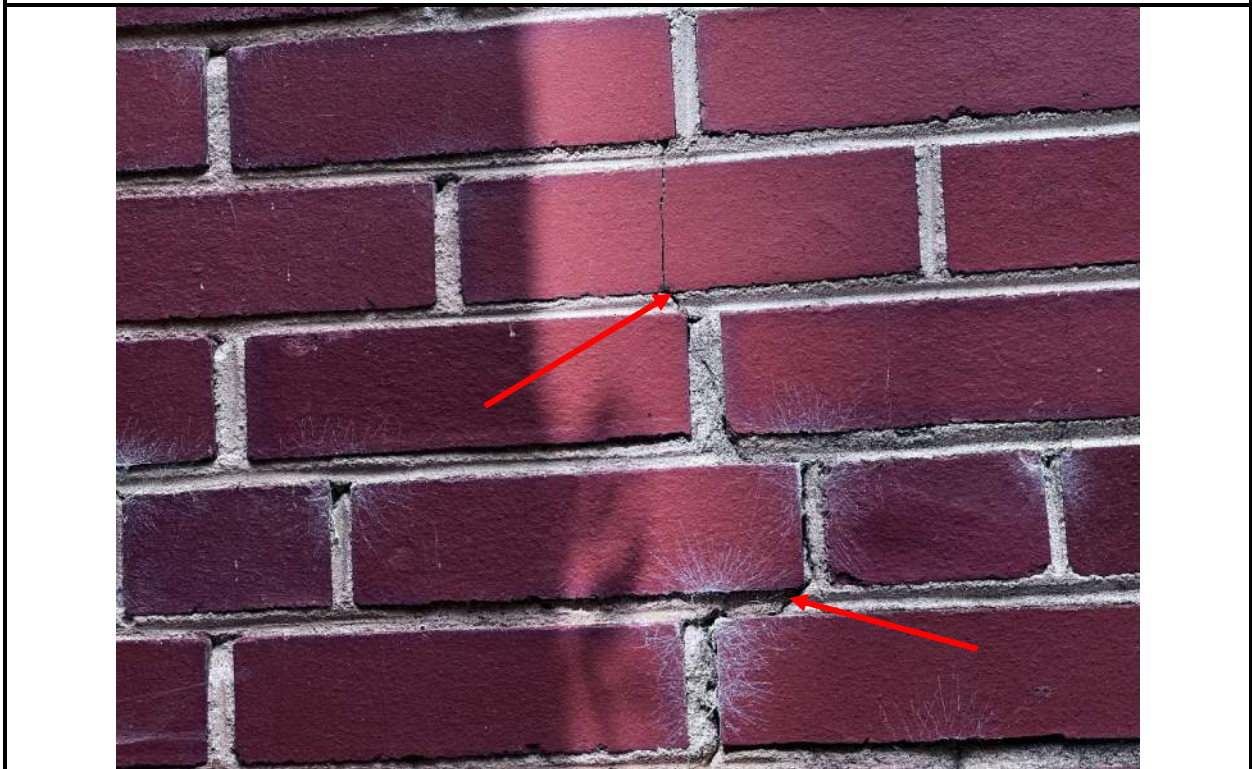
Photo 36: Minor settlement cracking in brick

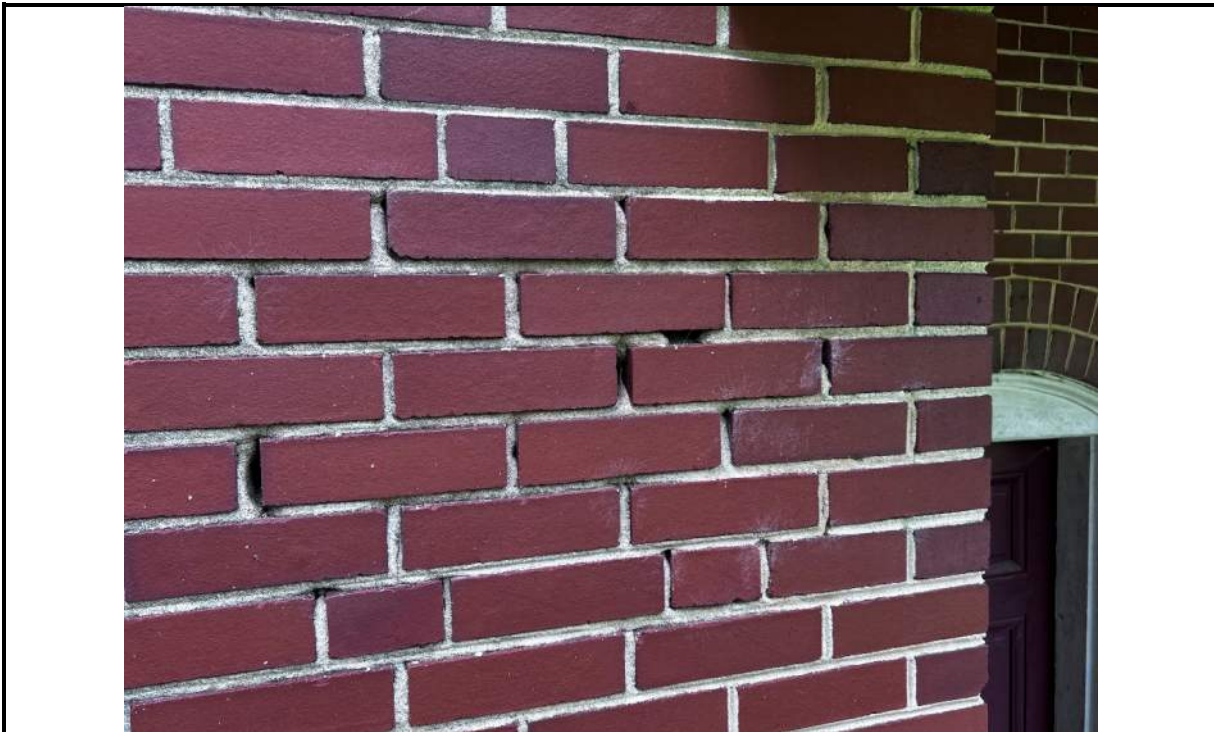
**Photo 37:** Eroded and missing mortar, in vicinity of wall damage in basement level mechanical room

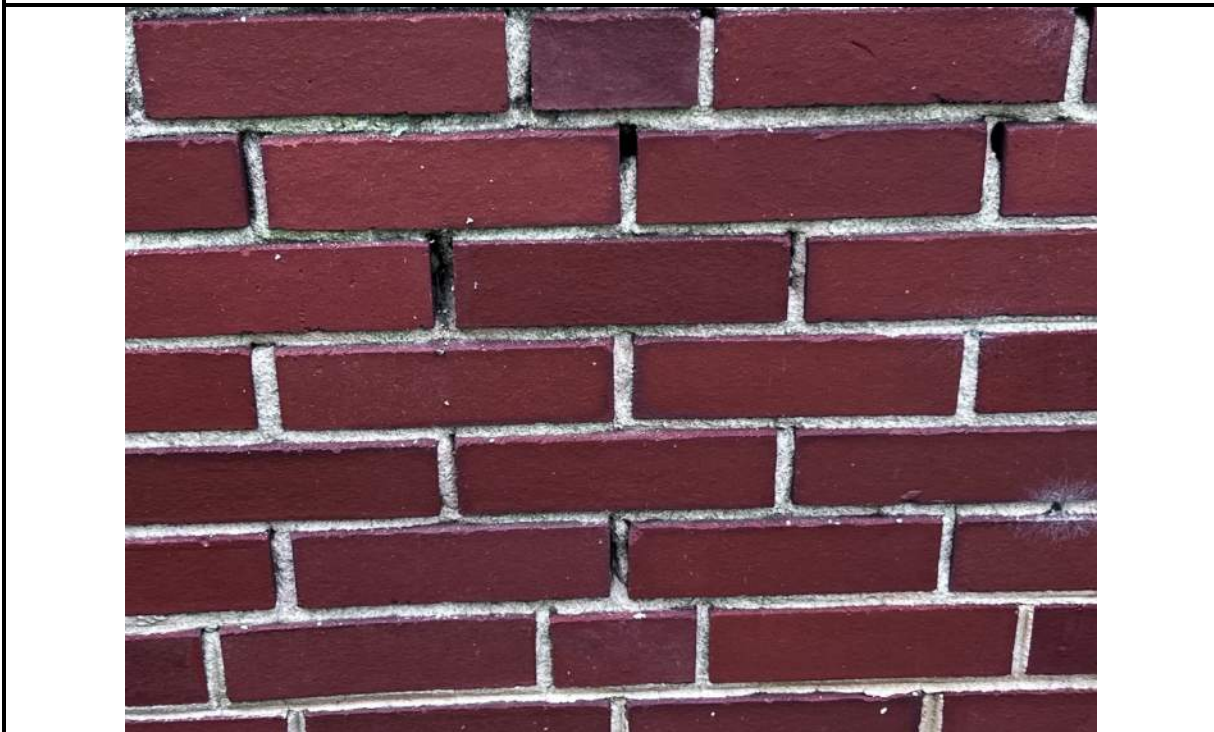
**Photo 38:** Eroded and missing mortar, in vicinity of wall damage in basement level mechanical room

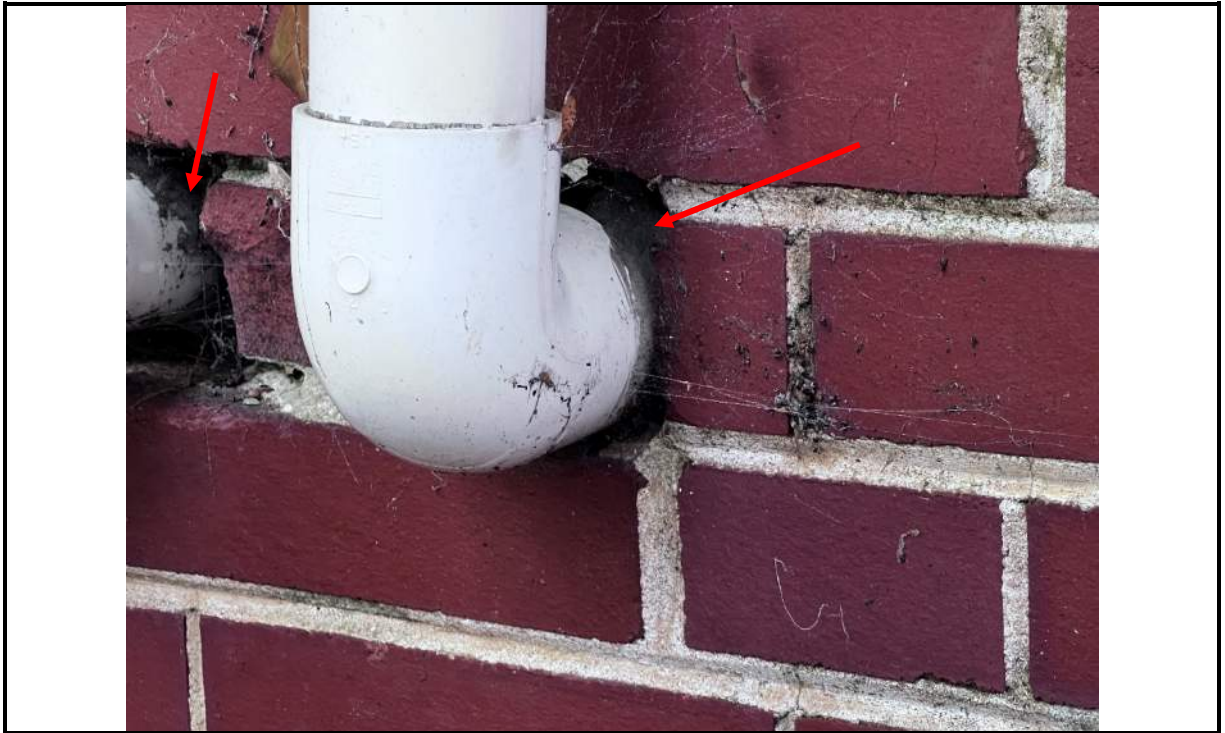
**Photo 39:** Unsealed pipe penetrations

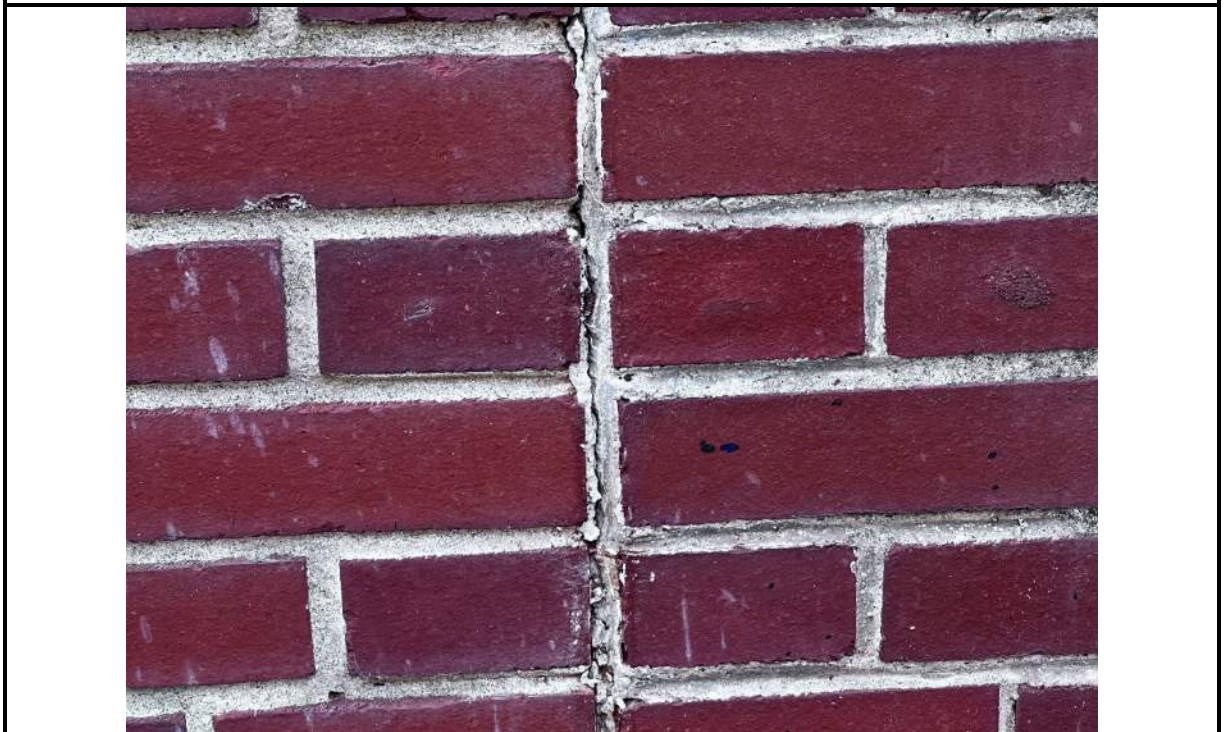
**Photo 40:** Deteriorated control joint

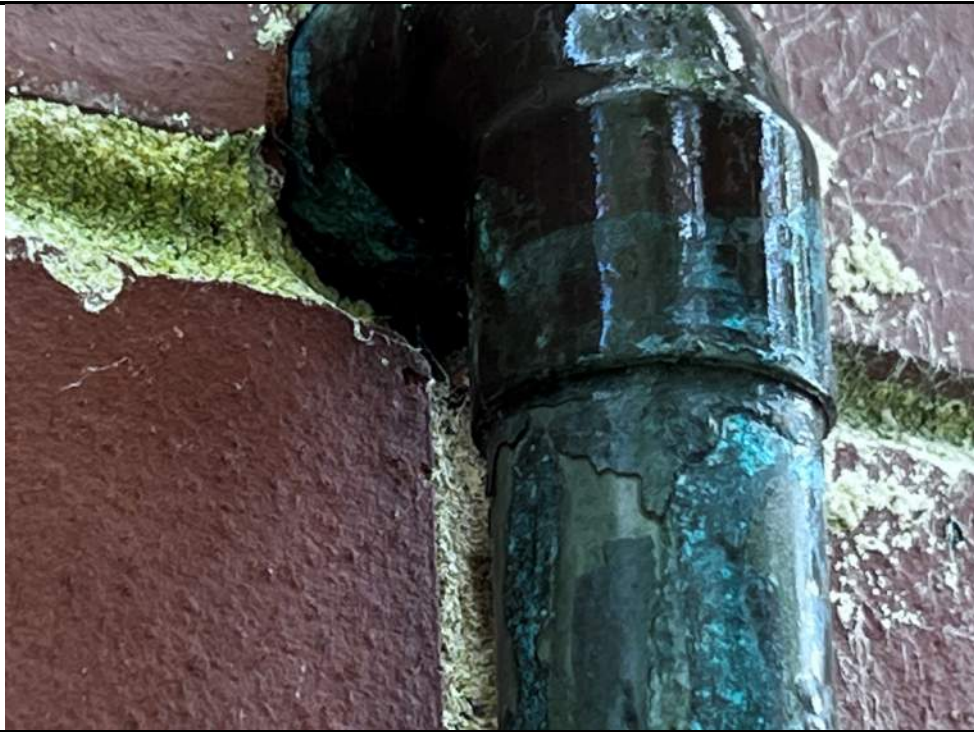
**Photo 41:** Unsealed wall penetration

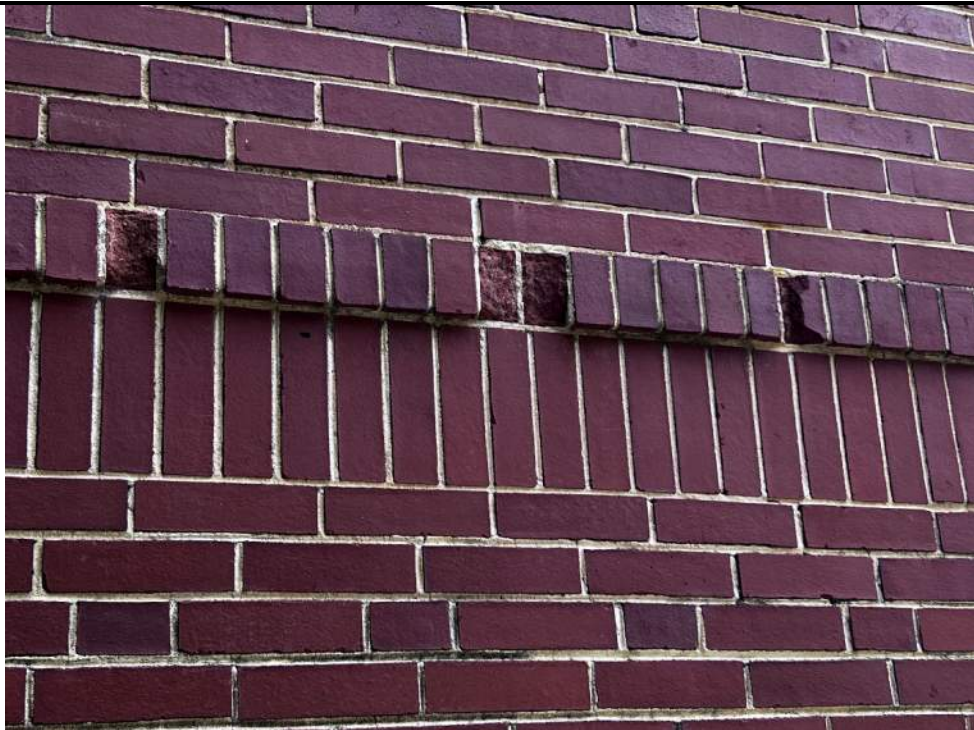
**Photo 42:** Spalled brick Rowlock band

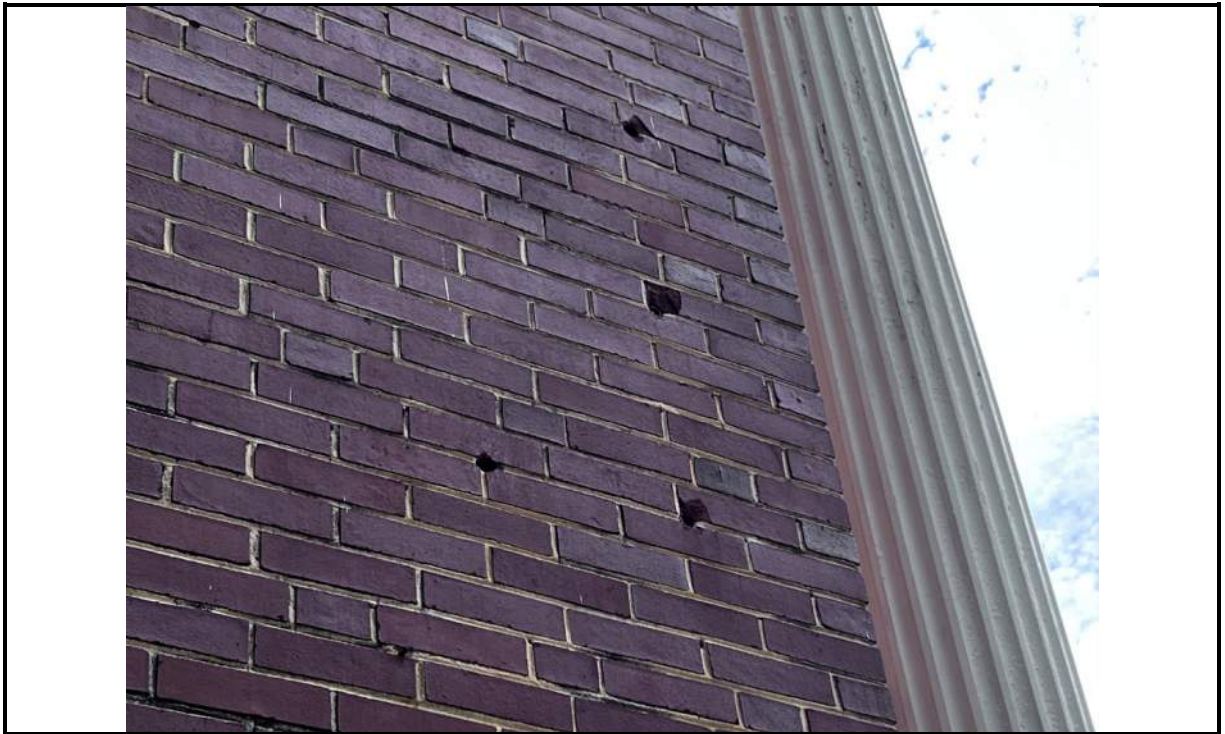
**Photo 43:** Open penetrations in masonry

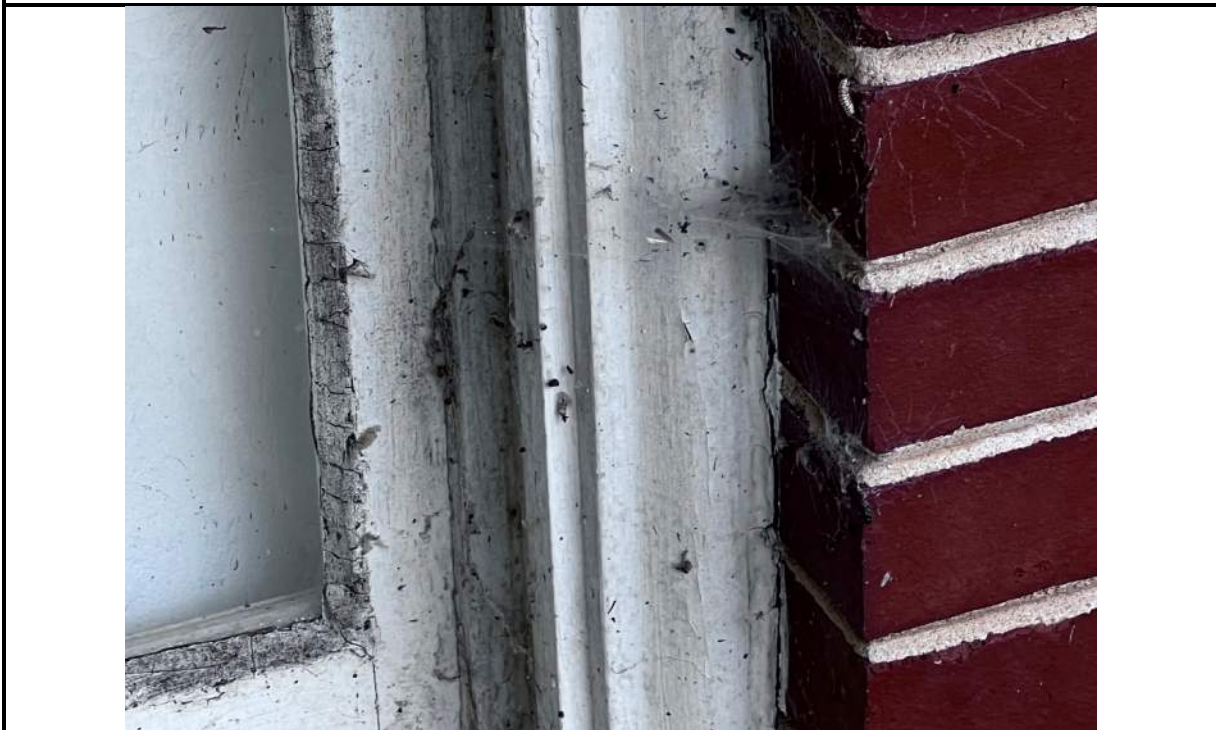
**Photo 46:** Cracked glazing putty, typical most wood window frames

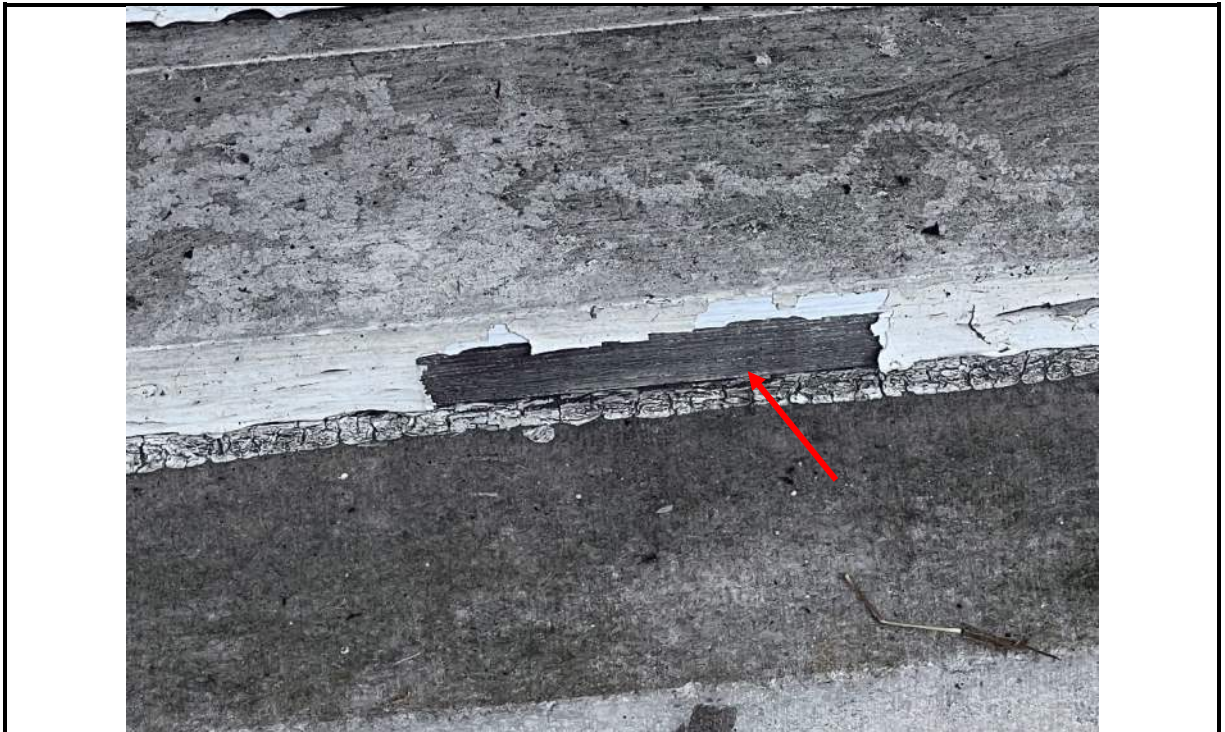
**Photo 47:** Exposed and weathered wood sill, sealant also failed

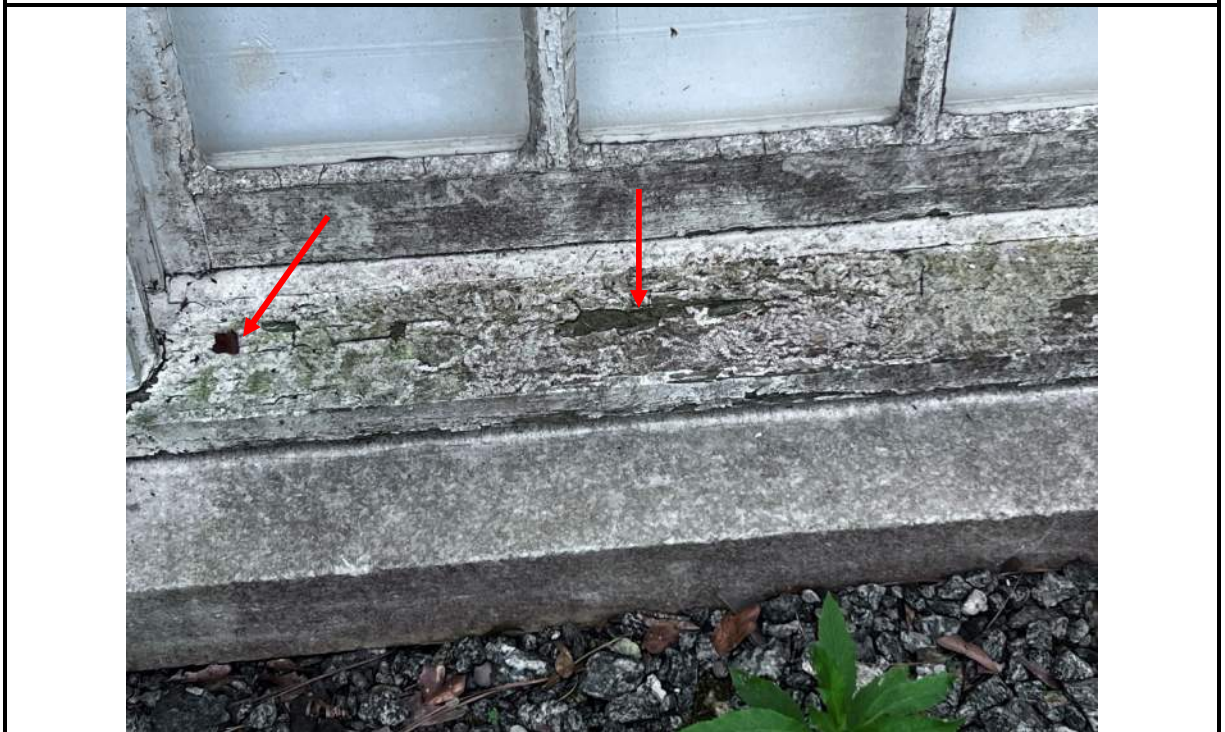
**Photo 48:** Deteriorated wood sill below window

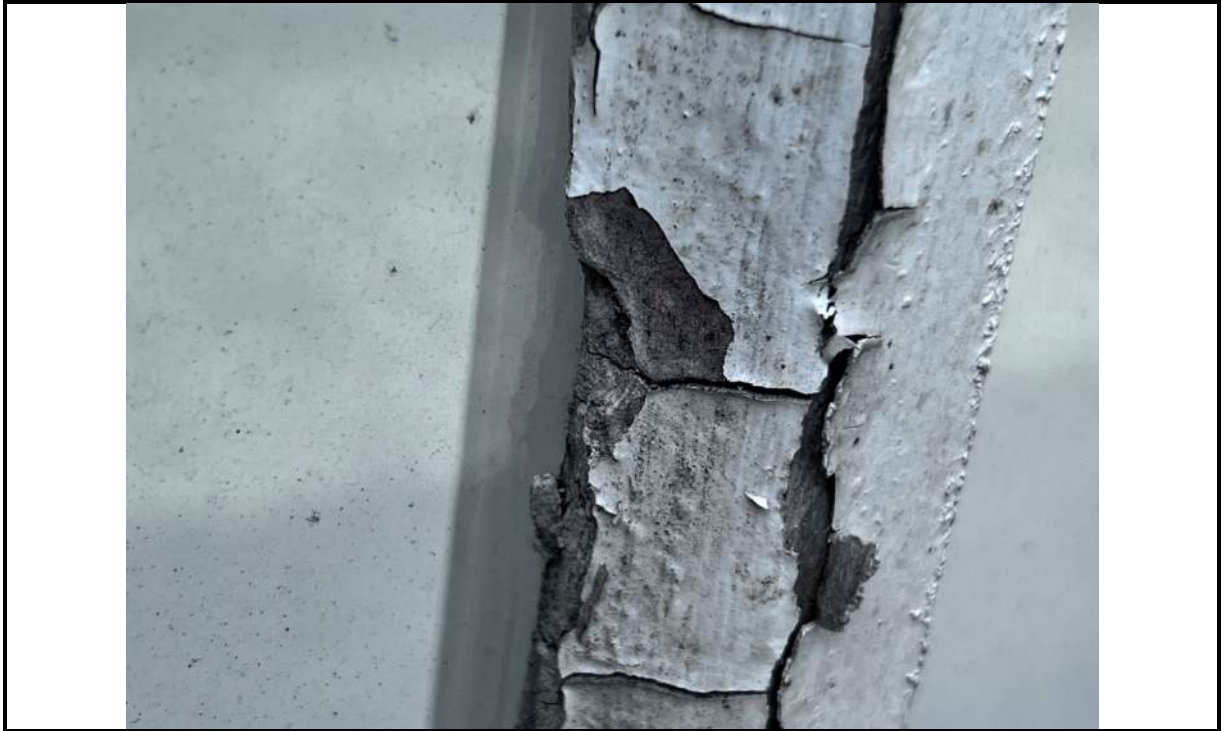
**Photo 49:** Glazing putty deterioration, typical condition most wood framed windows

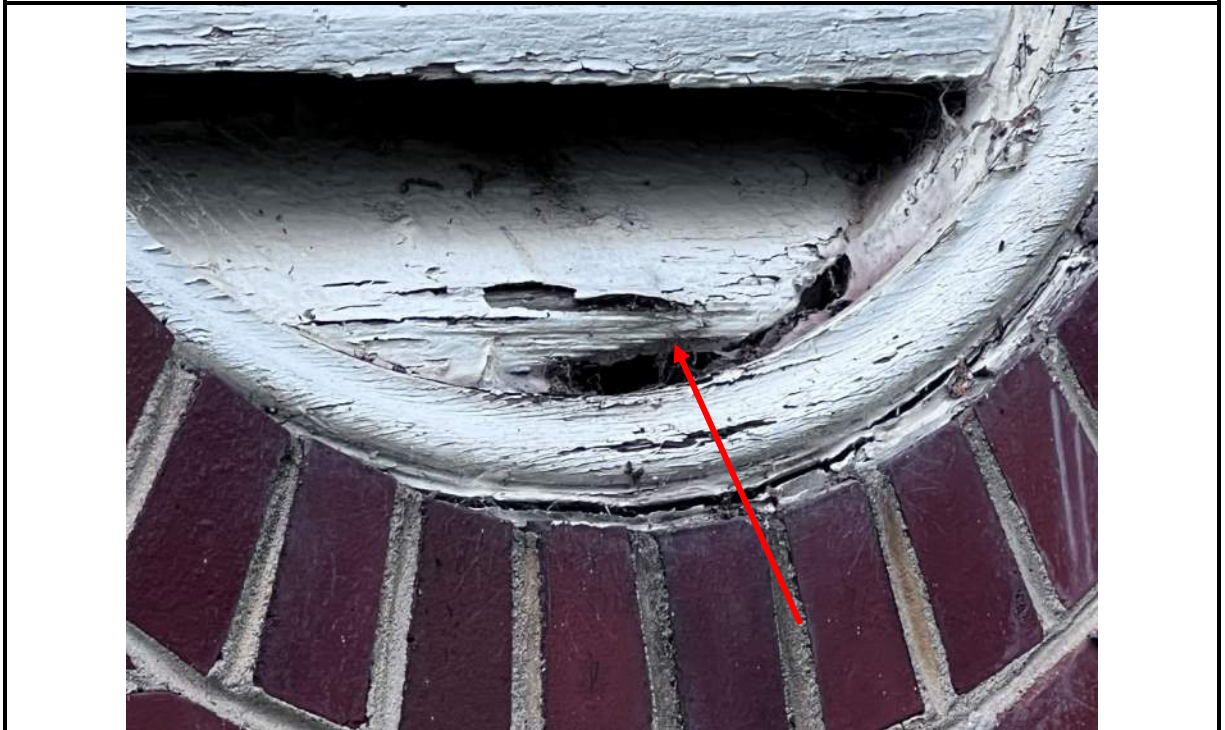
**Photo 50:** Deteriorated wood gable vent, perimeter sealant is also in a deteriorated condition

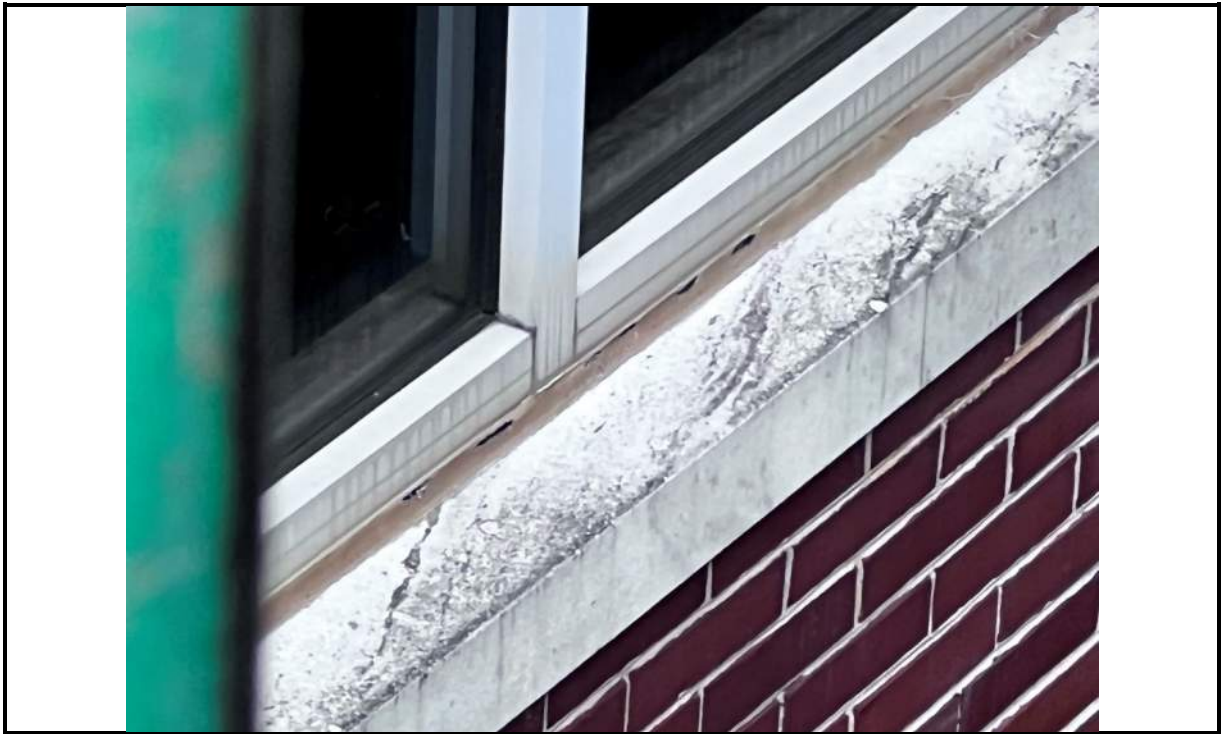
**Photo 51:** Adhesive failure of sealant around aluminum framed window systems

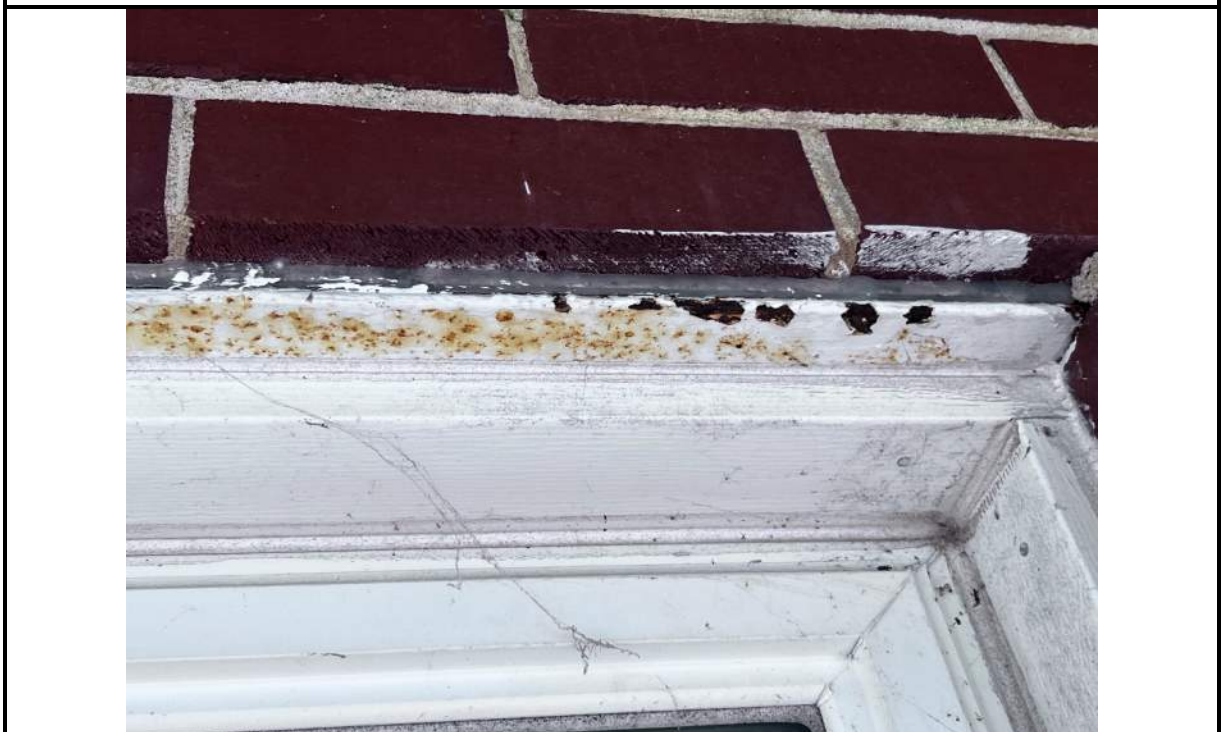
**Photo 52:** Many lintels above windows exhibit some metal corrosion

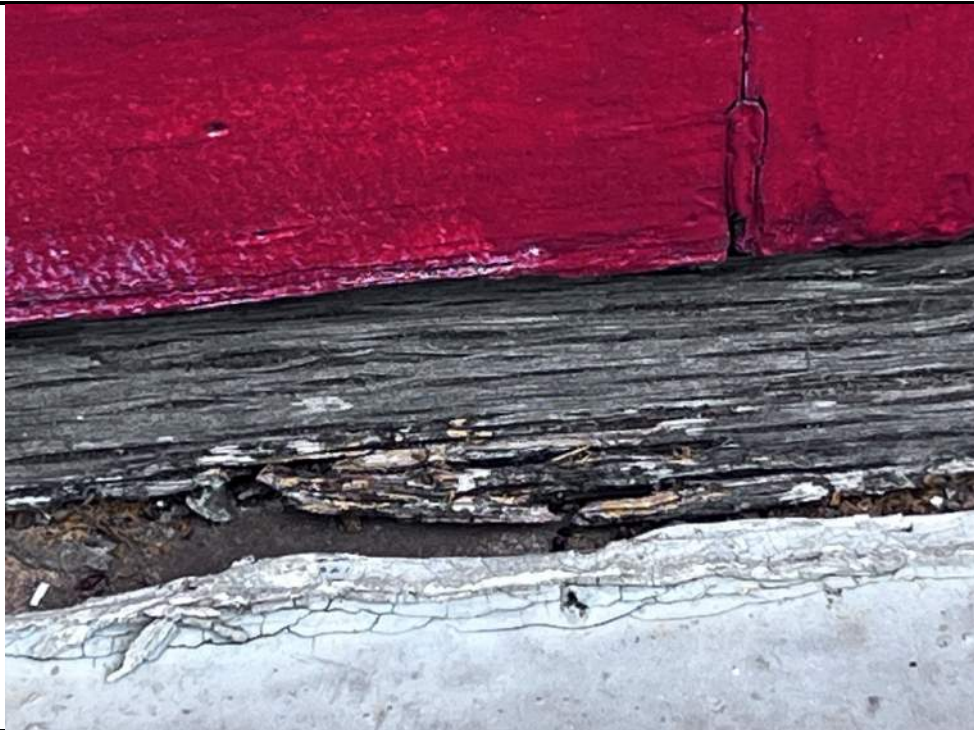
**Photo 53:** Threshold sill below door exposed and rotted

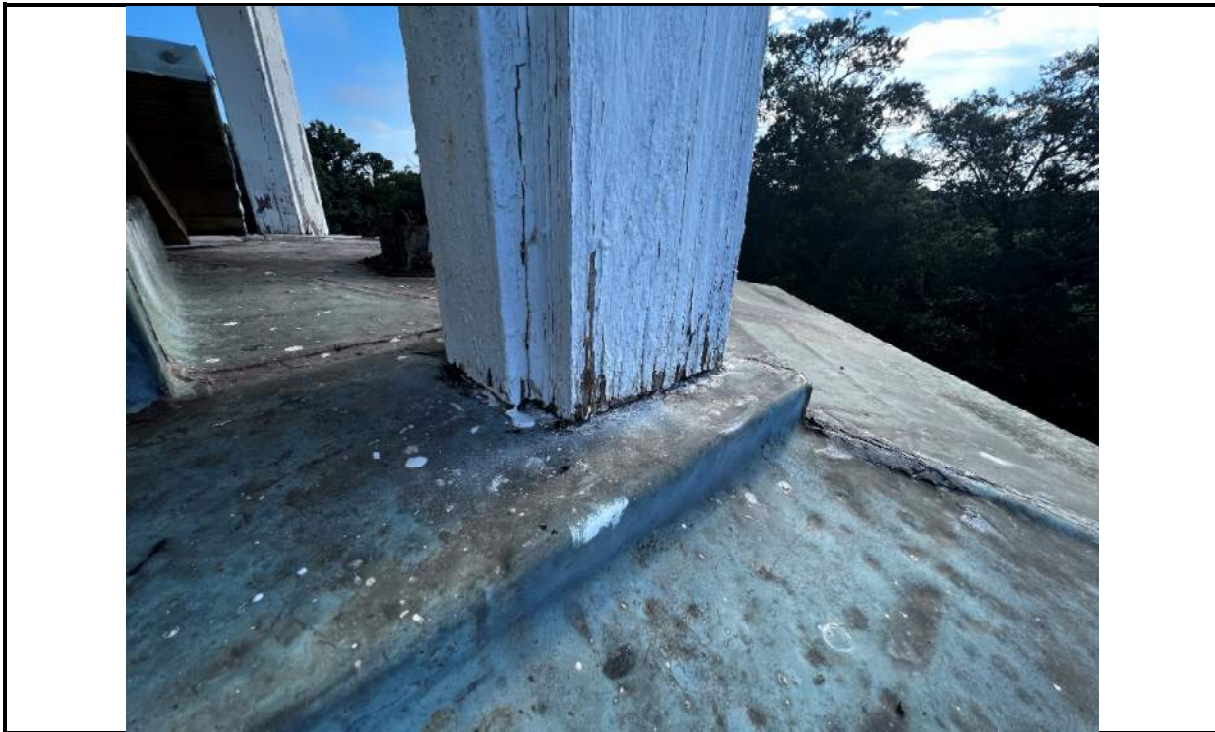
**Photo 57:** Steel roof support post exhibiting weathering and cracking

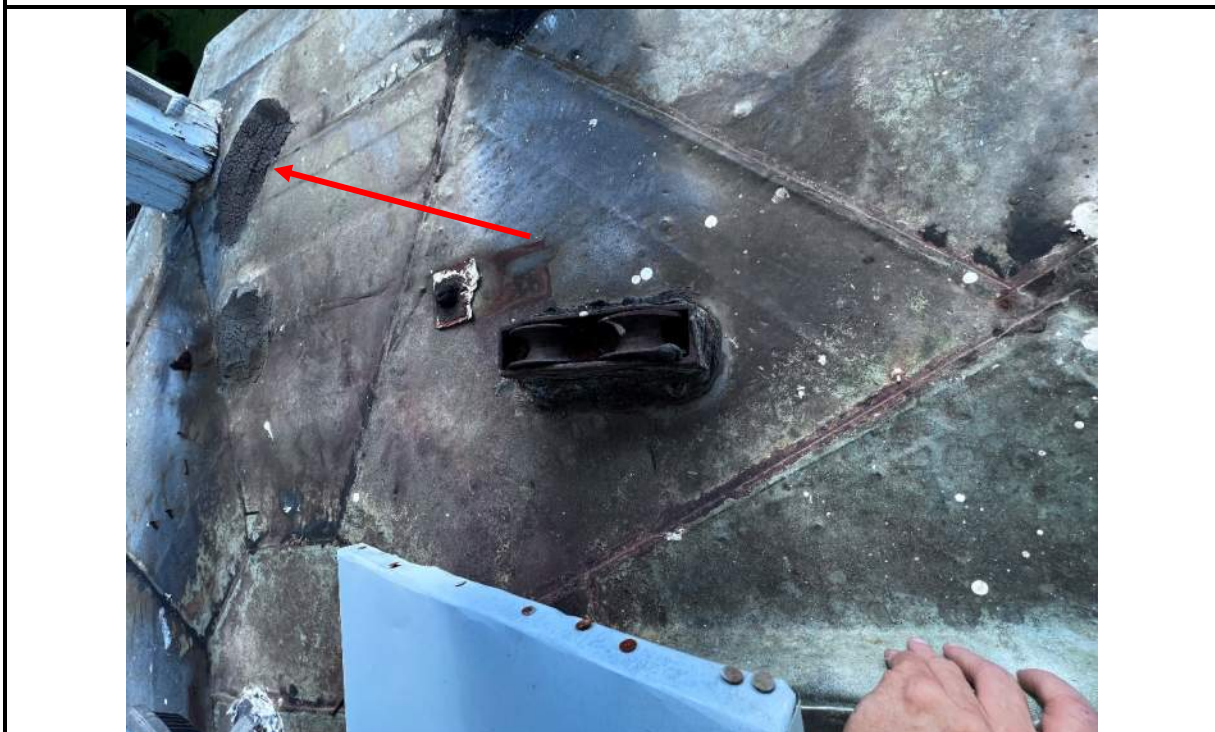
**Photo 58:** Previous repairs performed are temporary in nature and need to be maintained

- Remove and replace the existing shingle roofing
- Scrape and clean wood fascia, repair cracks and repaint
- Remove existing inappropriate repairs in copper roofing and properly patch
- Clean and resolder existing flat seam copper flooring
- Replace brick with spalled or broken brick faces

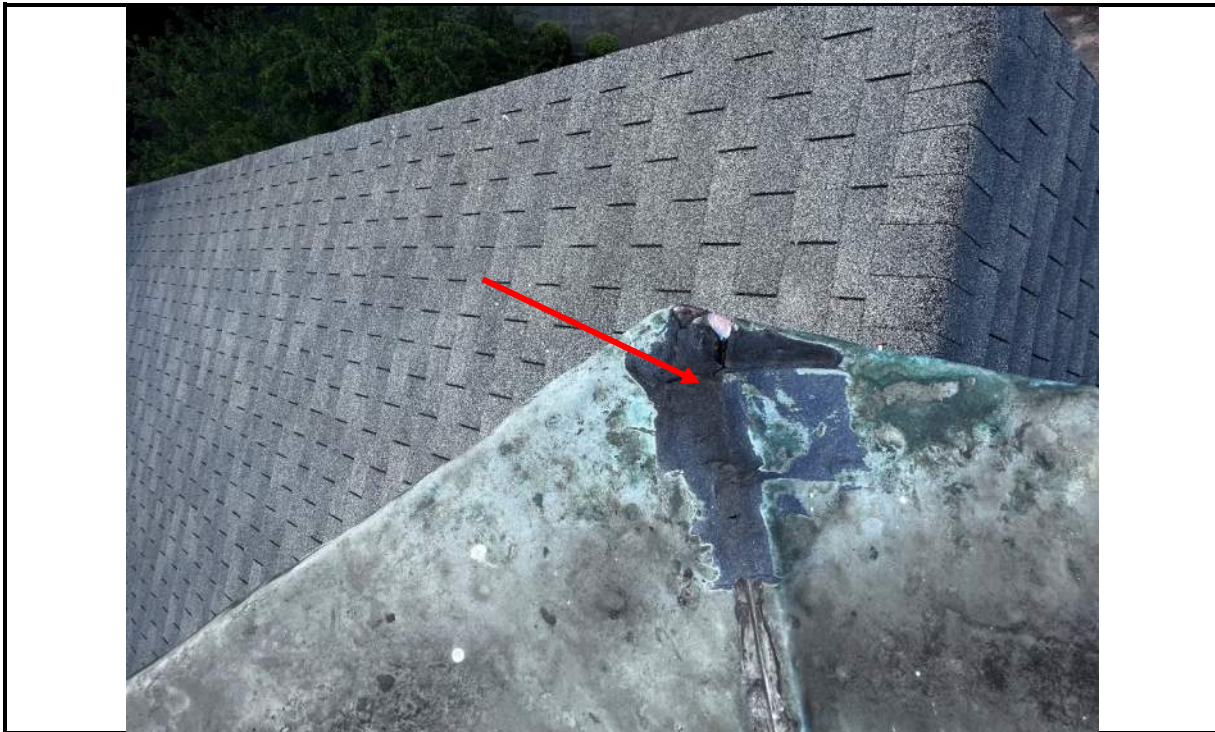
**Photo 59:** Previous repairs performed are temporary in nature and need to be maintained

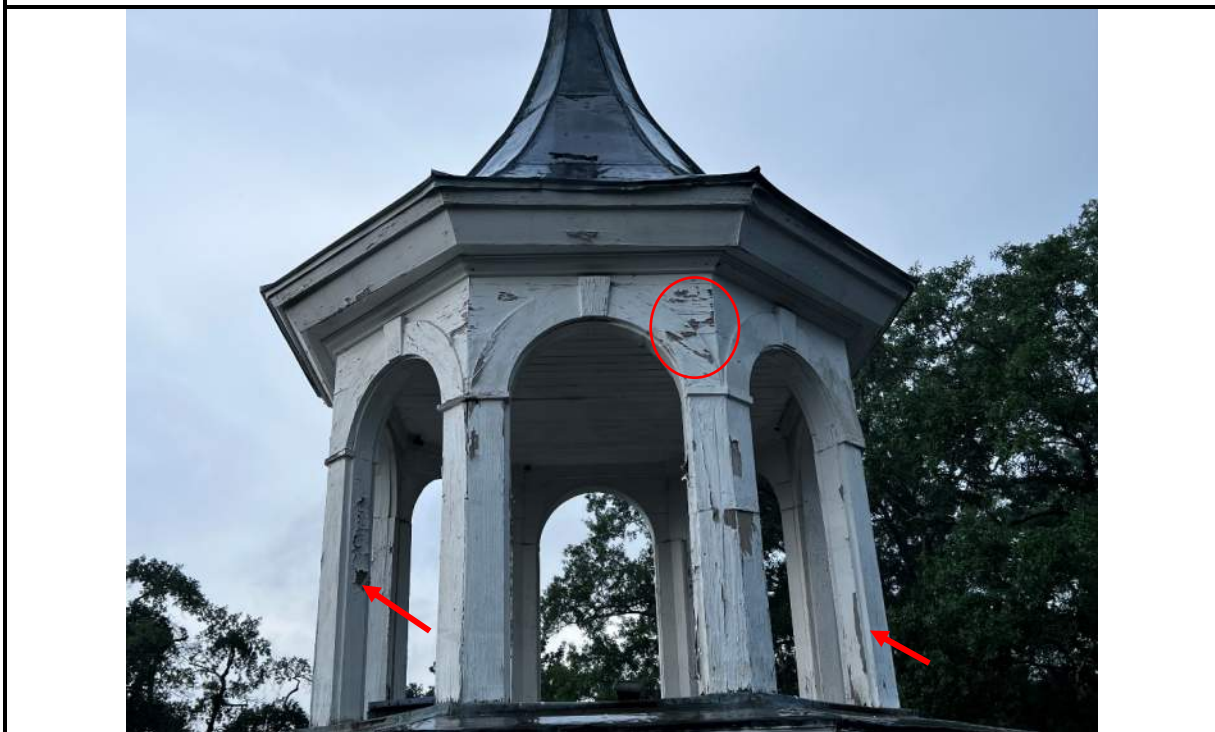
**Photo 60:** Overview of conditions typical all sides, paint in poor condition and exposed wood causing checking and cracking of the wood.

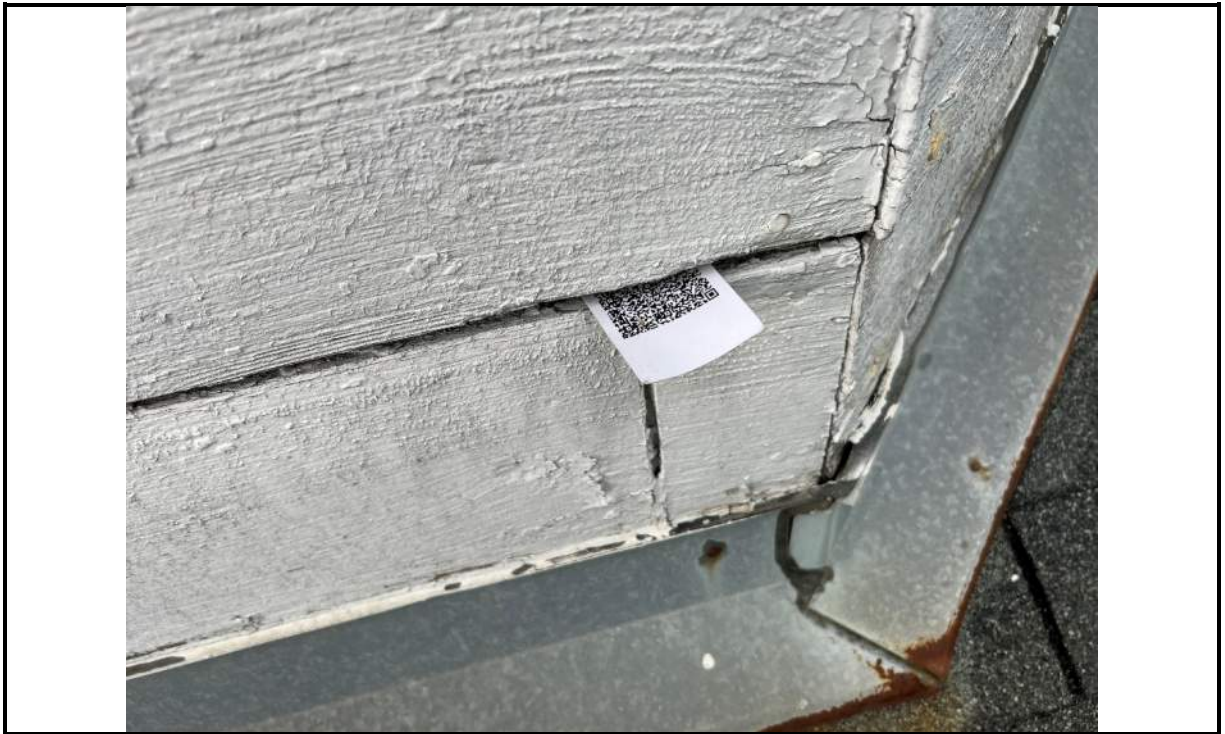
**Photo 61:** Steeple exterior wall panel in location of visible light in attic space (ref. photo 15)

- Check stability of the loose keystone located above the center of the arched window on east elevation, reattach as necessary as soon as it potentially appears to be safety issue.
- Seal up open gaps on the exterior of the steeple tongue and groove wall panels
- Low sloped shingled dormer, replace shingles with appropriate roofing system, clean, prime and repaint exposed wood trim

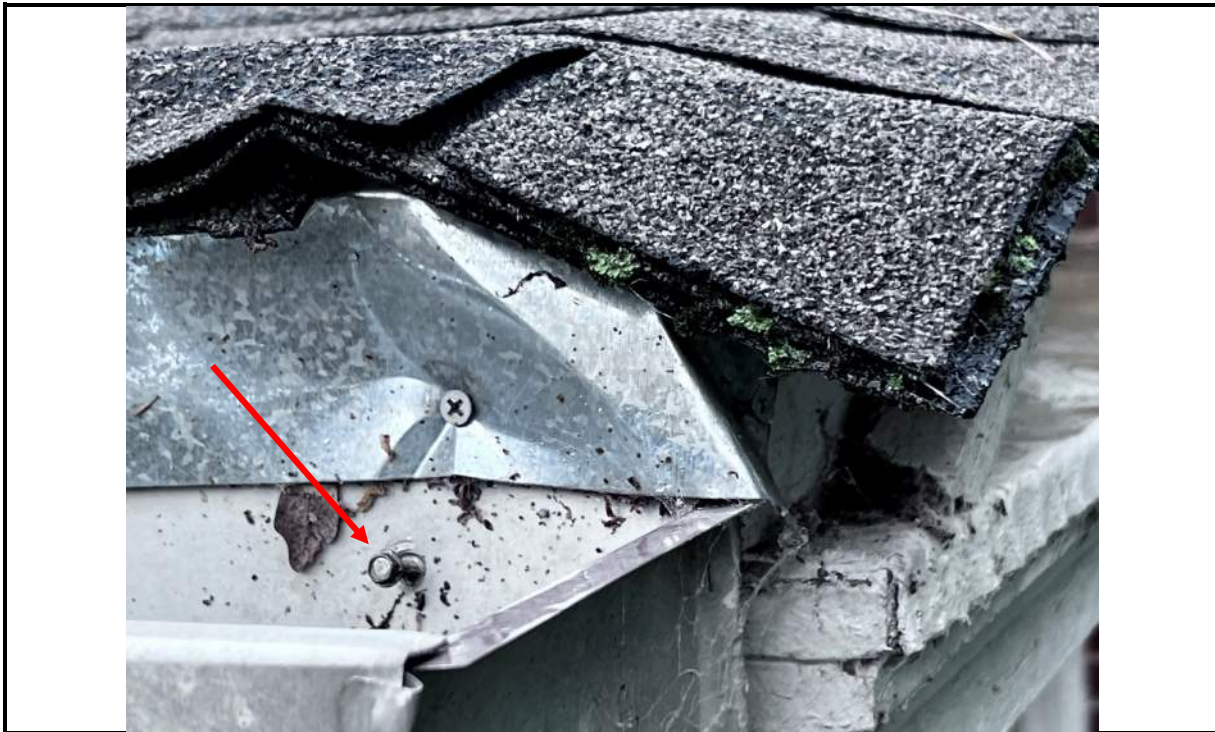
**Photo 63:** Poorly performed edge metal flashing, also note loose gutter screw

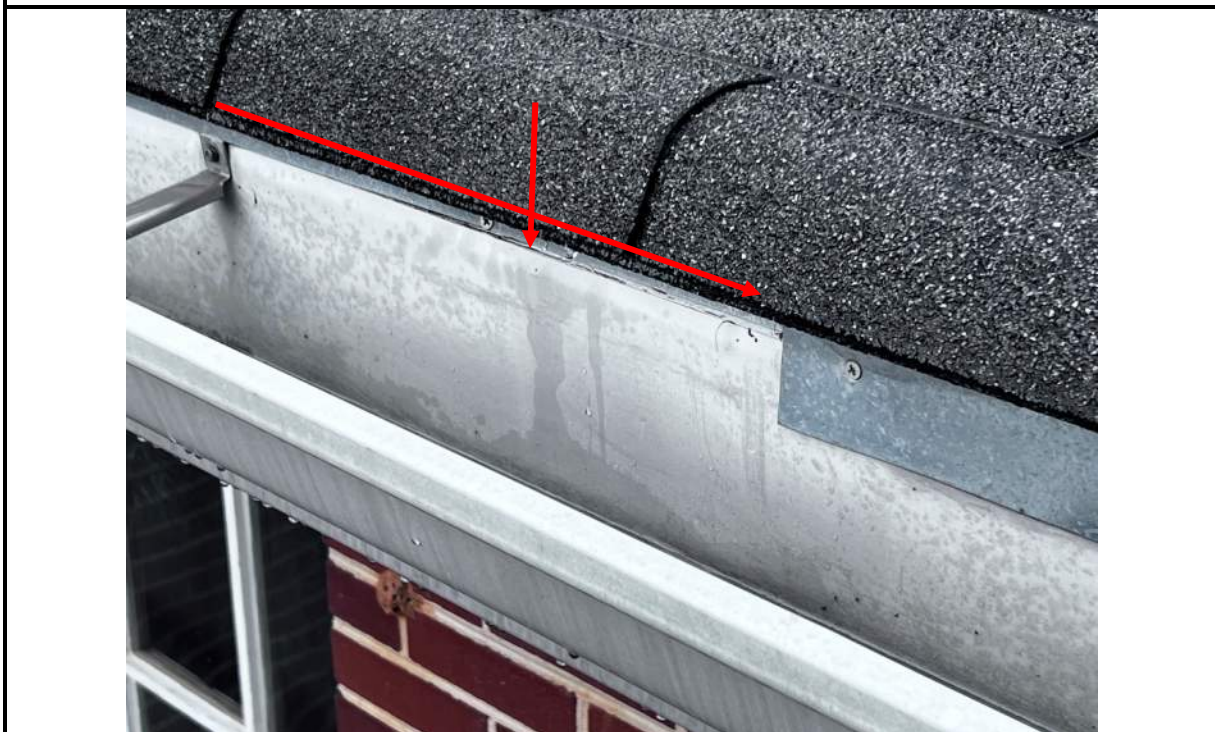
**Photo 64:** Shingle or edge metal does not cover the exposed top edge of gutter, roof may drip at this location

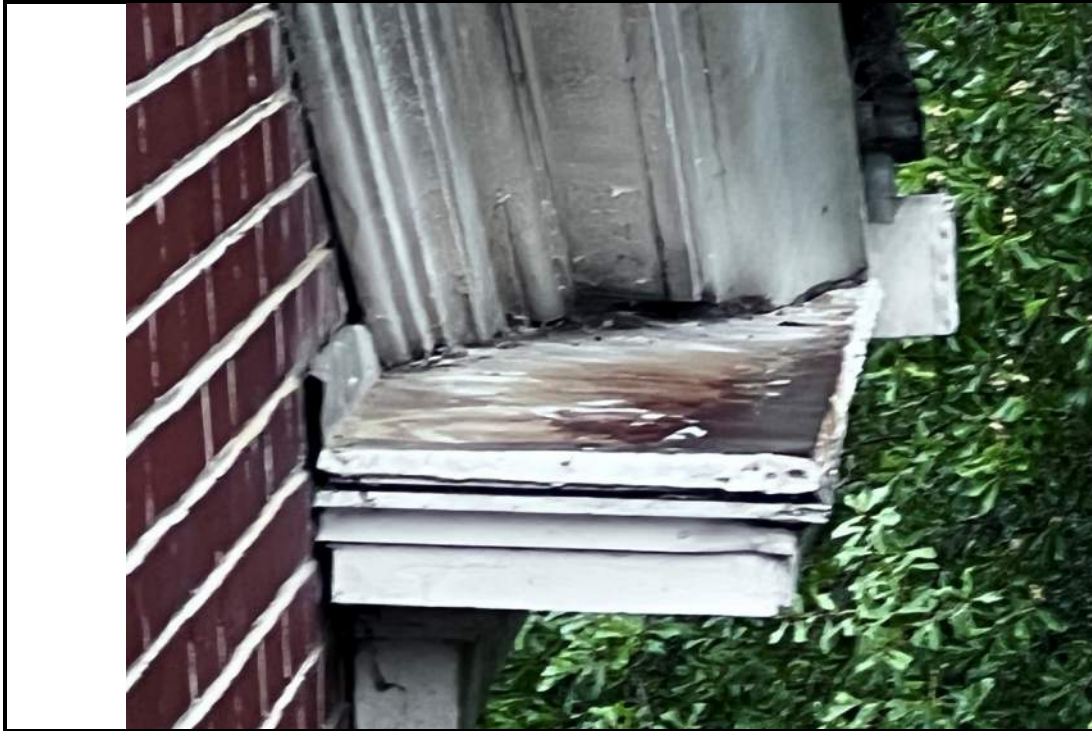
**Photo 65:** Metal cornice return cap exhibits some corrosion
