# REPORT OF NOVA SERVICES

**Cherokee County Arts Center**  
Canton, Cherokee County, Georgia

**Subject:** Limited Environmental, Structural, and Building Enclosure  
Assessment & Consulting Services Executive Summary Report  
**Cherokee County Arts Center**  
Canton, Cherokee County, Georgia  
NOVA Project Number 10102-3022152

**Subject: Report of Limited Visual Building Envelope Condition Assessment**  
94 North Street  
Canton, Georgia 30114  
NOVA Project Number: 10102-3022152

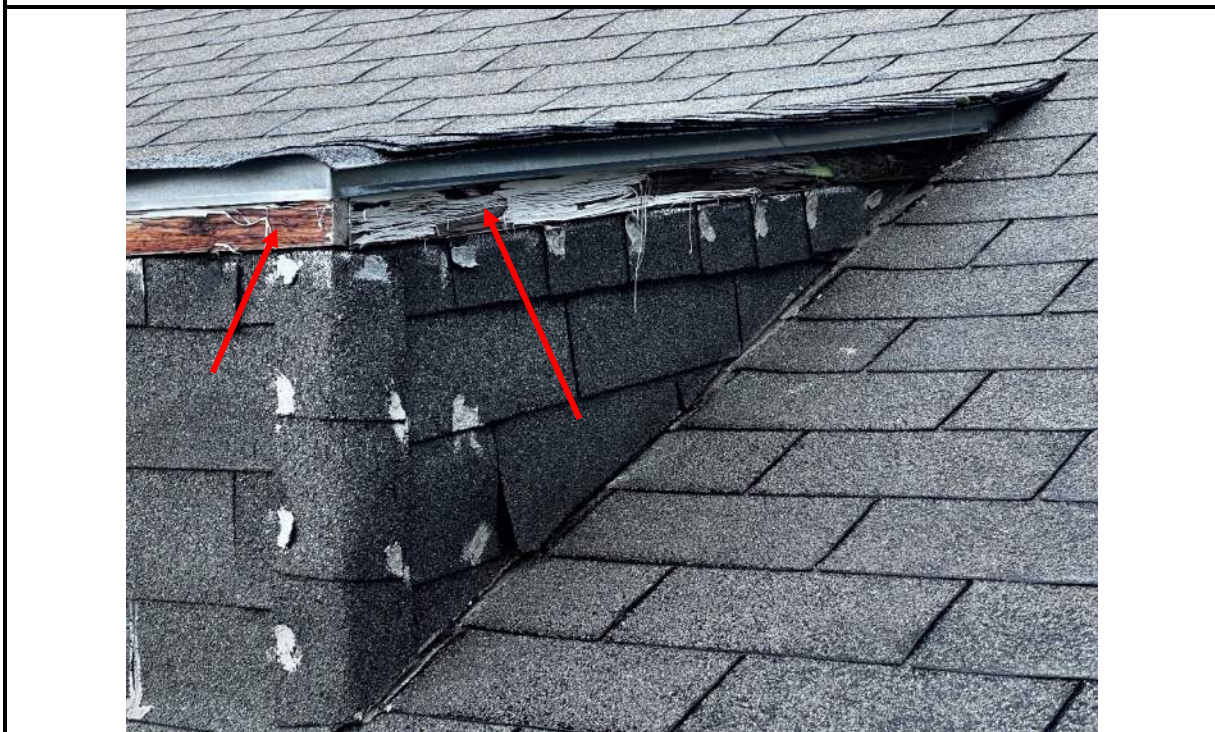
**Photo 74:** Exposed and deteriorated wood on 3-sides of popped up area

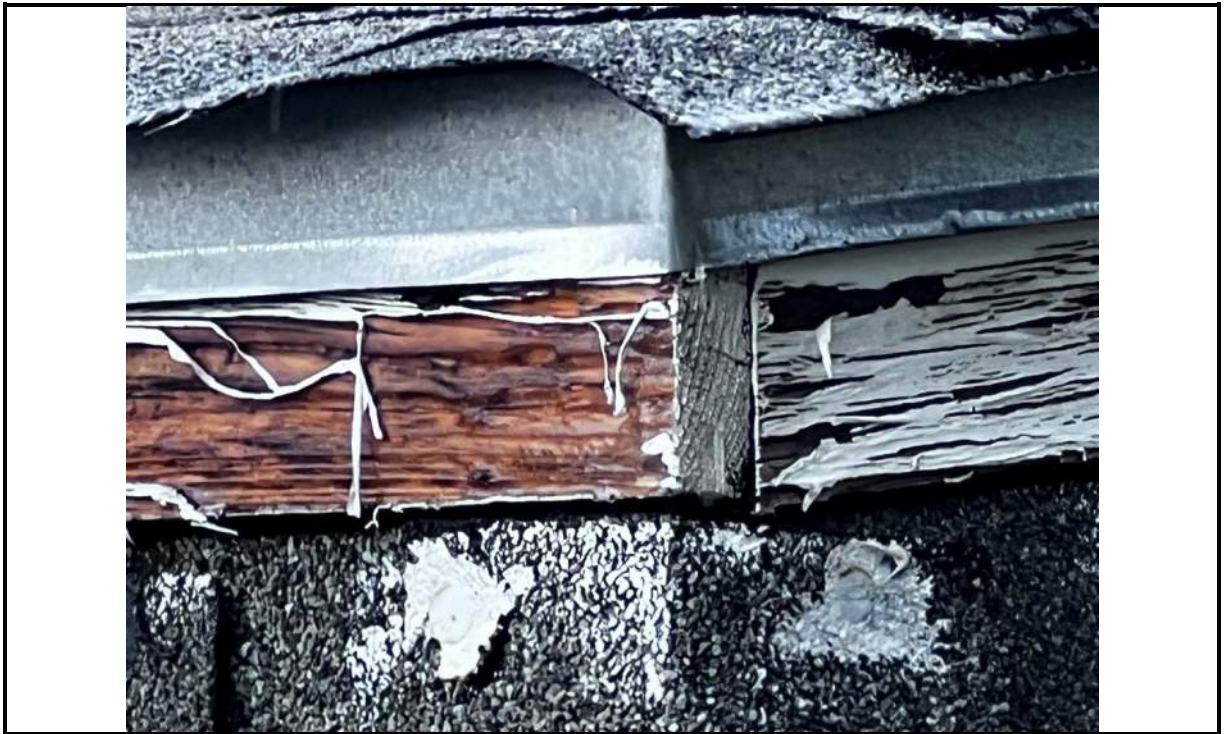
**Photo 75:** Exposed and deteriorated wood on 3-sides of popped up area

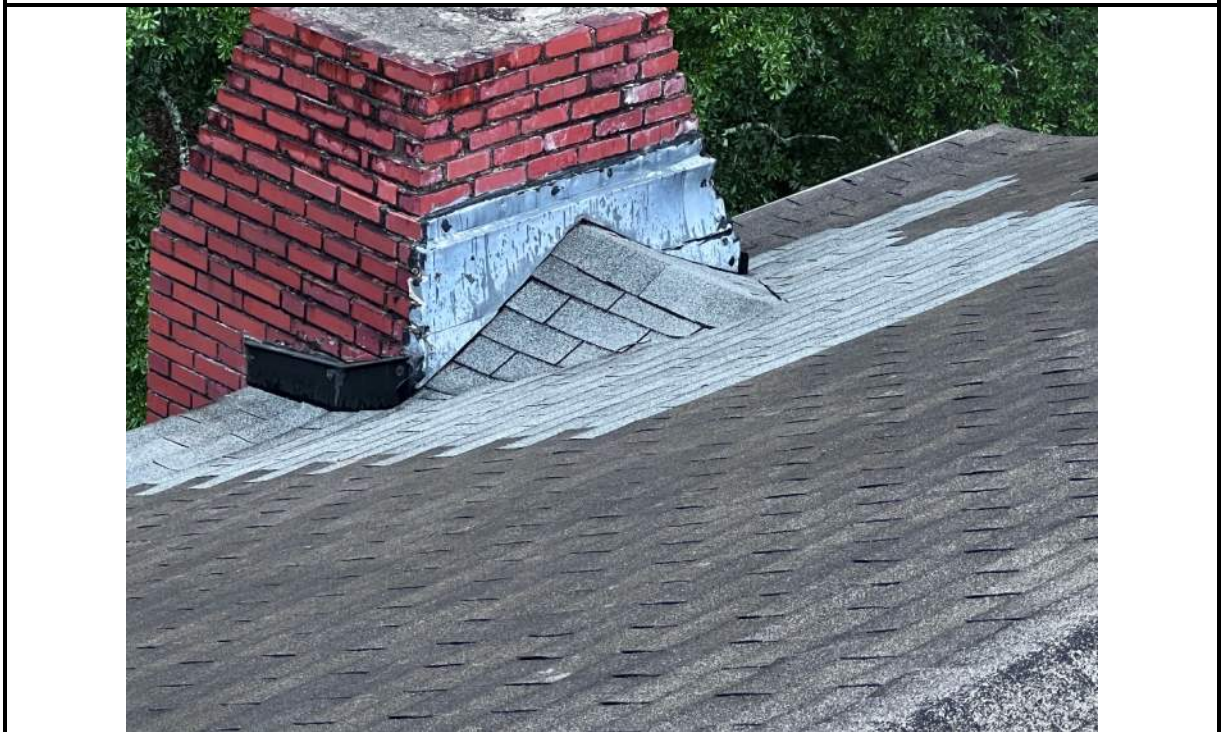
**Photo 76:** Location of previous roof repairs

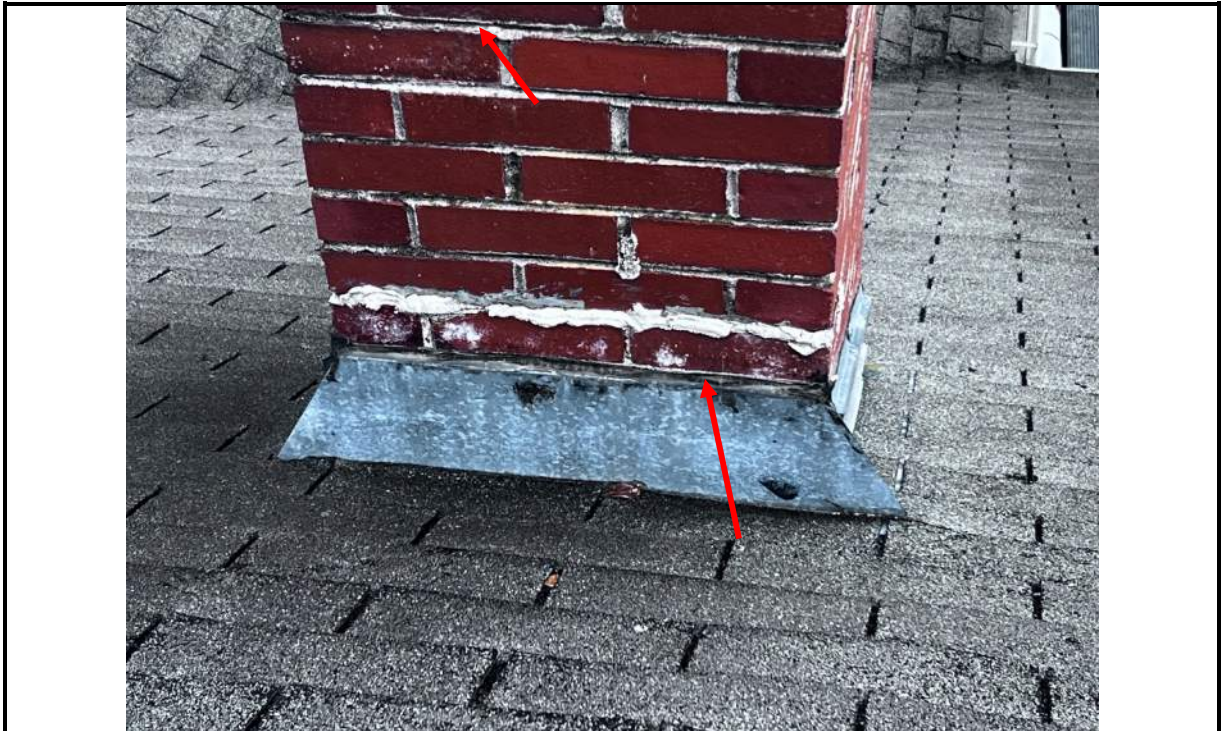
**Photo 77:** Chimney counter flashing exhibited deteriorated sealant as well as mortar erosion

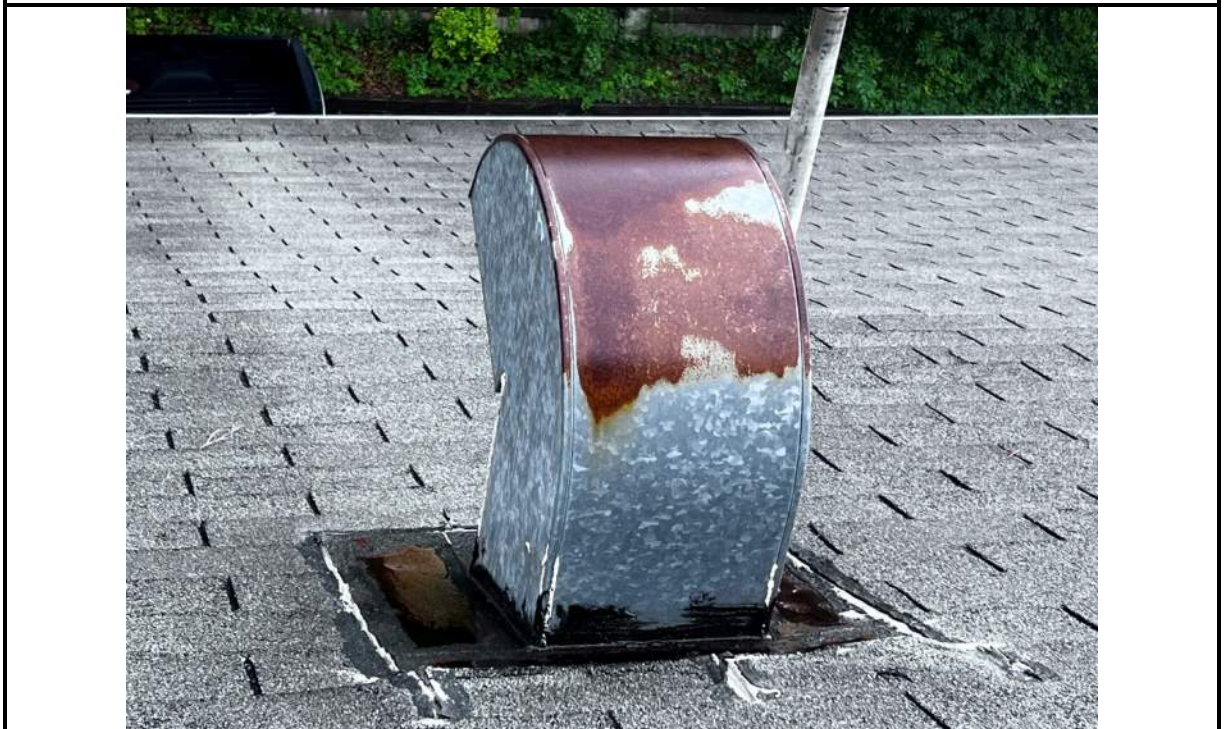
**Photo 78:** Metal component surface corrosion

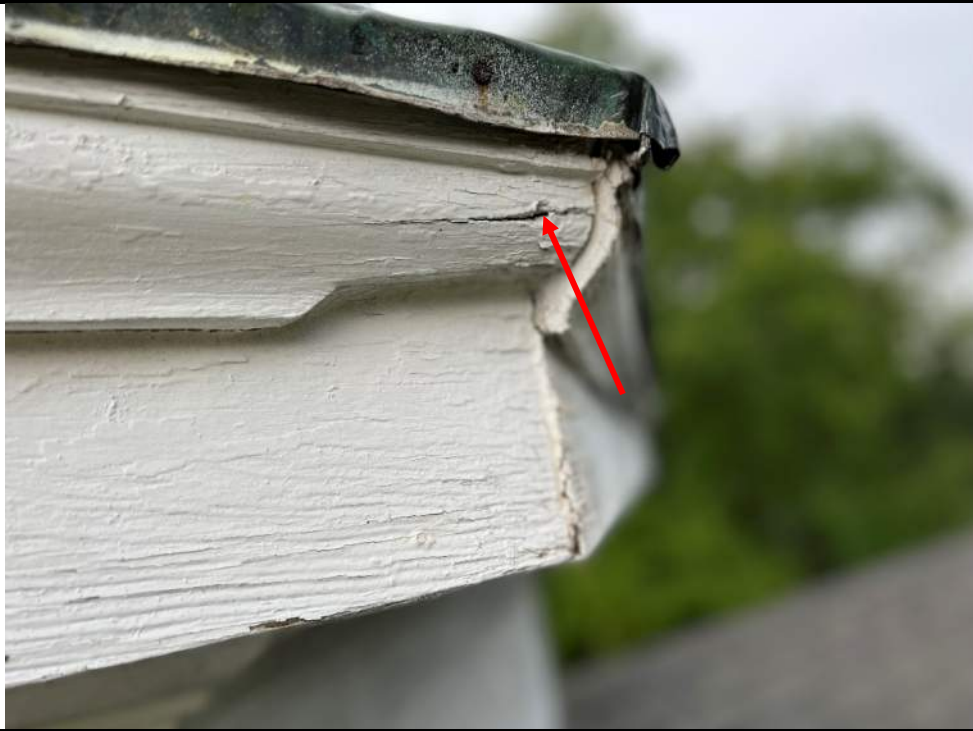
**Photo 79:** Wood trim at eaves and fascia exhibit paint peeling and some cracking

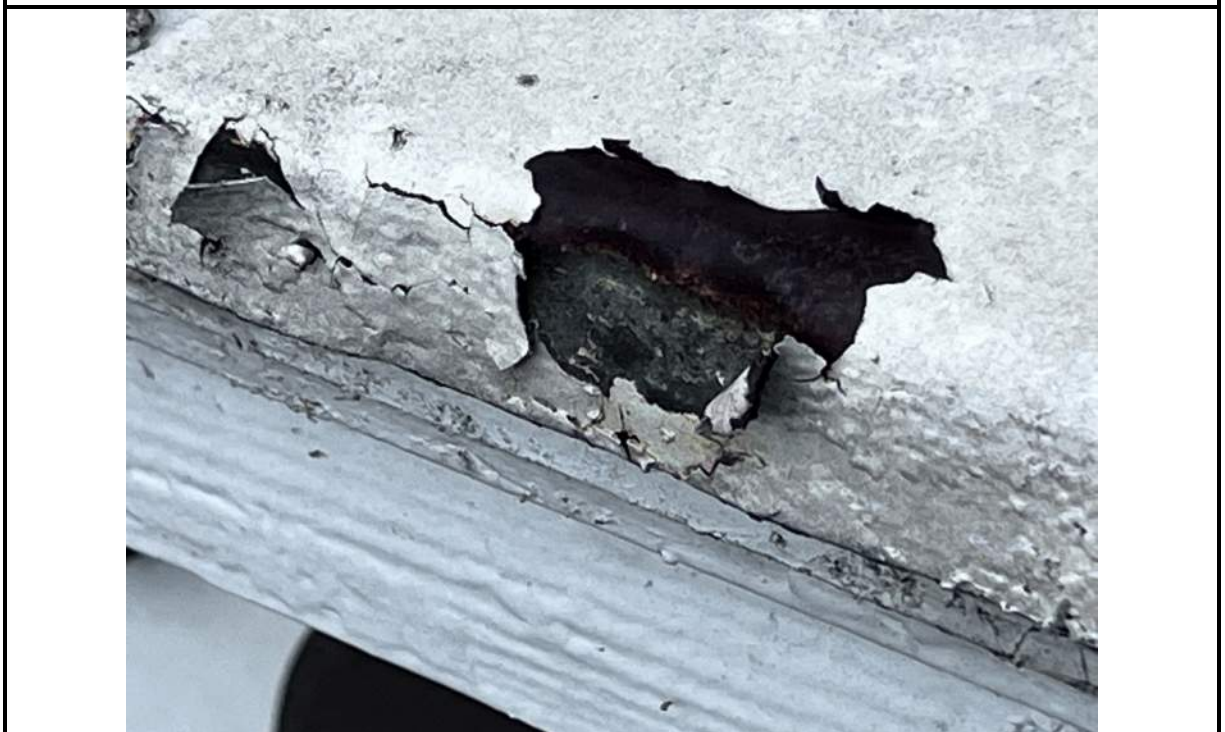
**Photo 84:** Isolated areas of metal corrosion on cornice return.

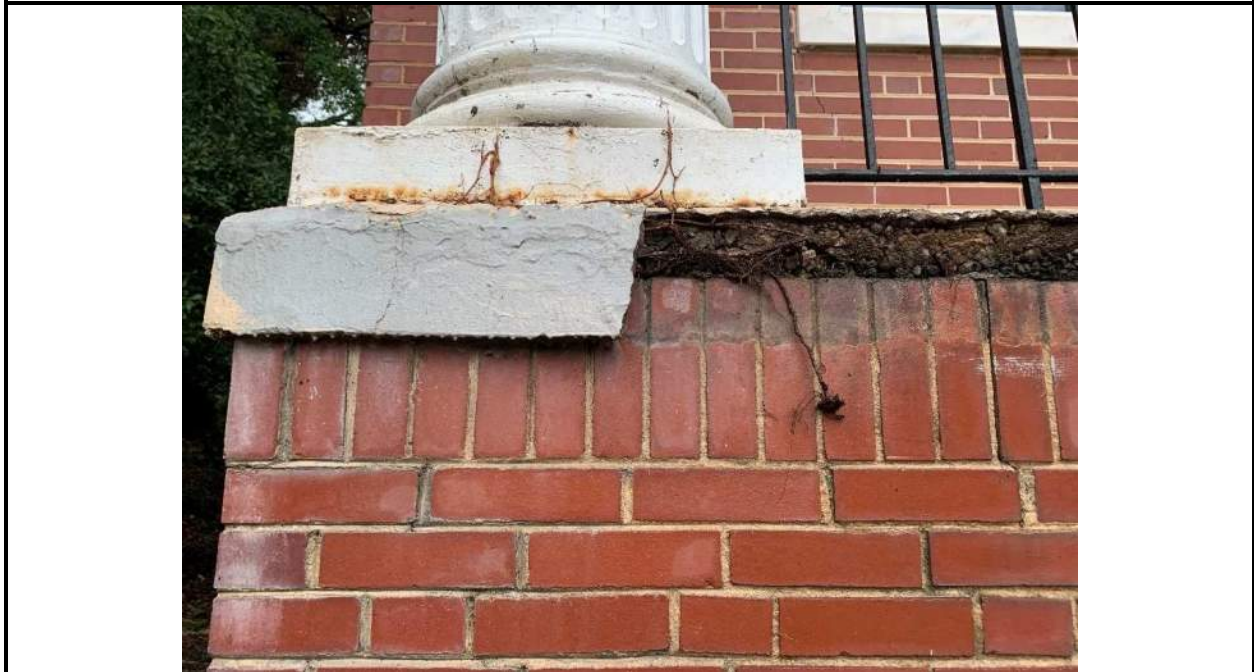
**Photo 5:** More Observed missing elevated concrete slab material and brick facade near south main entrance columns.

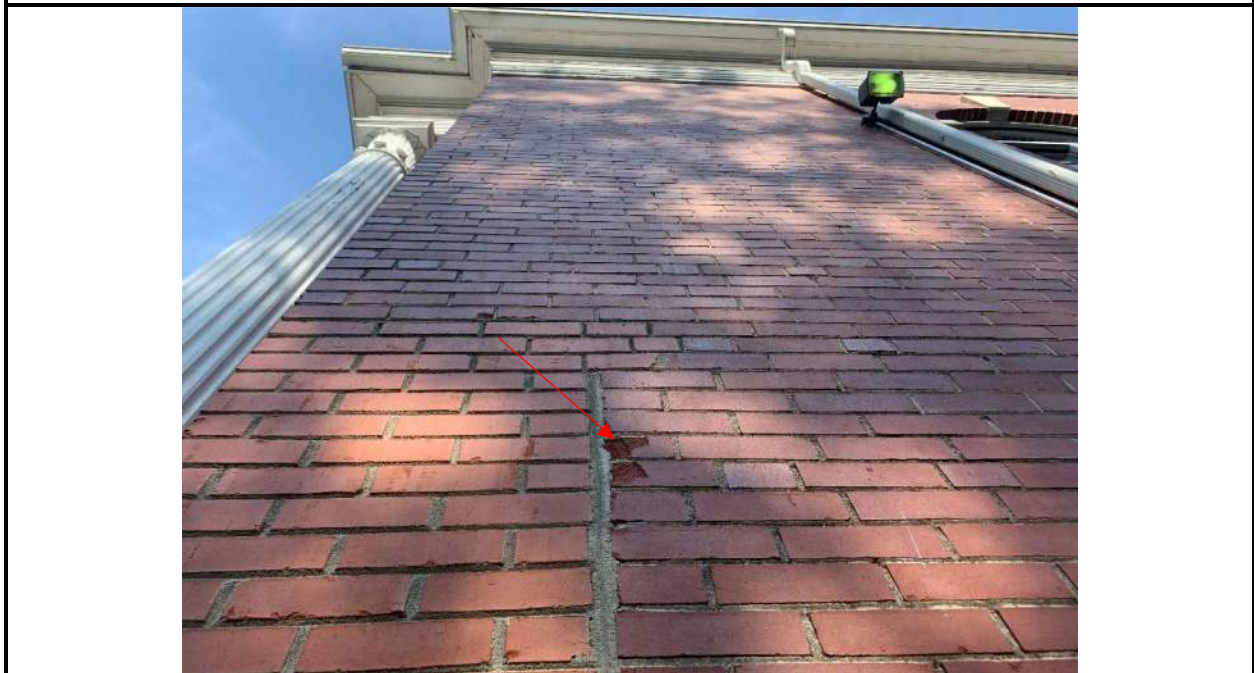
**Photo 6:** Typical exterior brick spall damage. Recommend replace damaged brick.

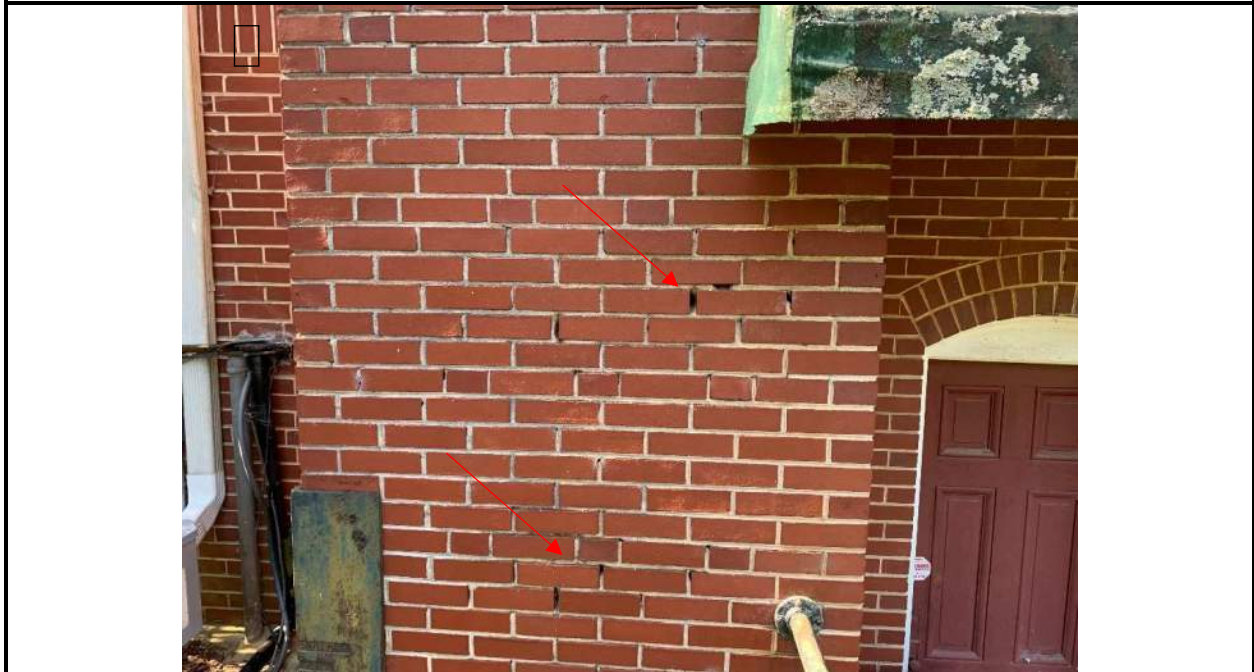
**Photo 7:** Typical mortar loss between exterior masonry brick. Tuckpoint repair recommended.

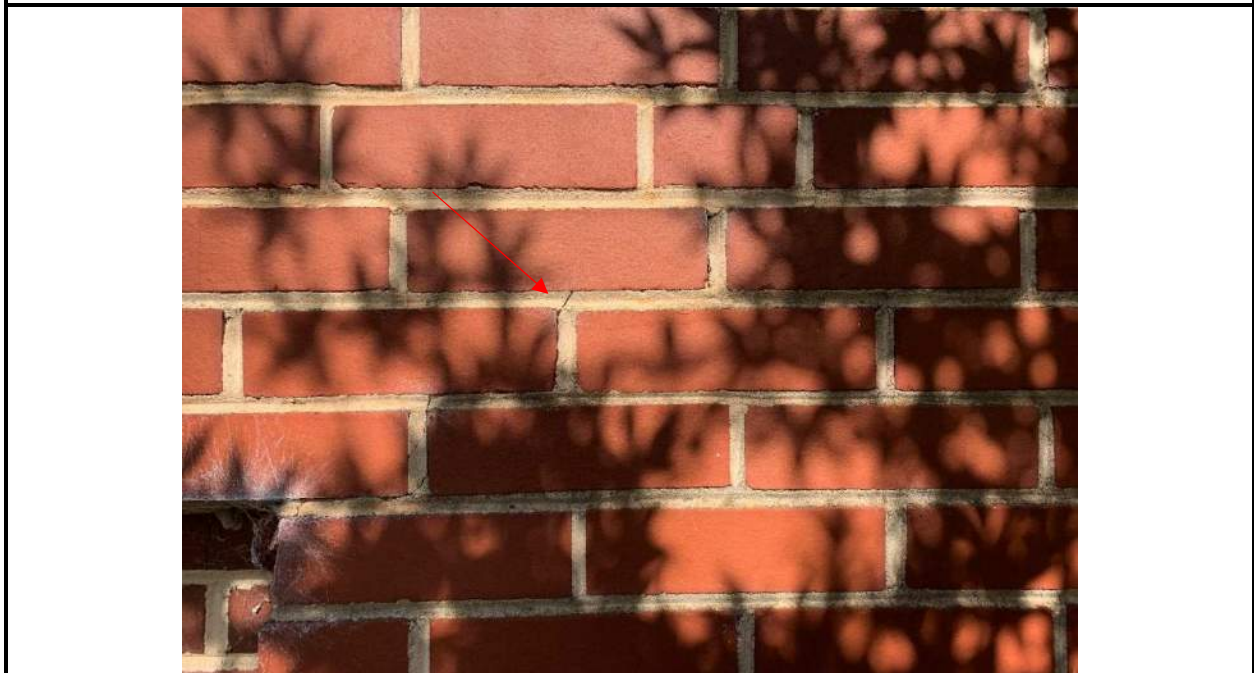
**Photo 8:** Isolated, low-severity stair-step crack in exterior brick façade.

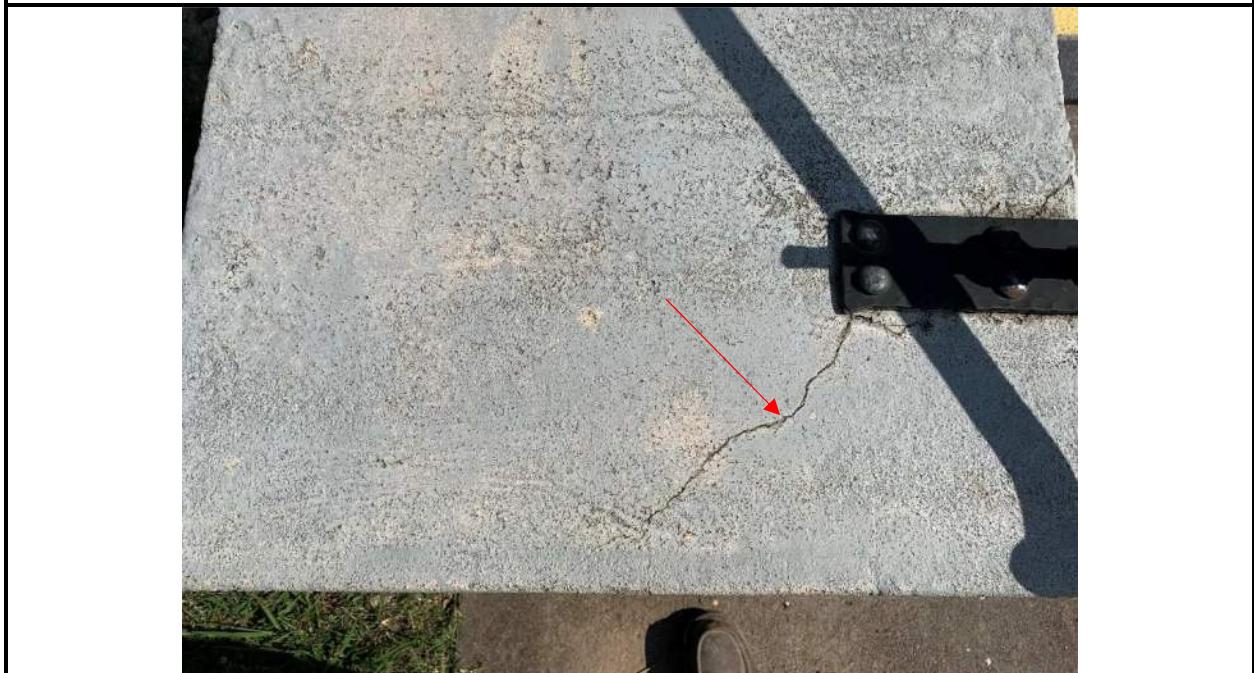
**Photo 18:** Previous stairwell and handrail, near grade. Crack width approximately 0.125 inches. Clean and apply elastomeric coating should be considered.

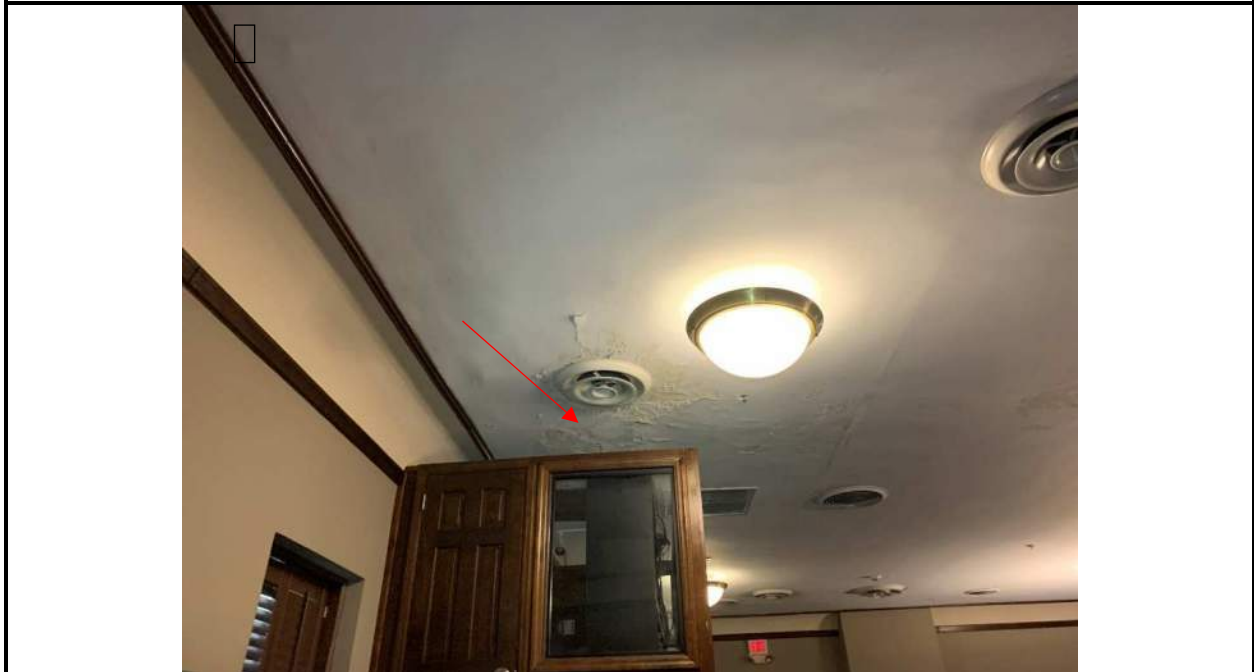
**Photo 25:** Observed second floor peeling paint in ceiling of theatre room. Possible water infiltration related damage.

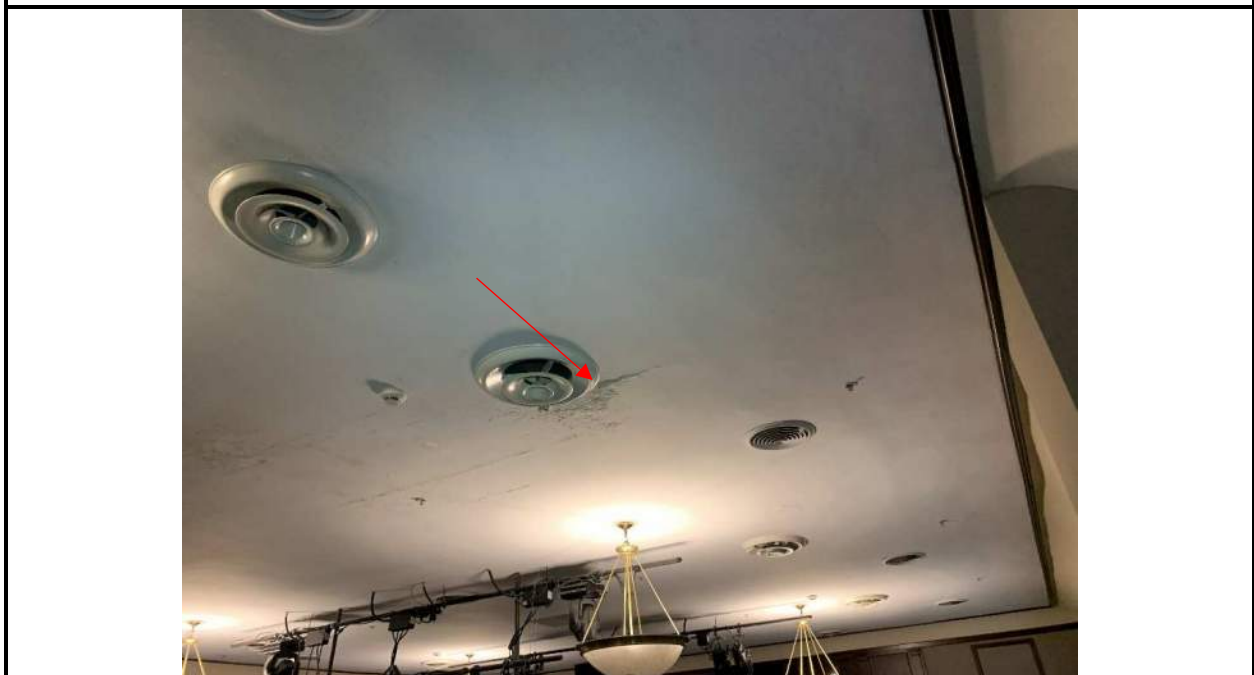
**Photo 26:** More observed second floor peeling paint in ceiling of theatre room. Possible water infiltration related damage.
