# REPORT OF ENVIRONMENTAL SERVICES

**2017 East Cherokee Drive  
Woodstock, Cherokee County, Georgia**

NOVA Project Number: 10102-3023022

**Subject:** Report of Environmental Services  
**2017 East Cherokee Drive**  
Woodstock, Cherokee County, Georgia  
NOVA Project Number 10102-3023022

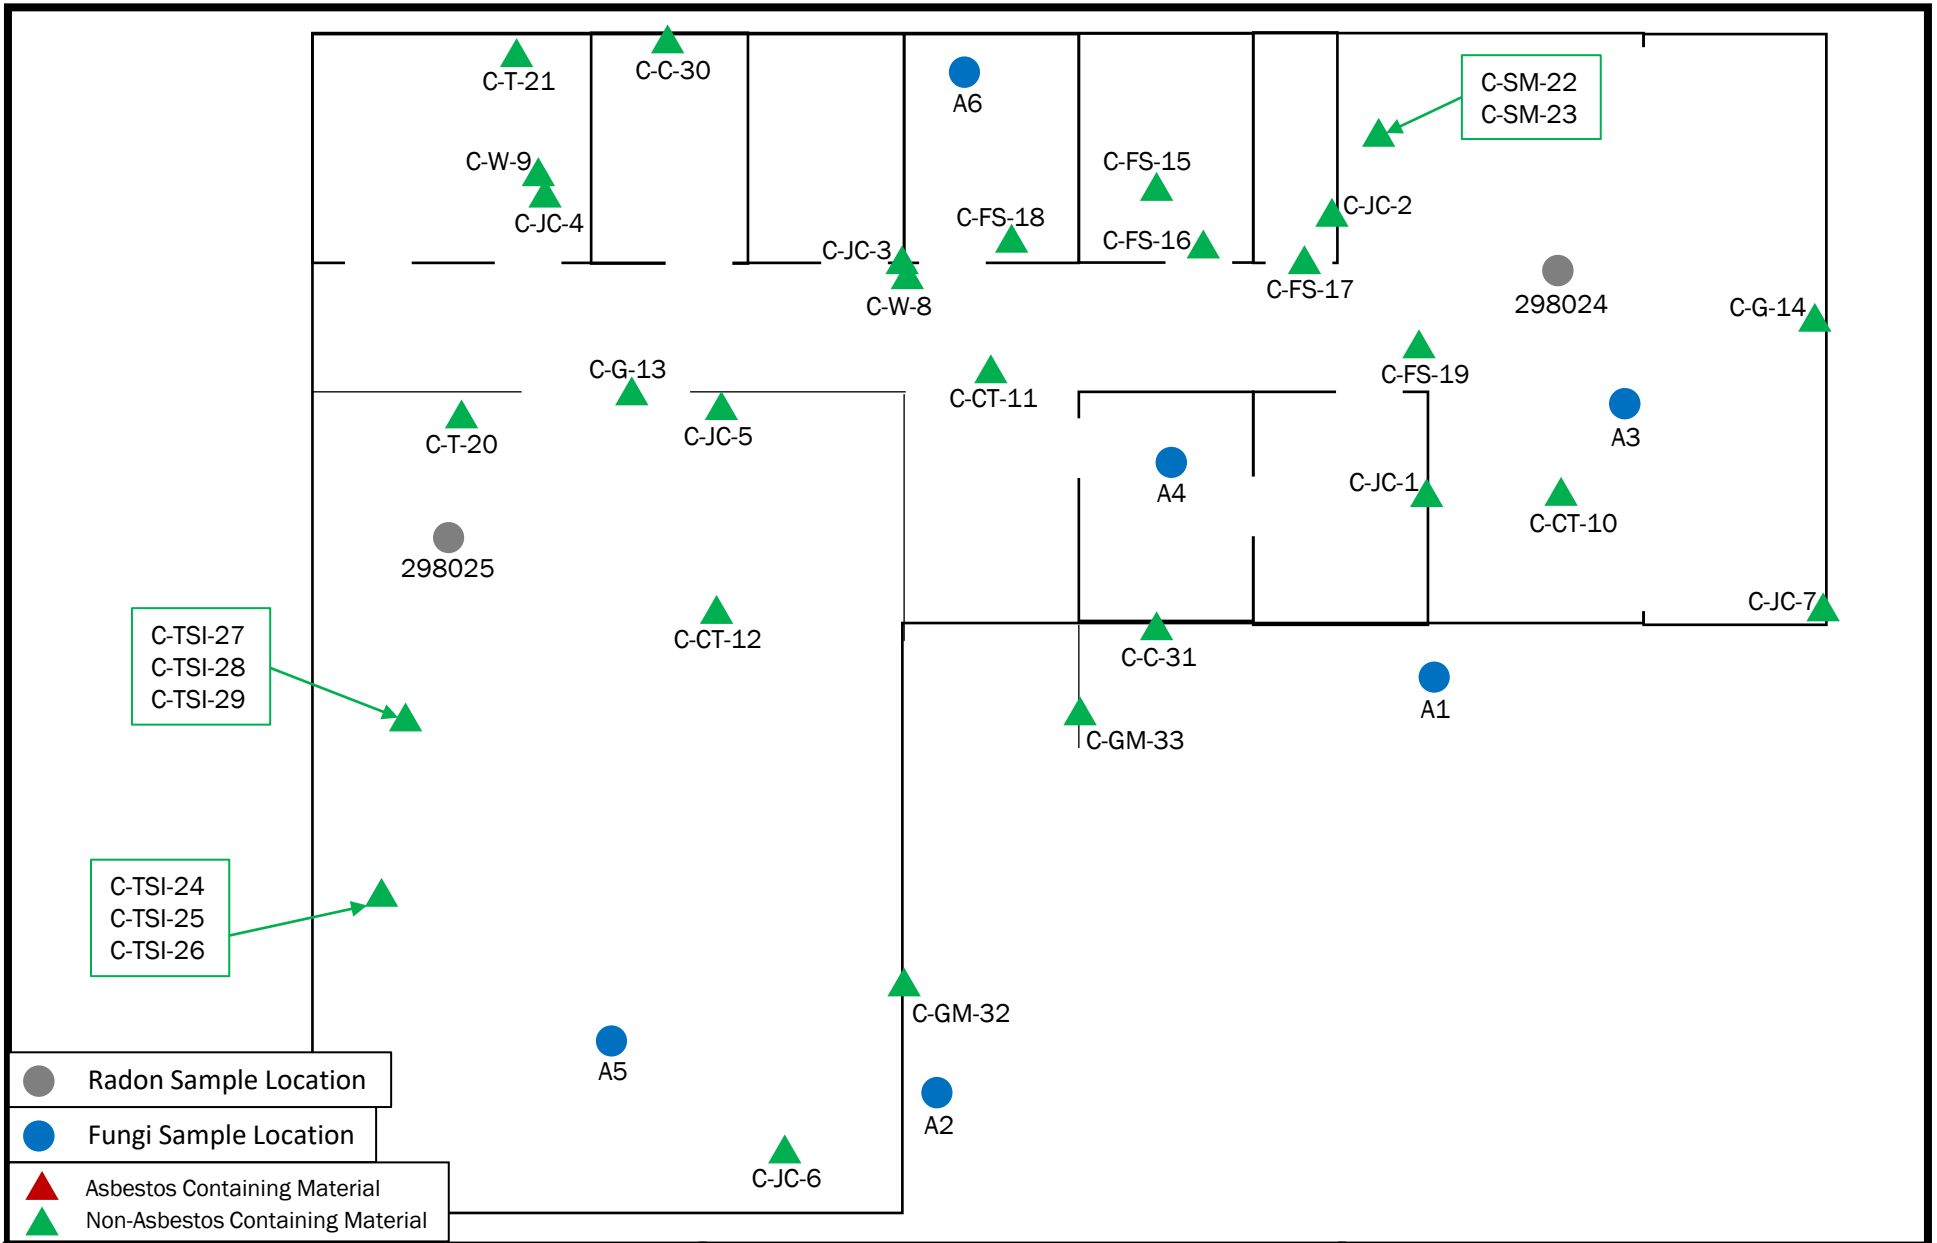
SAMPLE LOCATION PLAN

During this study, thirty-three (33) samples (containing 33 total layers) of joint compound, wallboard, ceiling texture, glue, floor sheeting, vapor barrier, mastic, Thermal System Insulation (TSI), caulking, grout, and mortar were analyzed by NOVA using Polarized Light Microscopy (PLM) with no analyzed samples indicating Asbestos Containing Material (ACM). A sample location plan is included in Appendix A of this Report.
