# REPORT OF NOVA SERVICES

**Cherokee County Arts Center**  
Canton, Cherokee County, Georgia

**Subject:** Limited Environmental, Structural, and Building Enclosure  
Assessment & Consulting Services Executive Summary Report  
**Cherokee County Arts Center**  
Canton, Cherokee County, Georgia  
NOVA Project Number 10102-3022152

**Subject: Report of Limited Visual Building Envelope Condition Assessment**  
94 North Street  
Canton, Georgia 30114  
NOVA Project Number: 10102-3022152

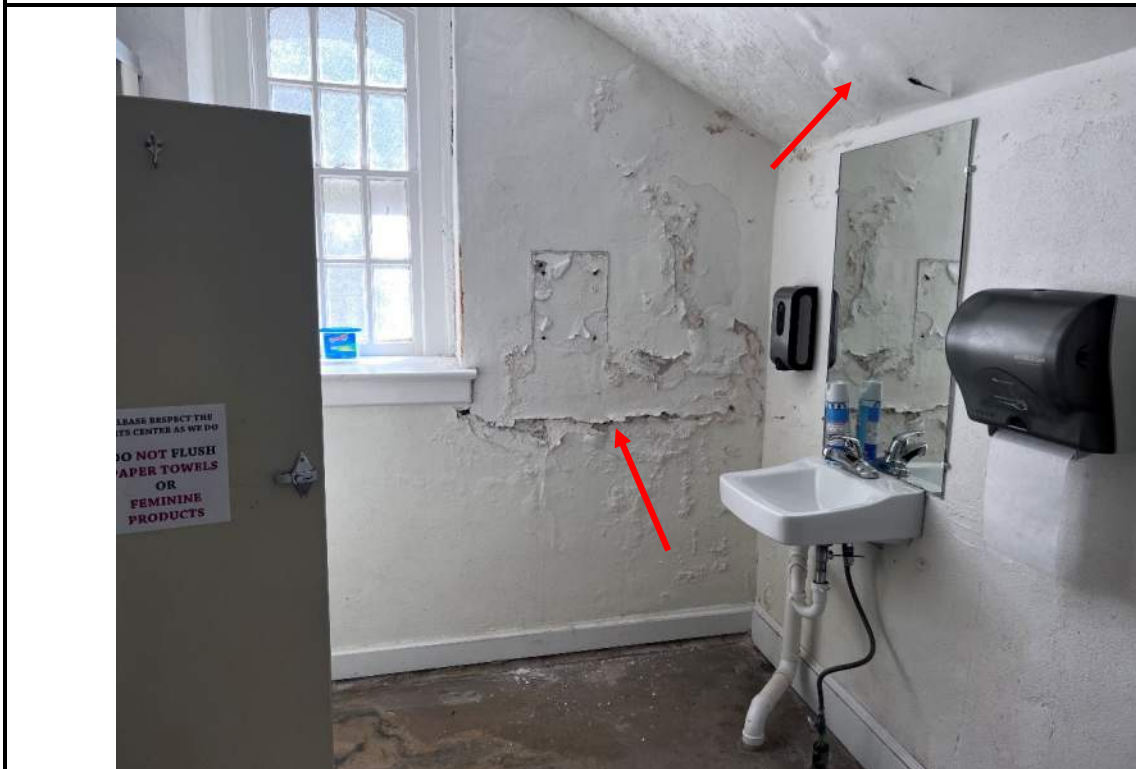
**Photo 6:** Blistered paint filled with efflorescence, south women's restroom, located below from exterior stairs

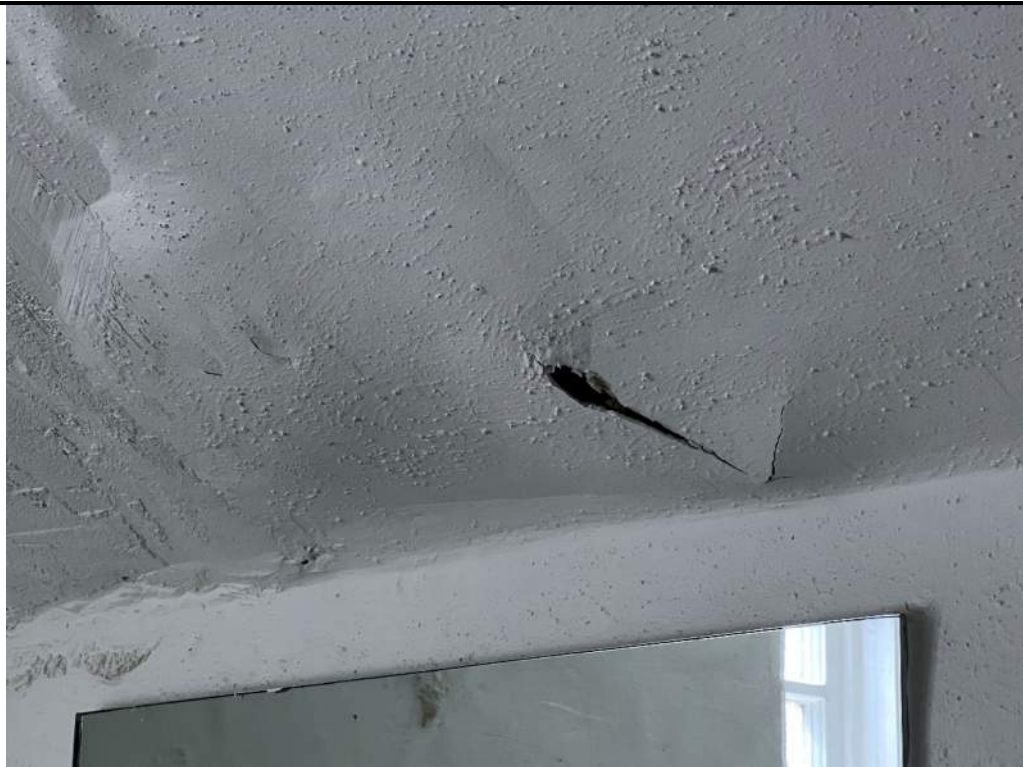
**Photo 8:** Paint blistering in south women's restroom

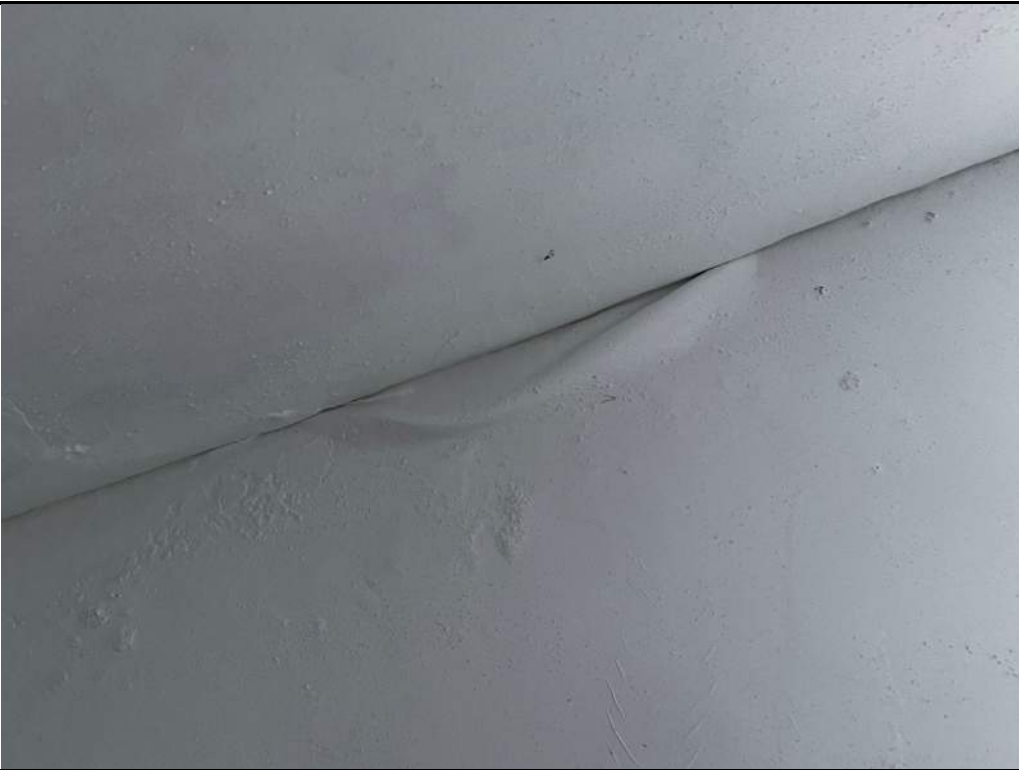
**Photo 9:** Blistered paint

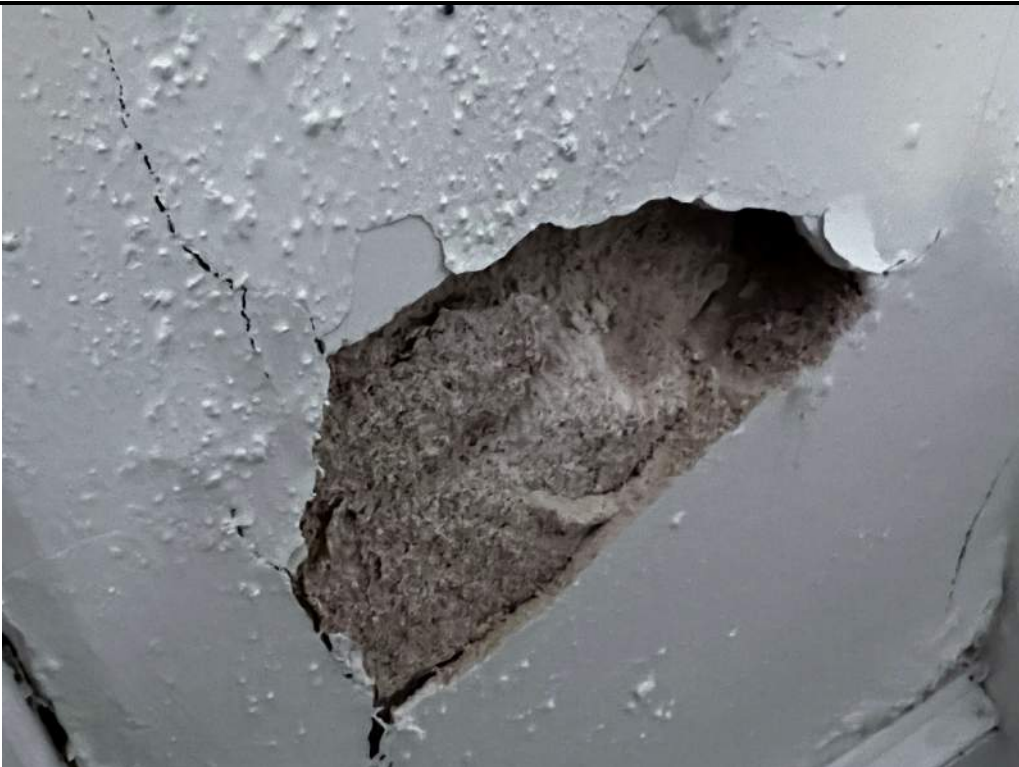
**Photo 10:** Fallen plaster

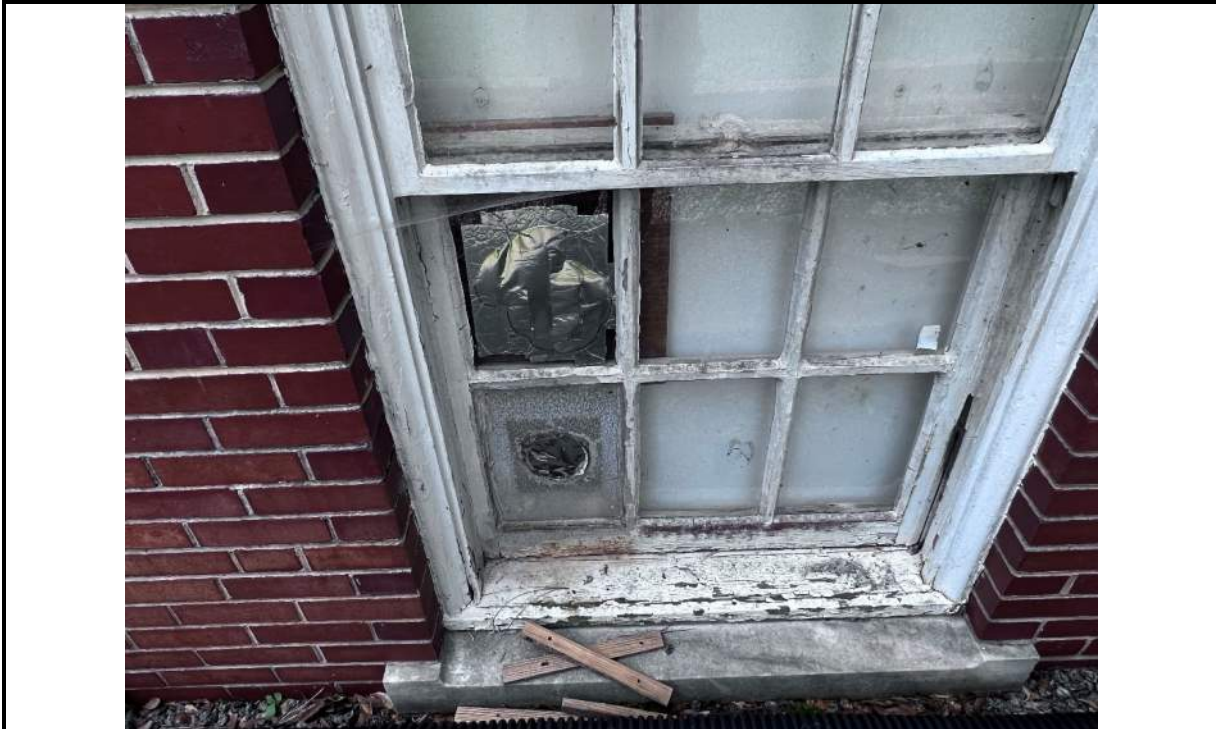
**Photo 45:** Vision lite openings infilled with metal, penetrations abandoned and taped over

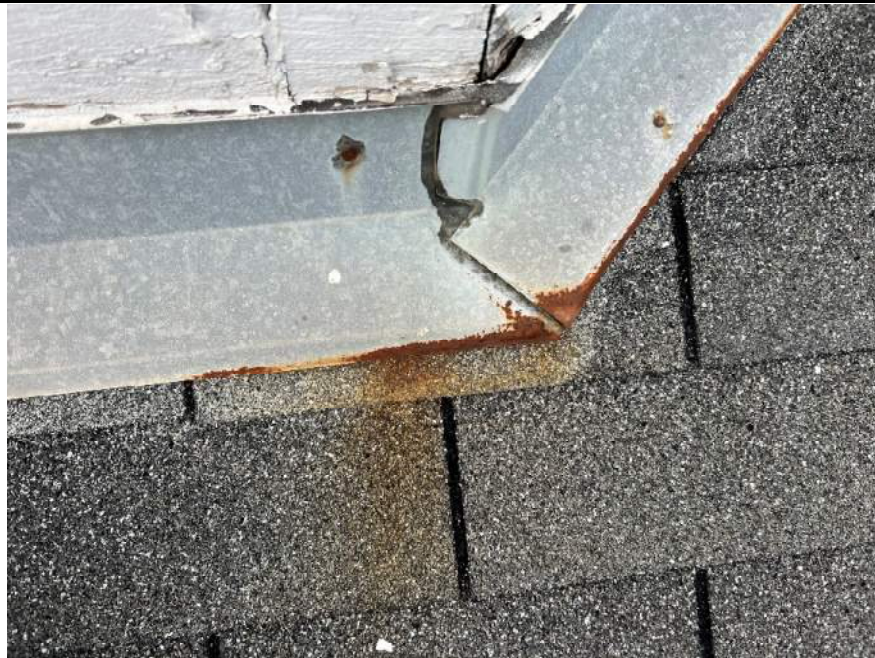
**Photo 66:** Corrosion of metal counter flashing around steeple

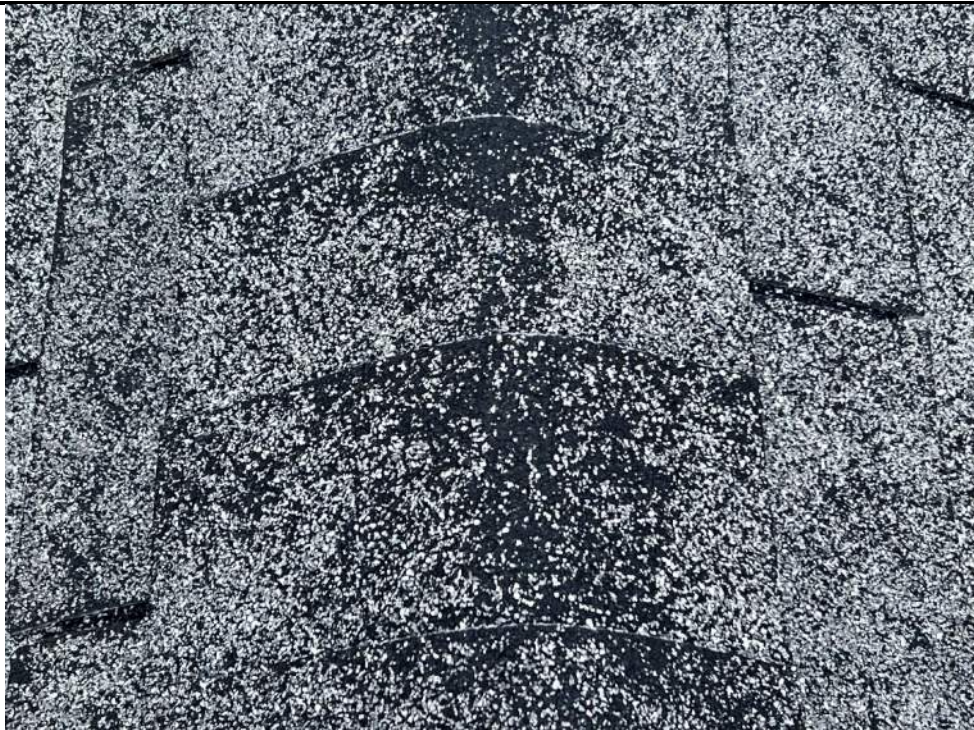
**Photo 67:** Erosion of ceramic granules from shingle surface

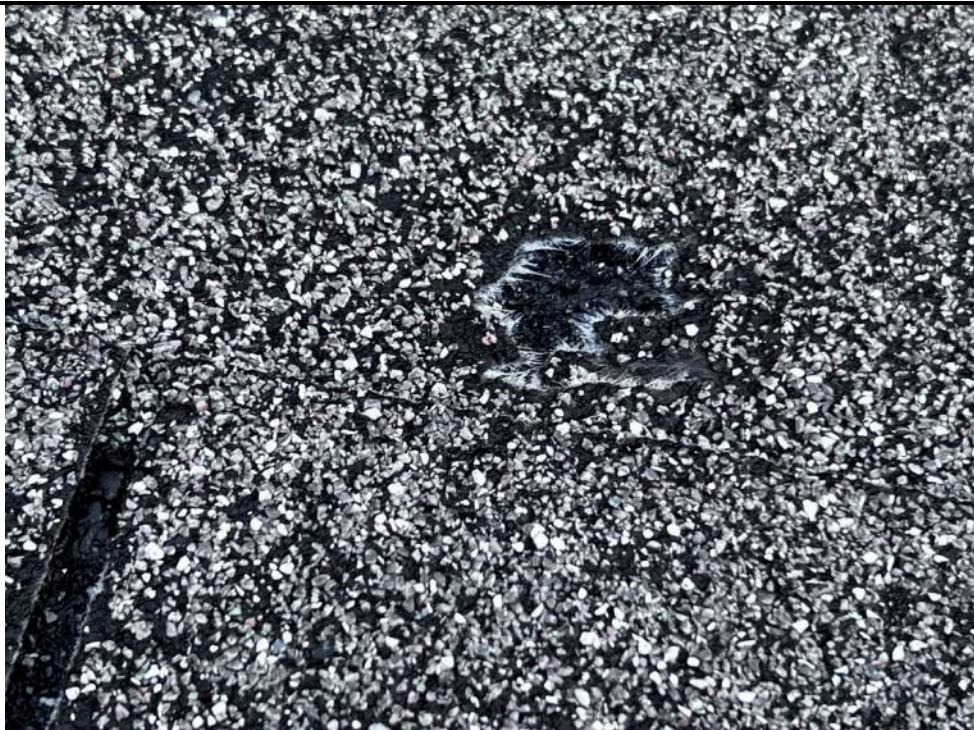
**Photo 68:** Hole in shingle, fiberglass reinforcing exposed

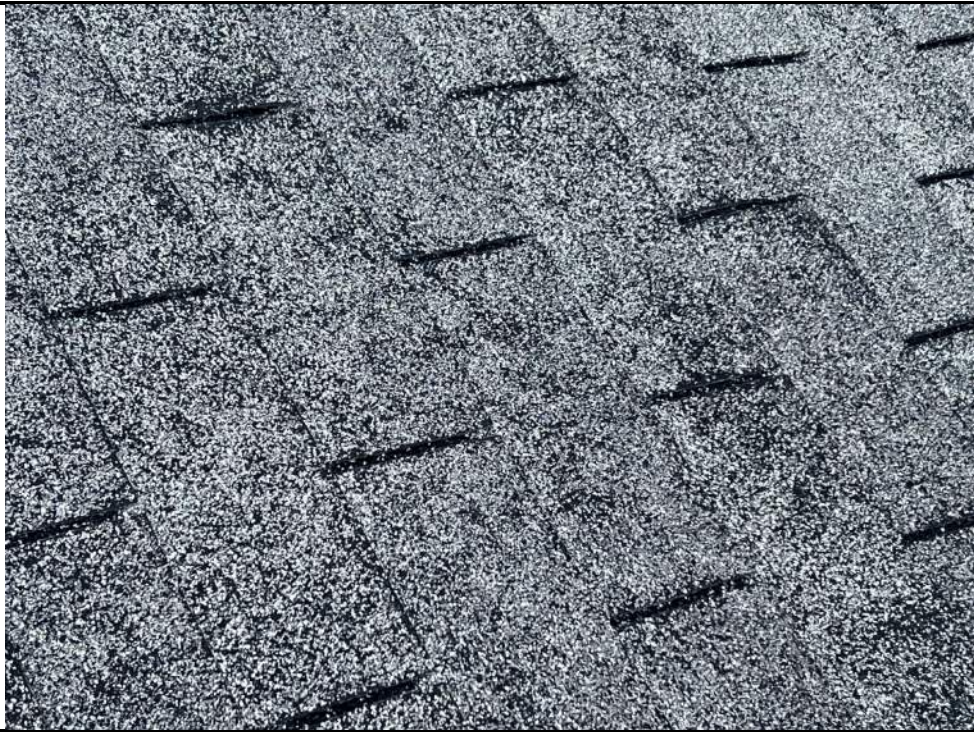
**Photo 69:** Erosion of ceramic granules from shingle surface

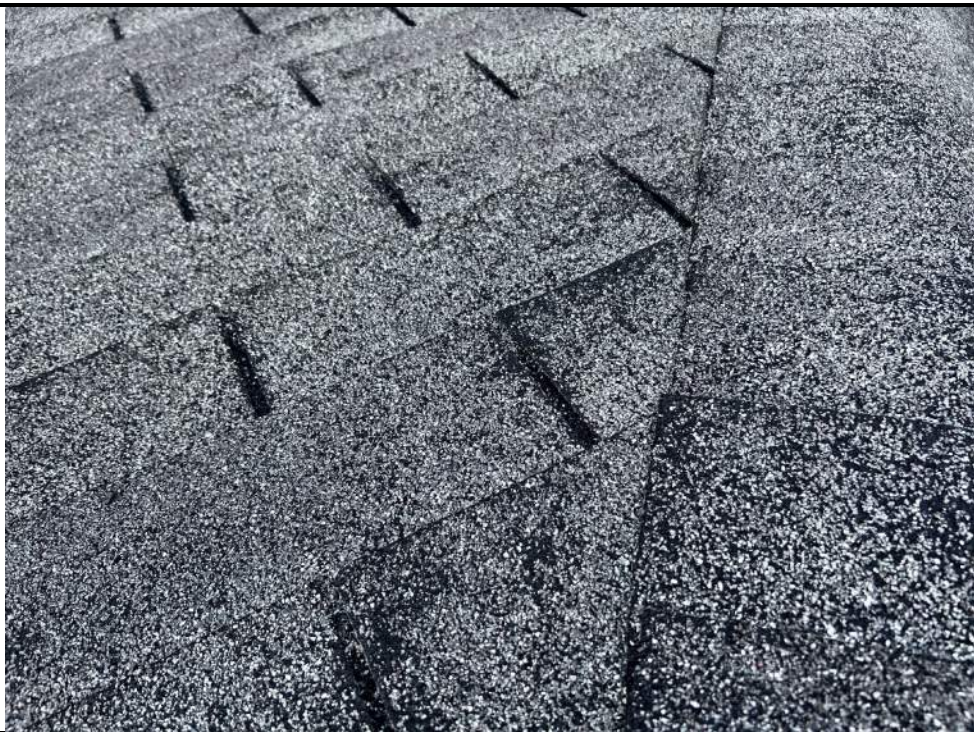
**Photo 70:** Erosion of ceramic granules from shingle surface

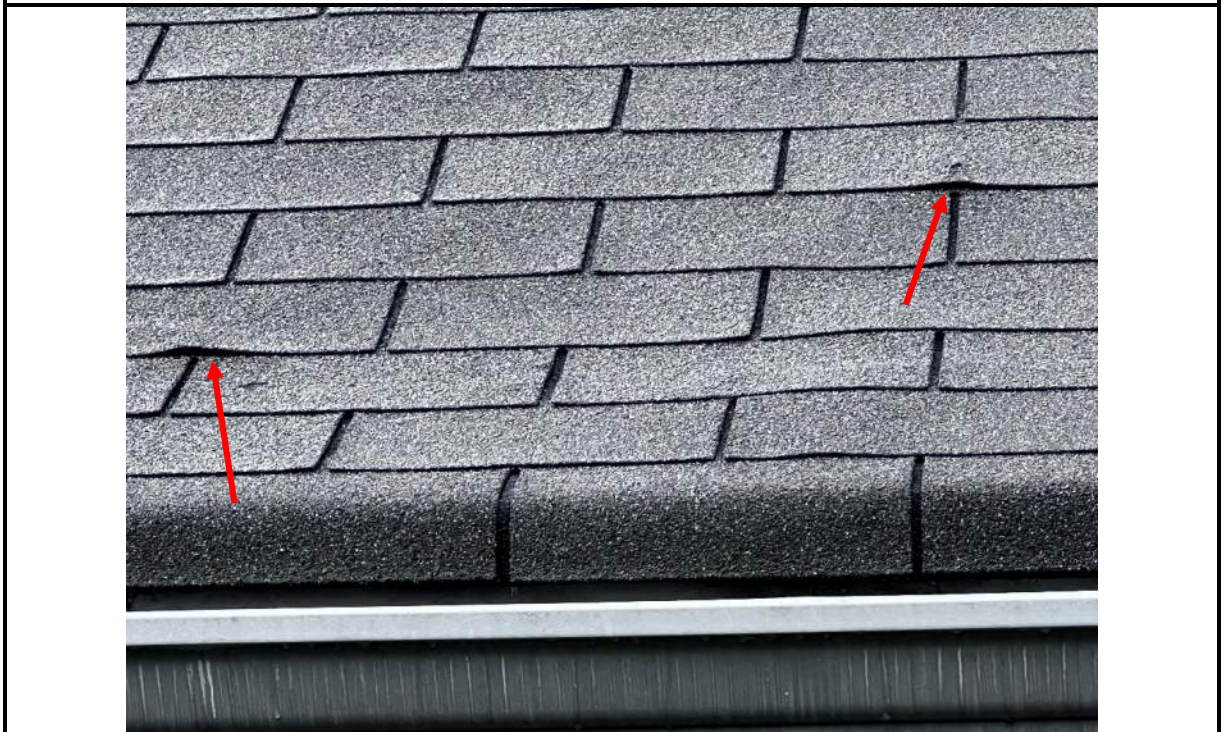
**Photo 72:** Shingle nails beginning to backout and raise the shingle tab above.

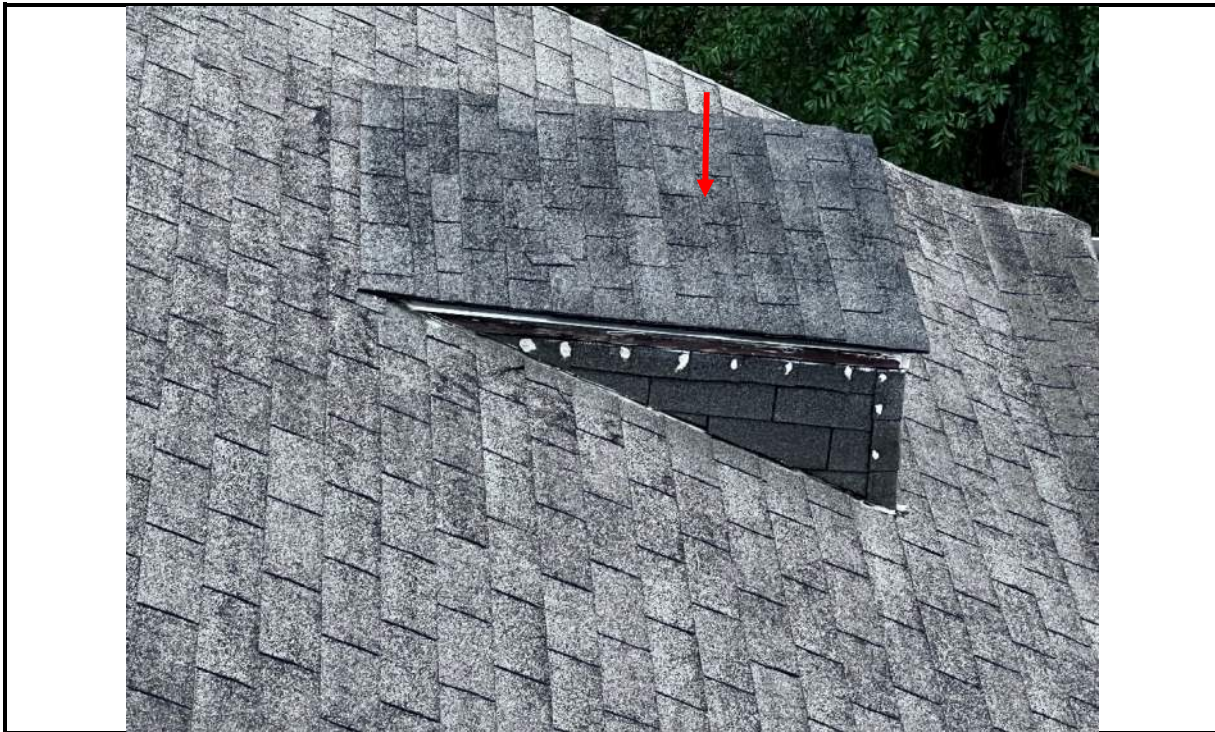
**Photo 73:** Roof pop-up dormer, insufficient slope for shingles

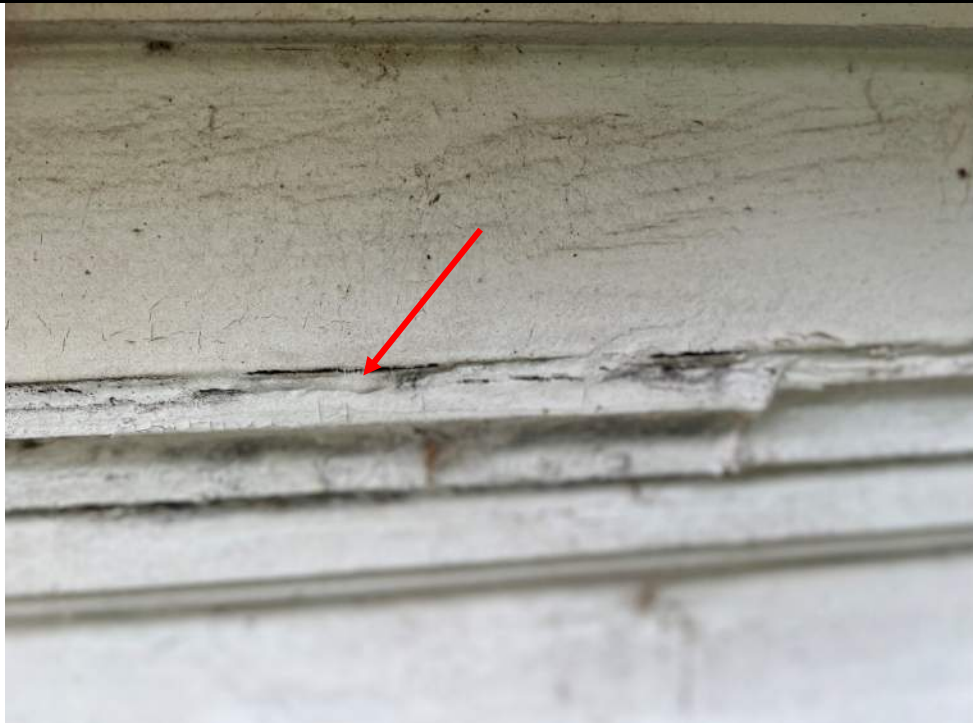
**Photo 80:** Wood trim at eaves and fascia exhibit paint peeling and some cracking

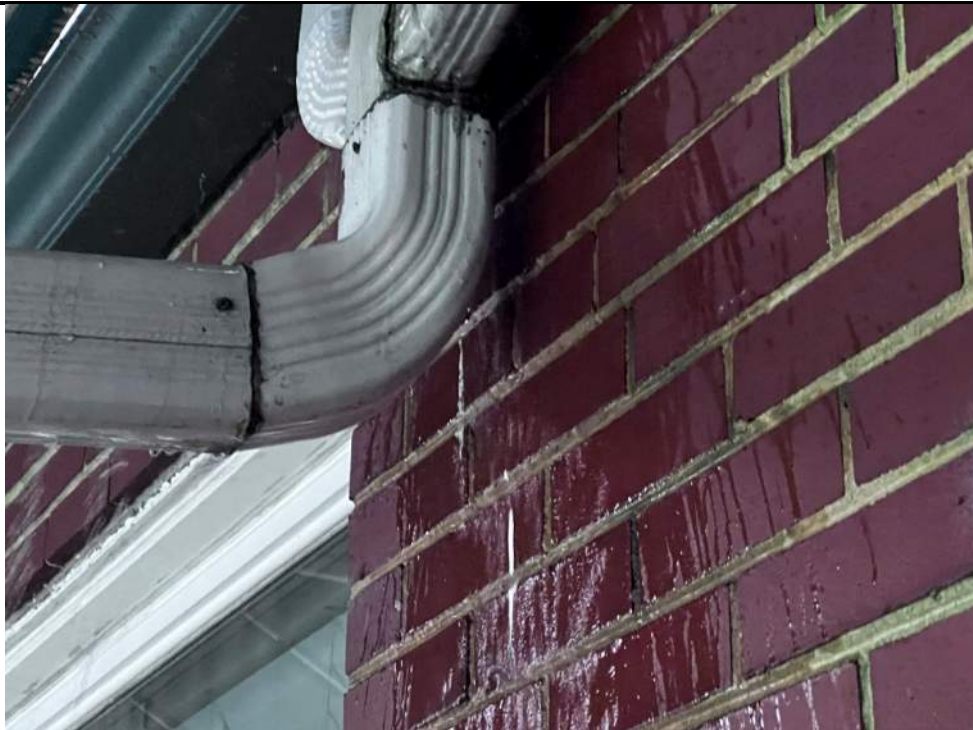
**Photo 81:** Capacity of main downspout insufficient with the additional gutter tie-ins.

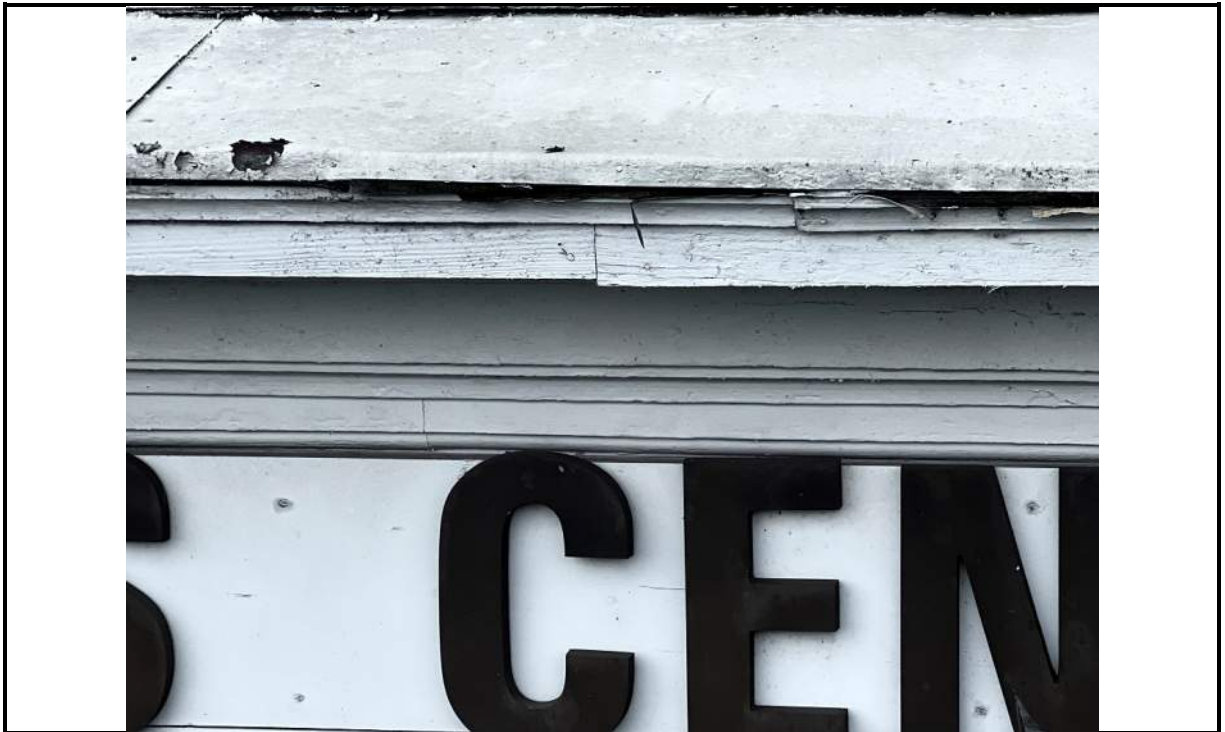
**Photo 83:** Exposed edge of wood substrate.

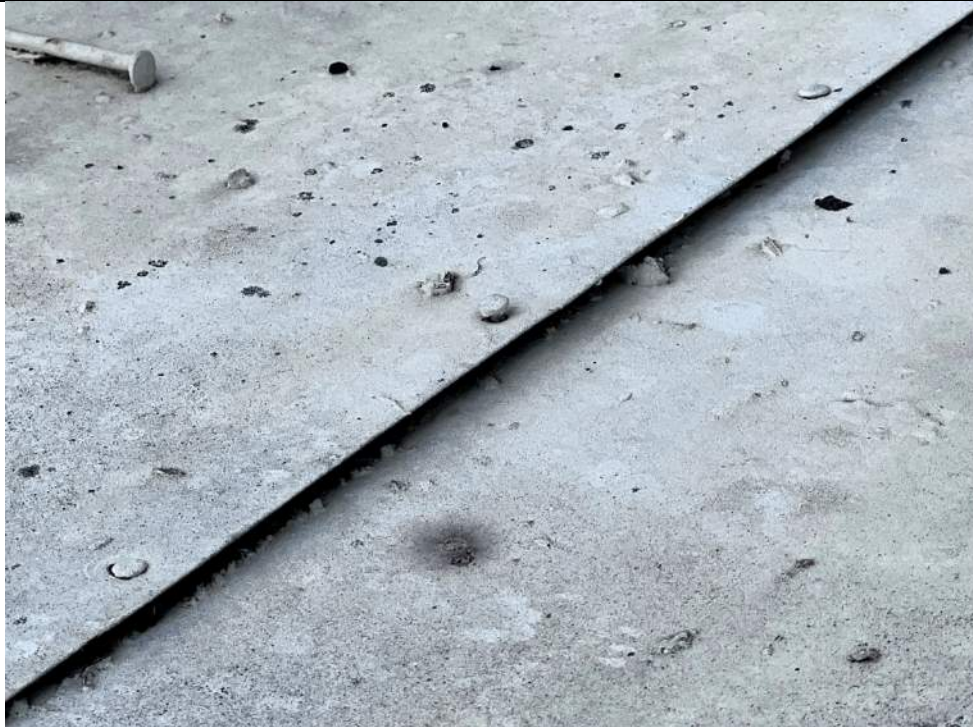
**Photo 85:** Open metal lap on cornice metal.

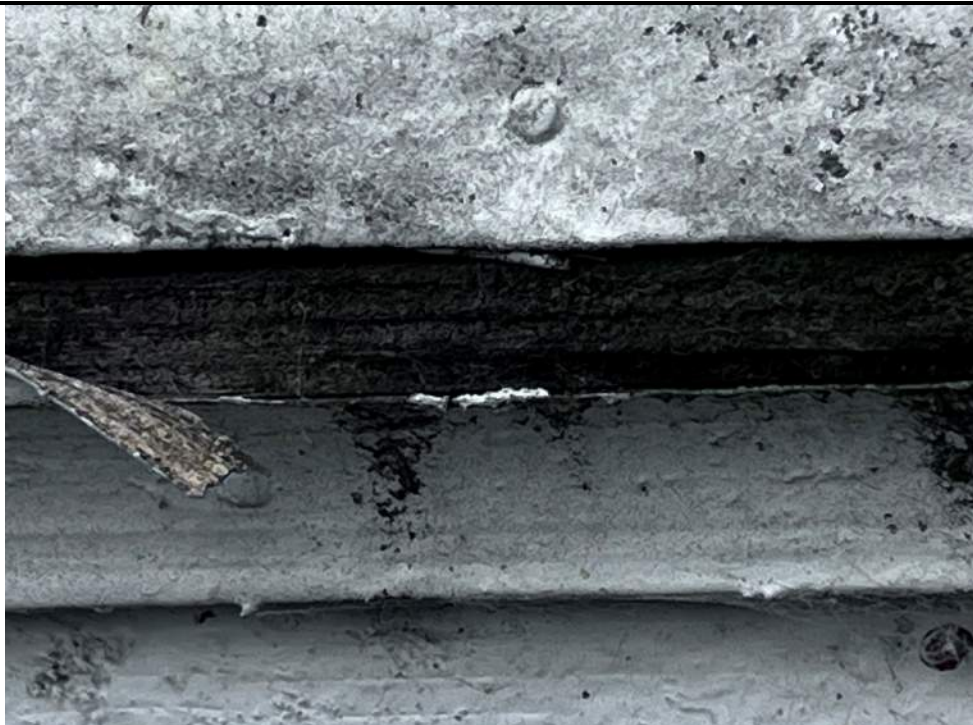
**Photo 86:** Exposed wood at edge of cornice metal.

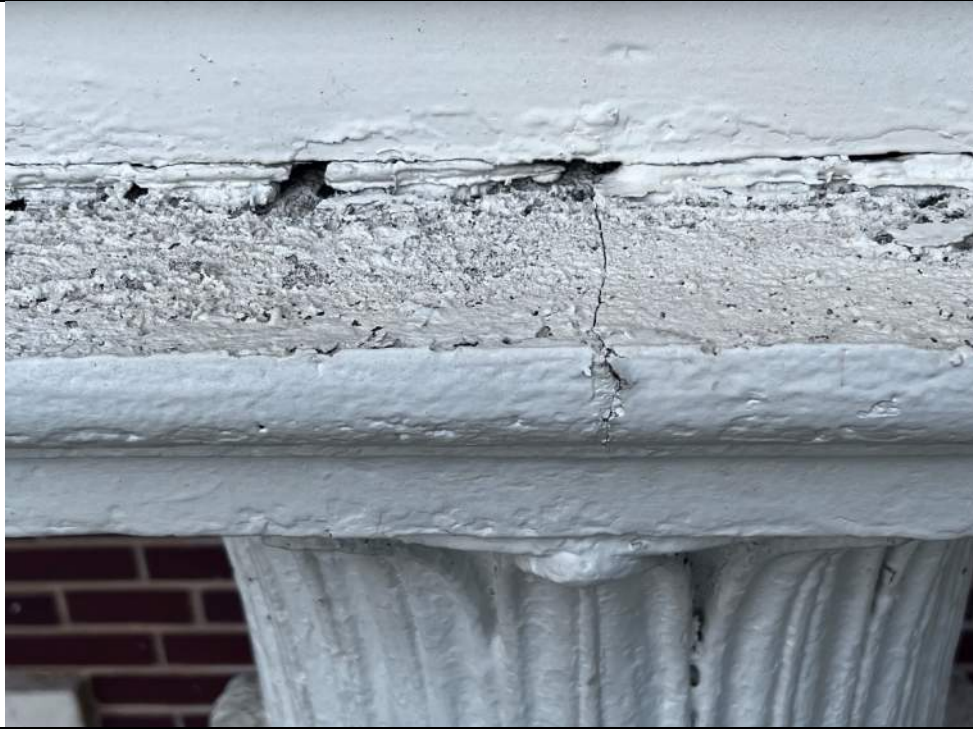
**Photo 87:** Small crack in the top of the column capital.

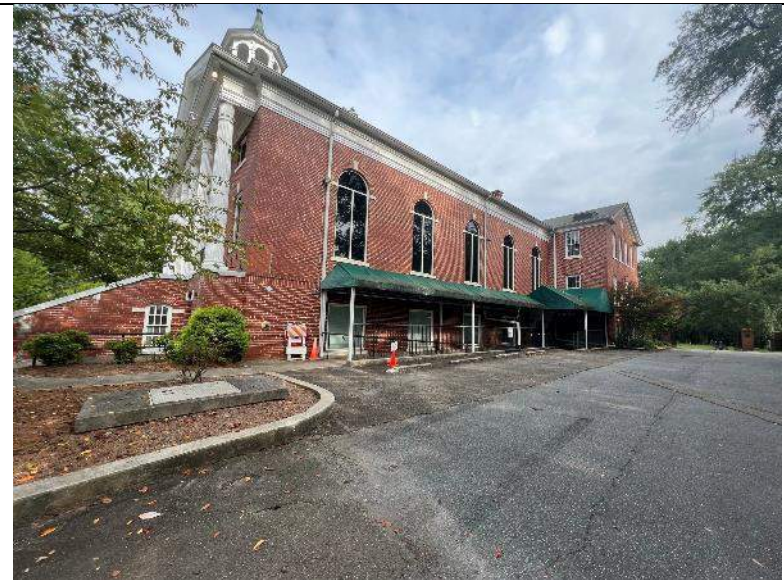
PHOTO #2: View of east elevation and accessible entrance.

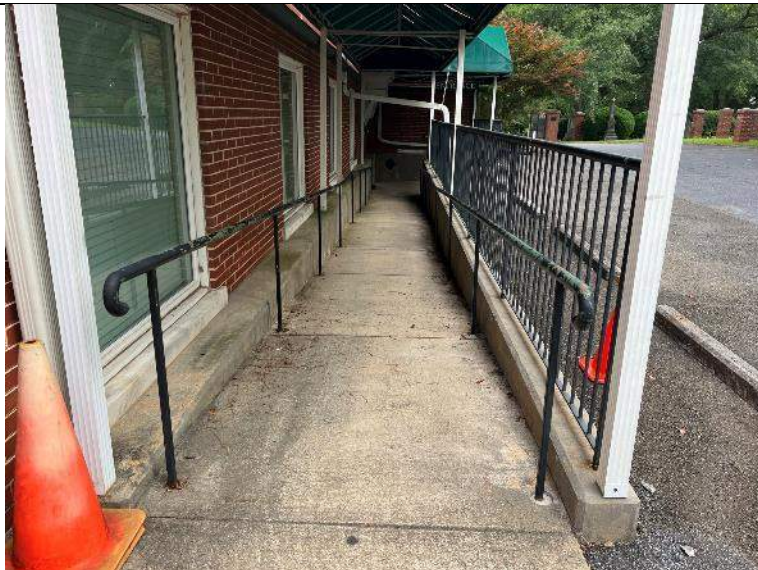
PHOTO #3: View of Ramp to accessible entrance from parking area.

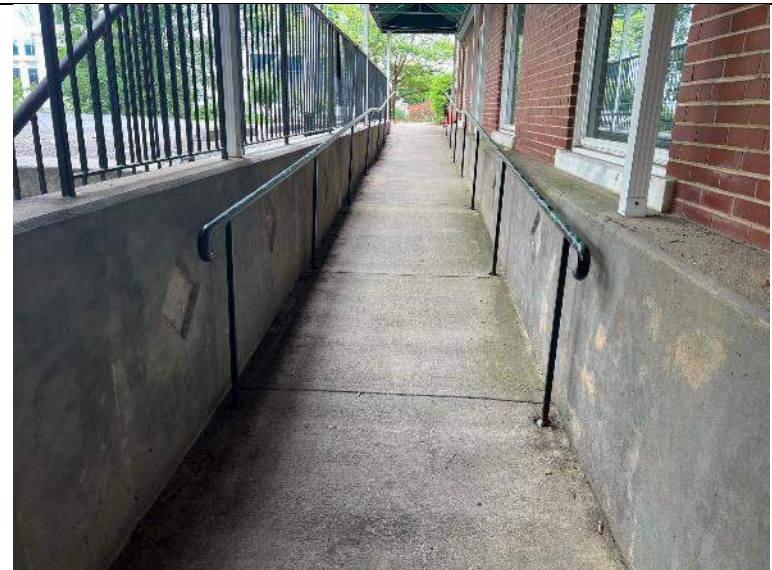
PHOTO #4: View of ramp on accessible route.

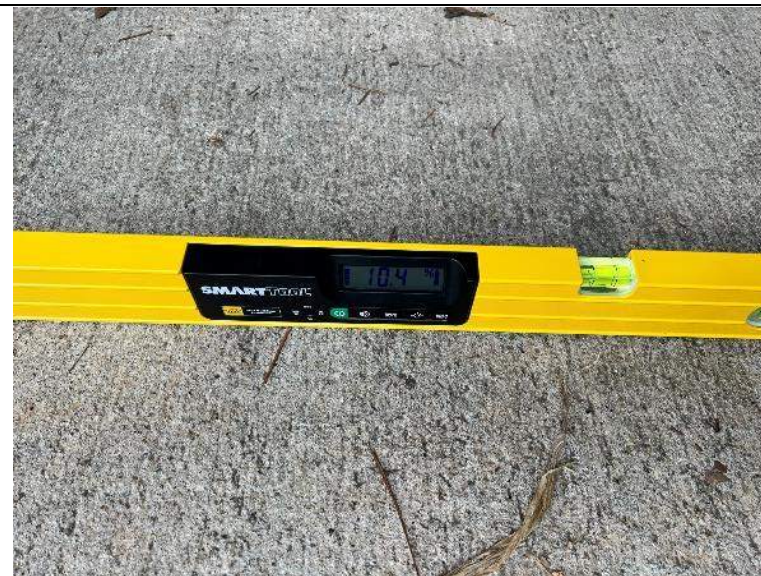
PHOTO #6: Running slope of 10.4% obtained (Non-Compliant). Running slopes on ramps should not exceed 8.3%.

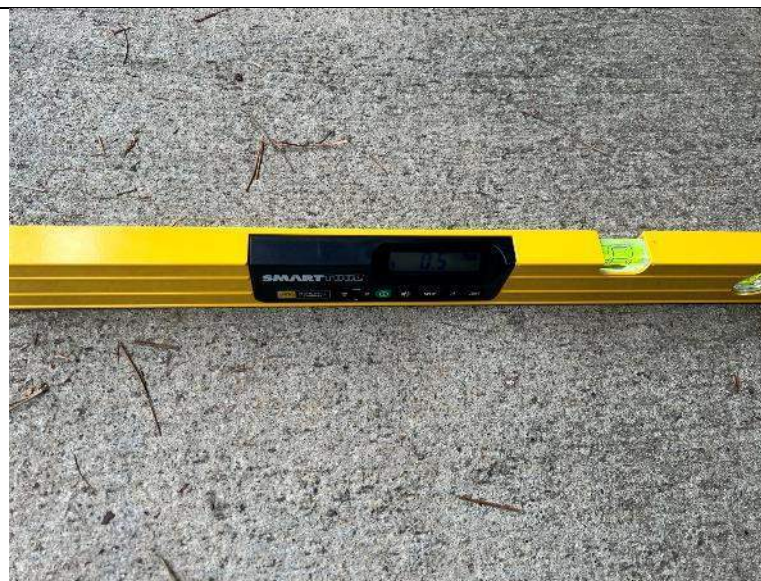
PHOTO #8: Cross slope of 0.5% obtained (Compliant). Cross slopes should not exceed 2.08%.

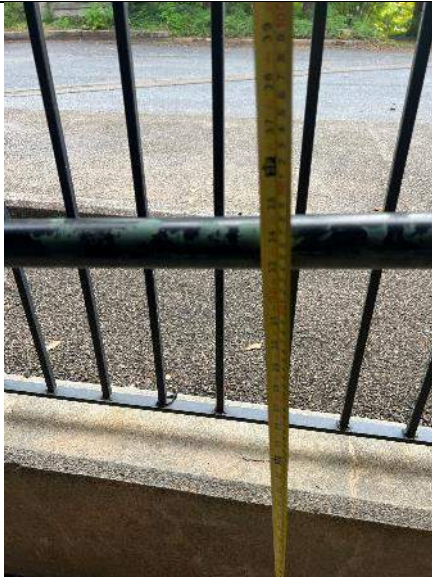
PHOTO #9: Height of gripping surface at railing on ramp is 35". (Compliant).

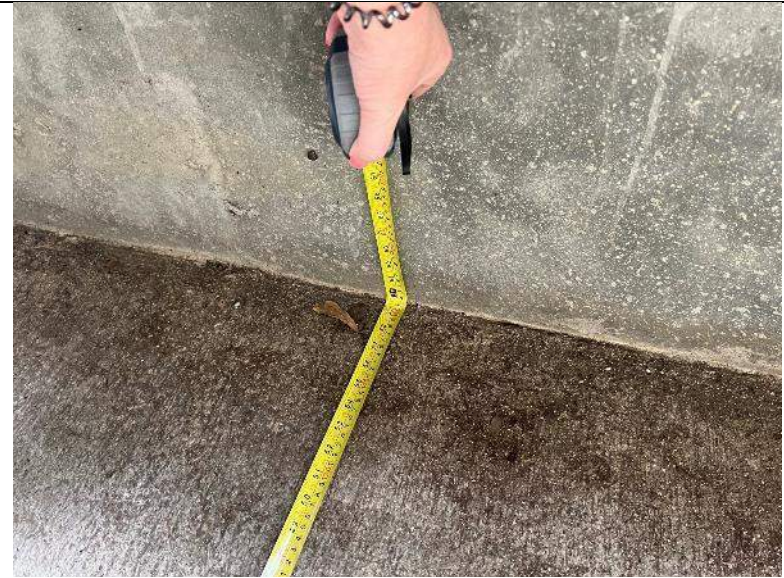
PHOTO #10: Ramp width is 60". (Compliant).

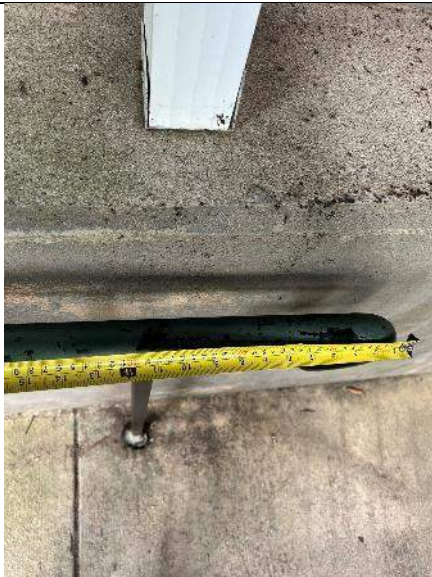
PHOTO #11: Railings include 12" overhang (Compliant).

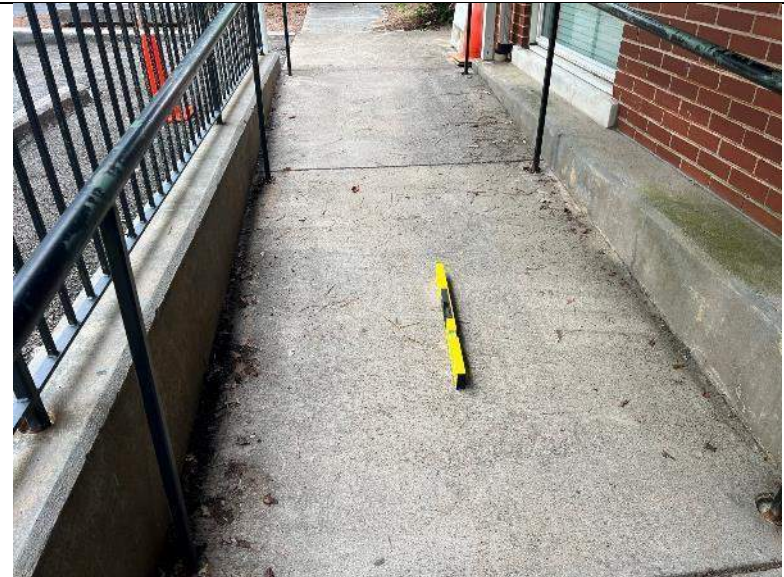
PHOTO #12: Edge protection is provided along full ramp run.

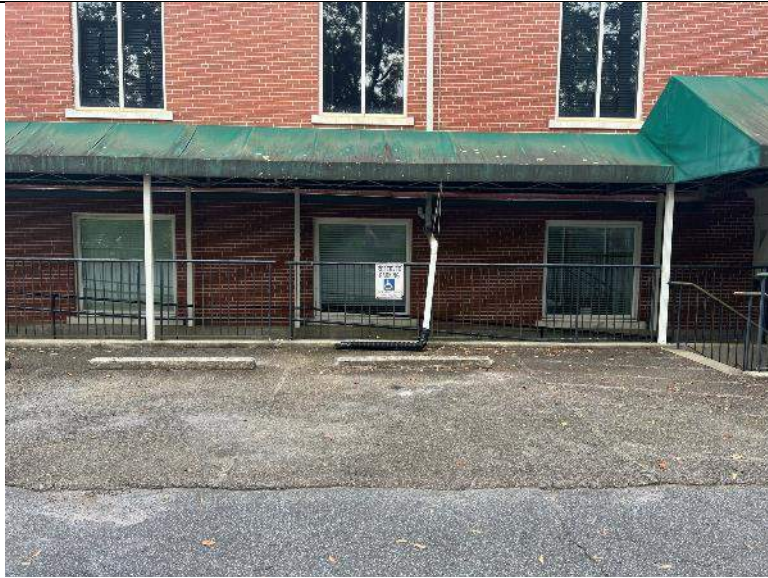
**PHOTO #13:** Designated accessible parking space. Note, it is not provided along the shortest accessible route and requires user to walk behind other vehicle to get to accessible route. (Non-Compliant).

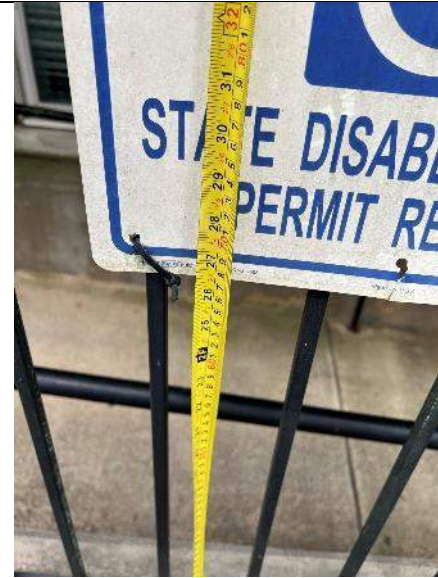
**PHOTO #14:** Signage height is 27" (Non-Compliant). Signs are required to be mounted a minimum of 60" above the grade of the parking space.

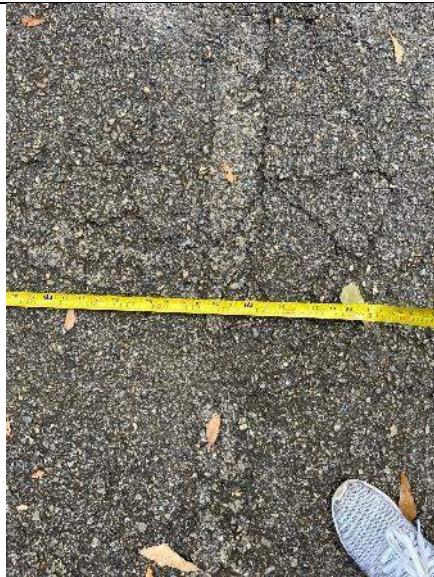
**PHOTO #15:** Access aisle width measurement of 82" (Compliant).

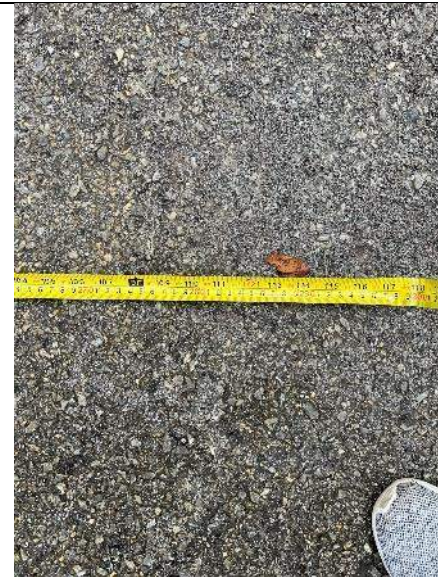
**PHOTO #16:** Accessible parking space width measurement of 110" (Compliant).

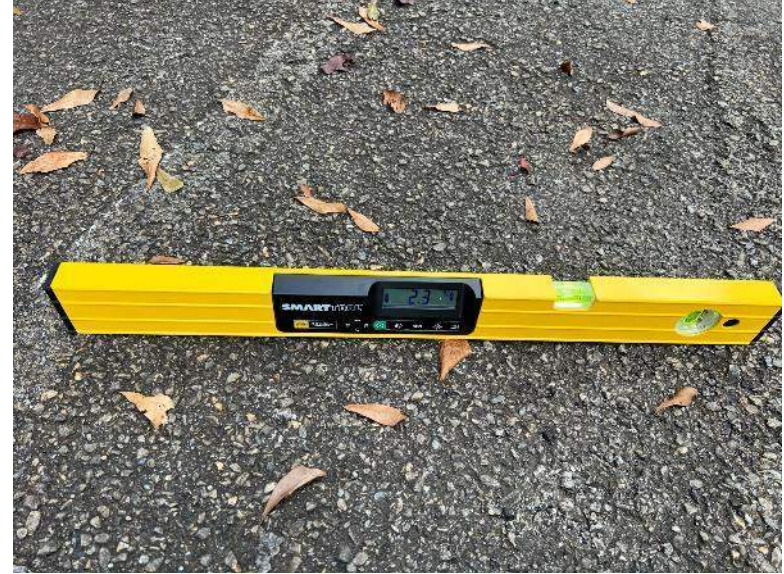
PHOTO #18: Running slope of 2.3% at access aisle (Non-Compliant). Running and cross slopes in access aisles and parking spaces should not exceed 2.08%.

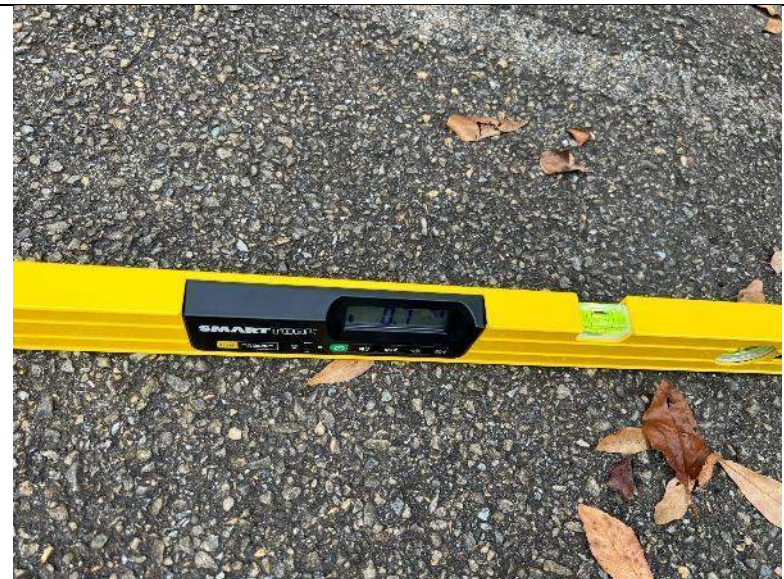
PHOTO #20: Cross slope measurement of 0.7% obtained (Compliant). Running and cross slopes in access aisles and parking spaces should not exceed 2.08%.

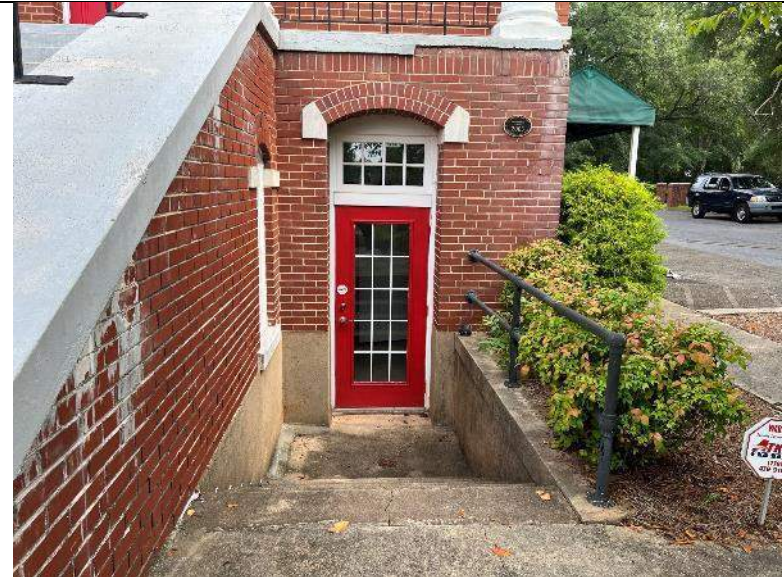
PHOTO #22: Alternate entrance – non accessible. Directional signage should be posted directing to accessible entrance.

- Non-accessible entrances do not have directional signage to accessible entrance. Additionally, the accessible entrance does not have designated accessible entrance signage. *Recommendation: Install signage.*

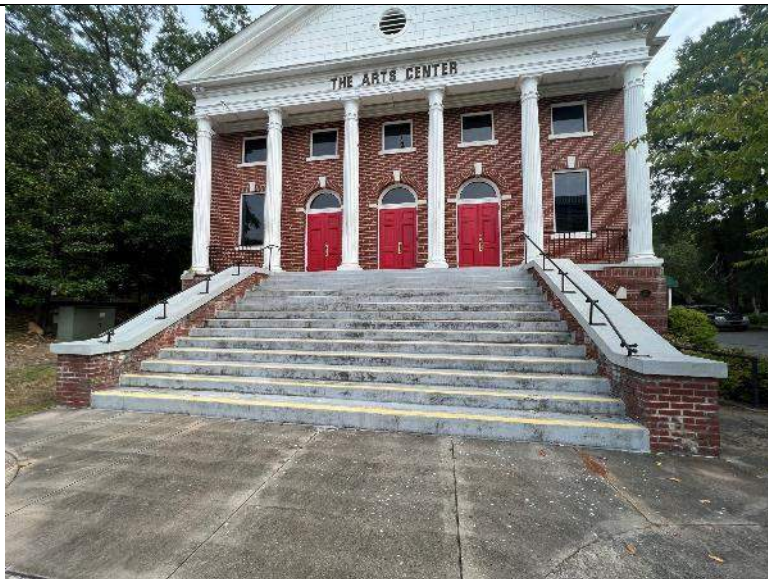
PHOTO #23: Alternate entrance – non accessible. Directional signage should be posted directing to accessible entrance.

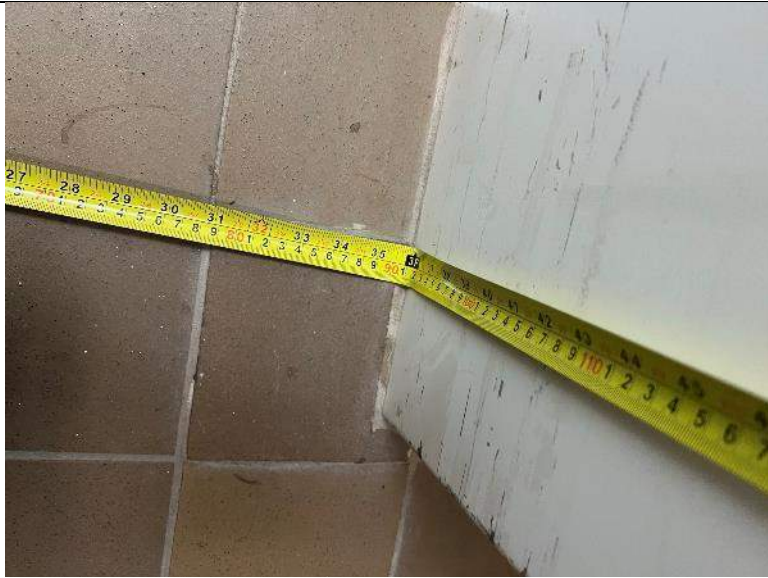
PHOTO #25: Elevator opening width is 36" (Compliant).

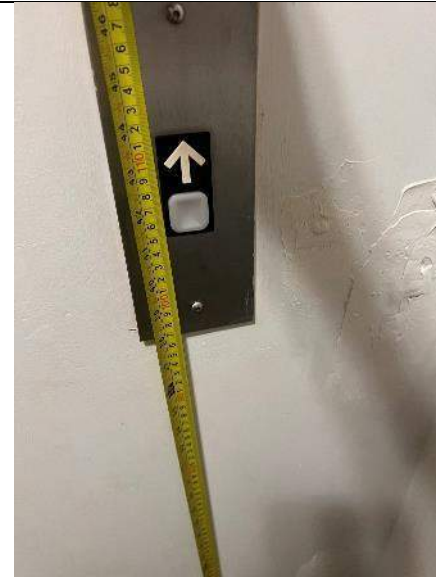
PHOTO #26: Call button height of 42" (Compliant)

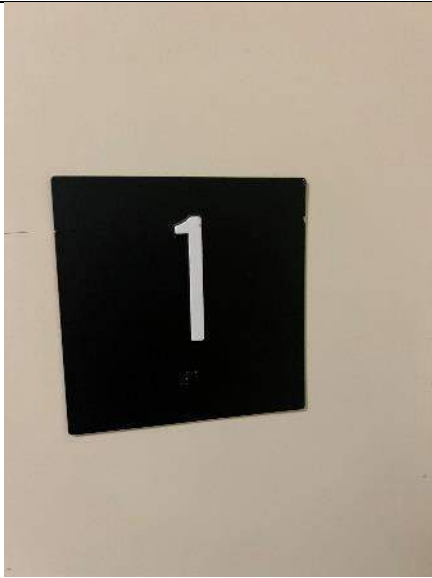
PHOTO #29: Tactile star not provided at floor signage. (Non-Compliant).

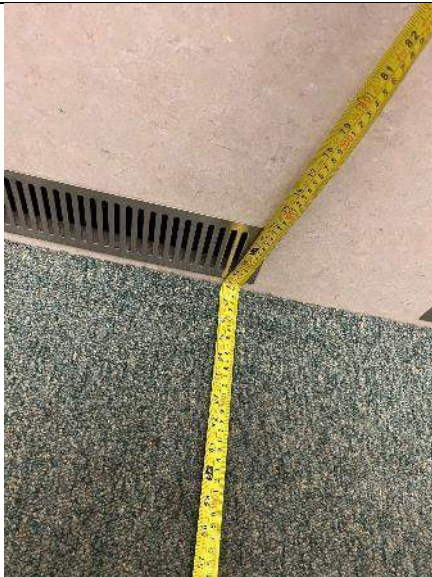
PHOTO #31: Elevator cab measurements 69" x 51" (Compliant).

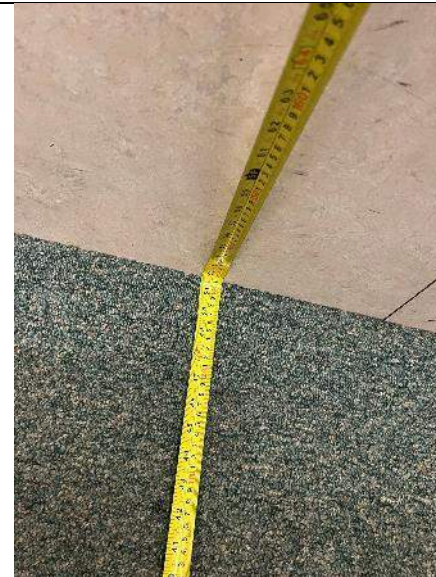
PHOTO #32: Elevator cab measurements 69" x 51" (Compliant).

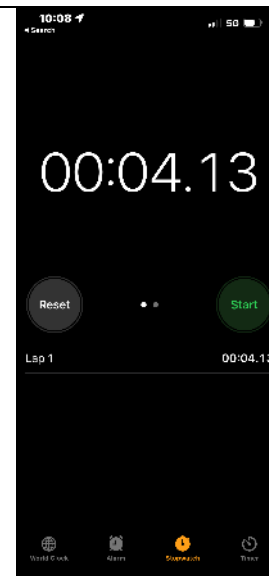
PHOTO #34: Door closing speed of 4.13 seconds at women's restroom on second floor (Non-Compliant)

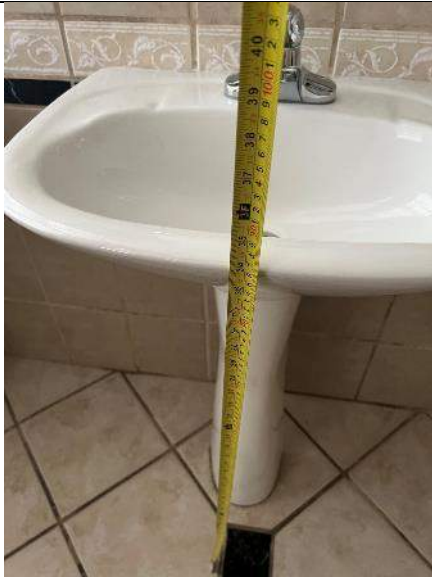
PHOTO #37: Sink height of 34" in women's restroom second floor. (Compliant)
