# REPORT OF NOVA SERVICES

**Cherokee County Arts Center**  
Canton, Cherokee County, Georgia

**Subject:** Limited Environmental, Structural, and Building Enclosure  
Assessment & Consulting Services Executive Summary Report  
**Cherokee County Arts Center**  
Canton, Cherokee County, Georgia  
NOVA Project Number 10102-3022152

**Subject: Report of Limited Visual Building Envelope Condition Assessment**  
94 North Street  
Canton, Georgia 30114  
NOVA Project Number: 10102-3022152

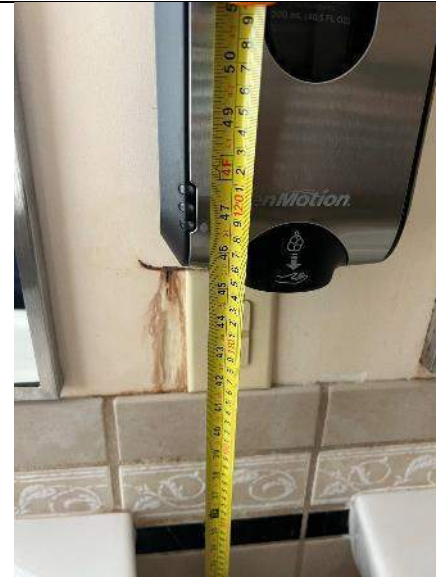
PHOTO #38: Soap dispenser height of 45" in women's restroom second floor (Compliant).

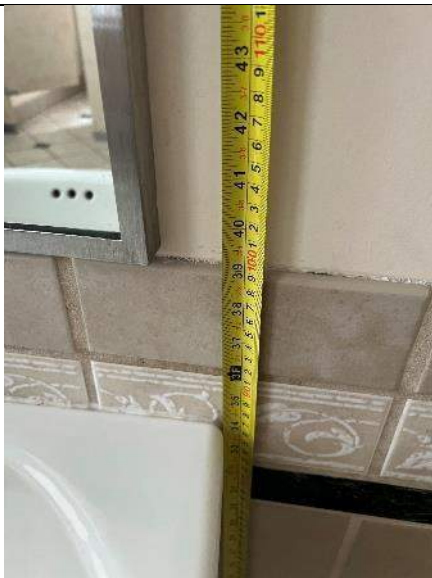
PHOTO #39: Mirror height of 40" in women's restroom second floor (Compliant).

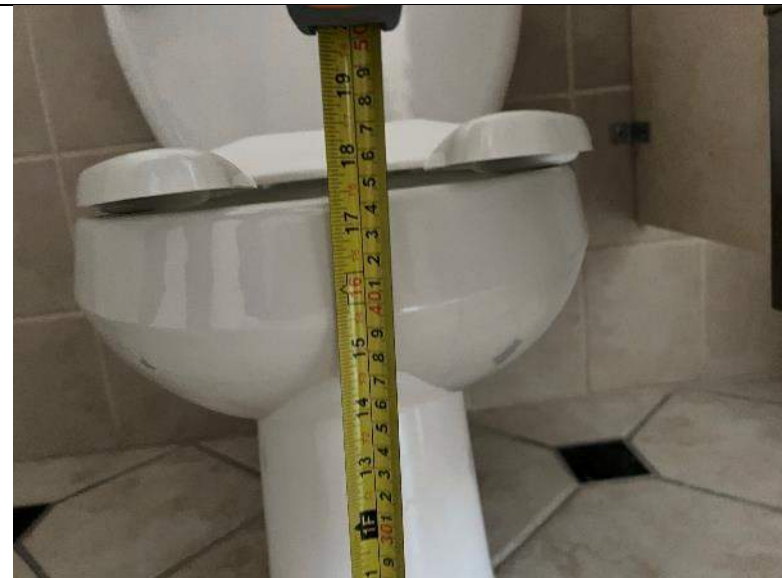
PHOTO #40: Toilet height of 18" in women's restroom second floor (Compliant).

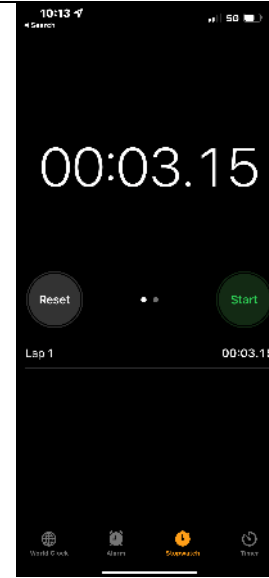
PHOTO #42: Door closing speed of 3.15 seconds at men's restroom on second floor (Non-Compliant).

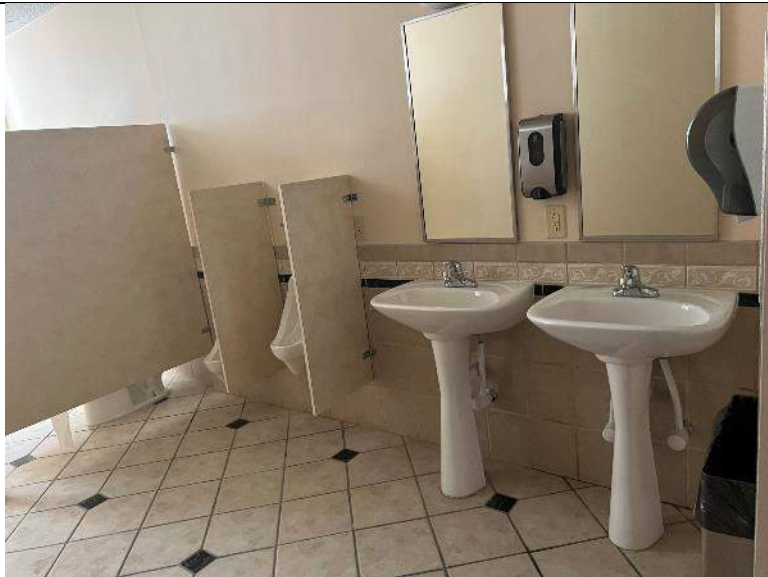
PHOTO #43: Overview of lavatory area in men's restroom on second floor.

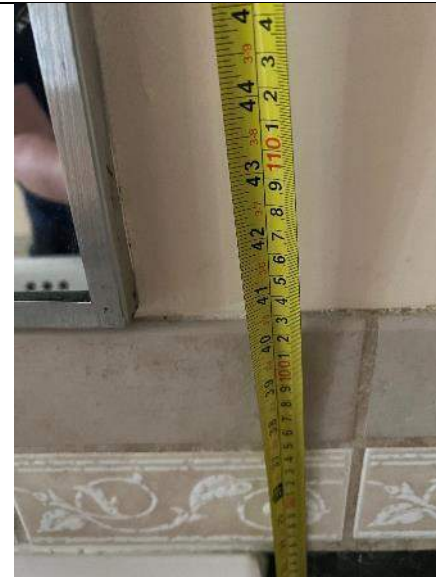
PHOTO #44: Mirror height of 41 inches in men's restroom on second floor (Compliant).

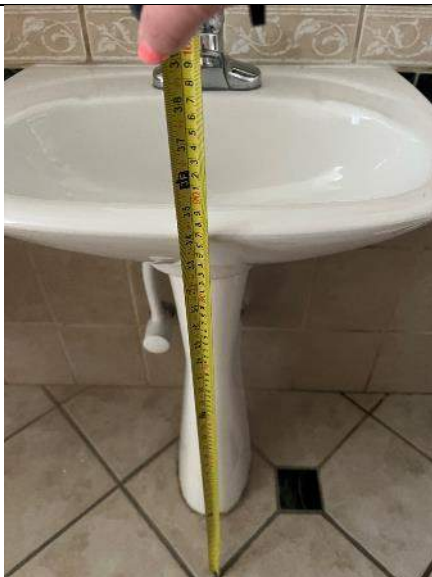
PHOTO #45: Sink height of 34" in men's restroom on second floor (Compliant).

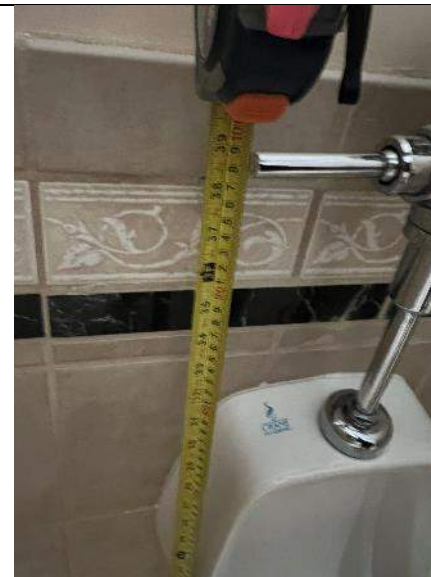
PHOTO #46: Urinal handle at 39" in men's restroom on second floor (Compliant).

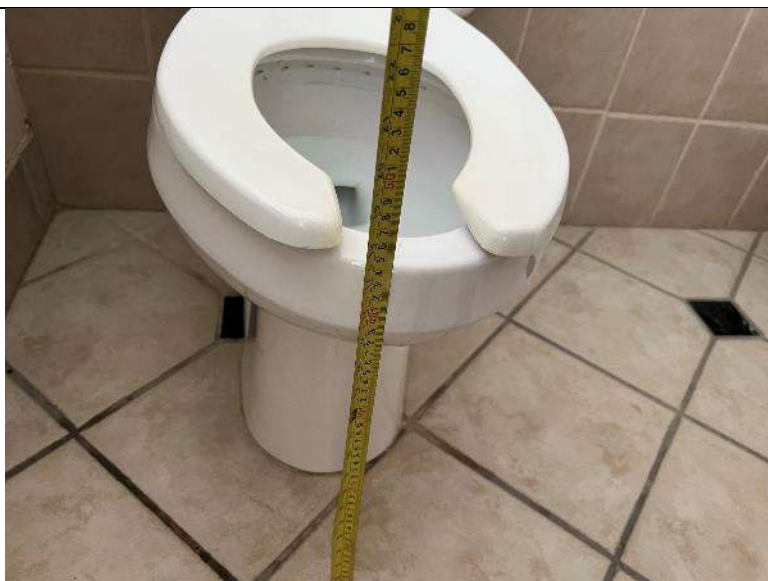
PHOTO #47: Toilet height of 18" in men's restroom on second floor (Compliant).

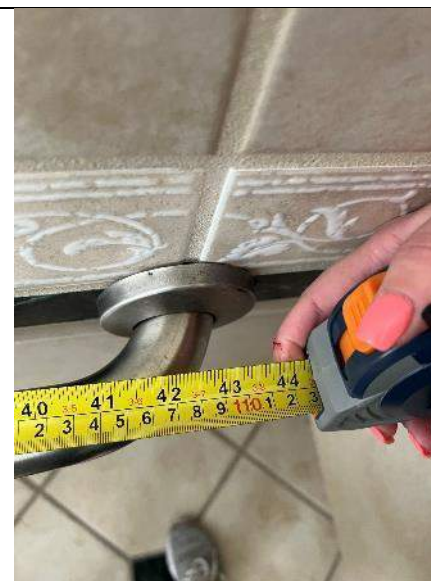
PHOTO #48: 42" Grab bar located in men's restroom on second floor (Compliant).

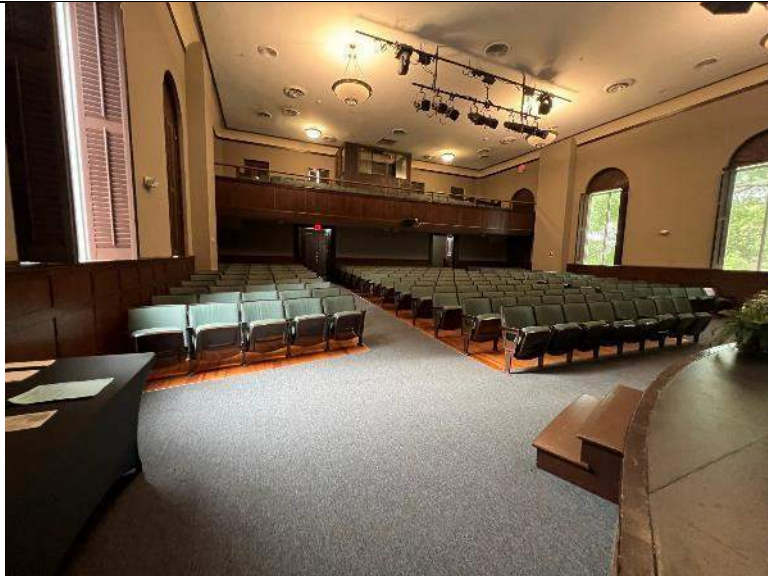
PHOTO #49: Overview of theater. Accessible seating could be placed at open space on front row on left and right sections.

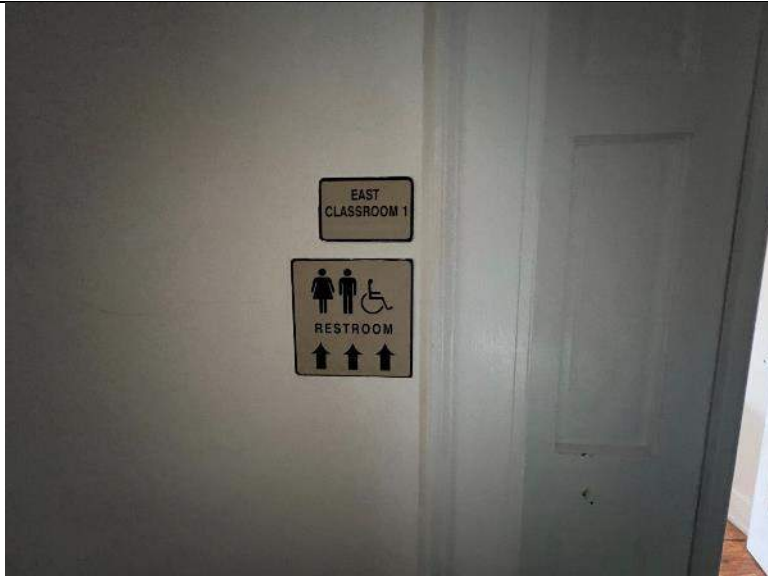
PHOTO #53: Accessible restroom signage in east classroom.

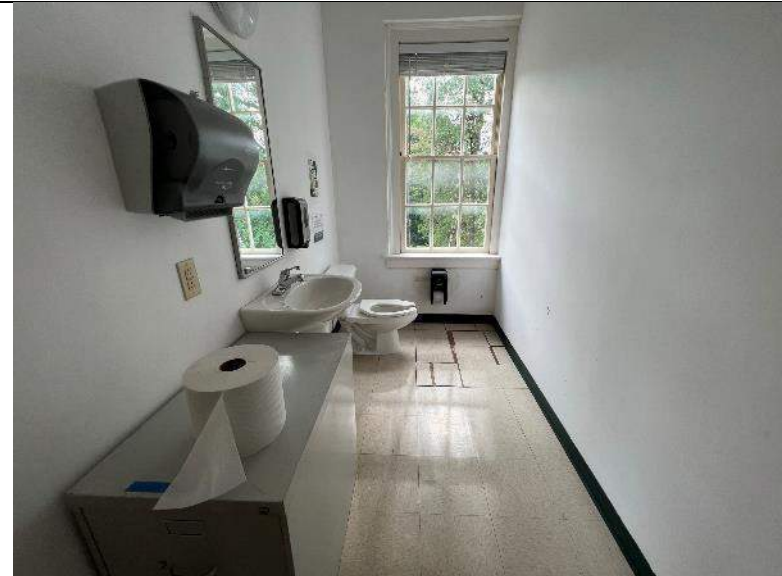
- Restroom in the east classroom is designated accessible but does not meet all requirements. The toilet is mounted too far from the wall and sits too low and accessories are mounted too high over an obstruction (cabinet). Additionally, proper clearance between toilet and sink of 42" is not provided and grab bars are not provided. *Recommendation: Reconfigure restroom to meet accessibility requirements or remove signage indicating this restroom is accessible and provide directional signage to the accessible restroom on the second floor.*

PHOTO #54: Overview of accessible restroom in east classroom.

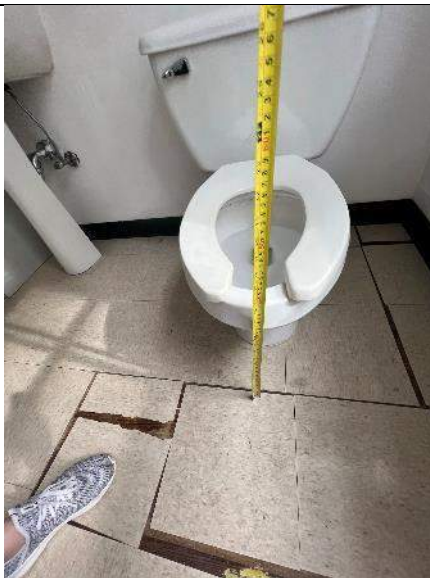
PHOTO #55: Toilet height of 16" (Non-Compliant).

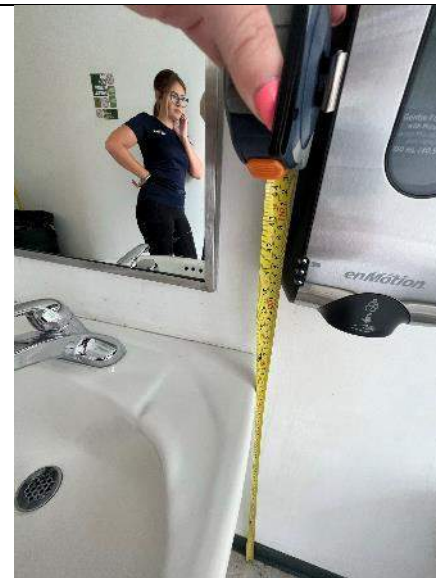
PHOTO #56: Mirror and soap dispenser height at 40" (Compliant).

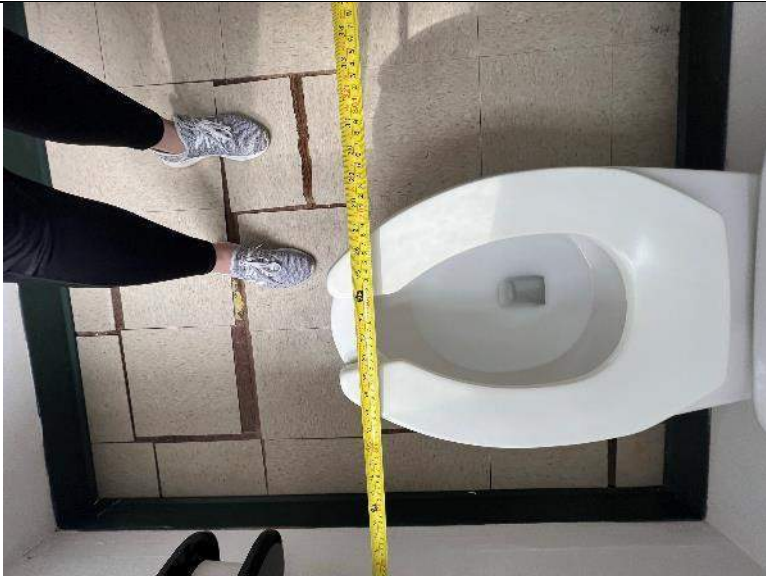
PHOTO #57: Toilet center is 22" from wall (Non-Compliant). Should be between 16-18".

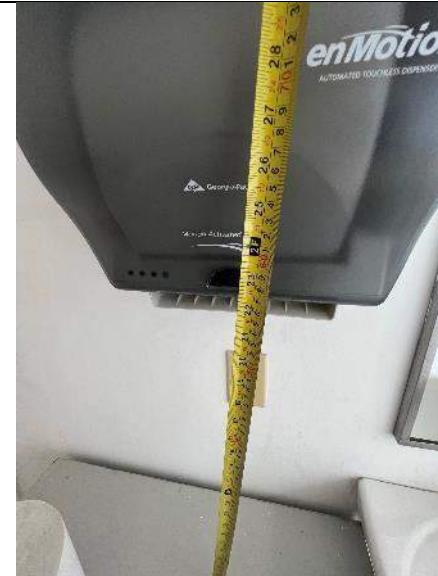
PHOTO #58: Paper-towel holder mounted too high for over an obstruction.

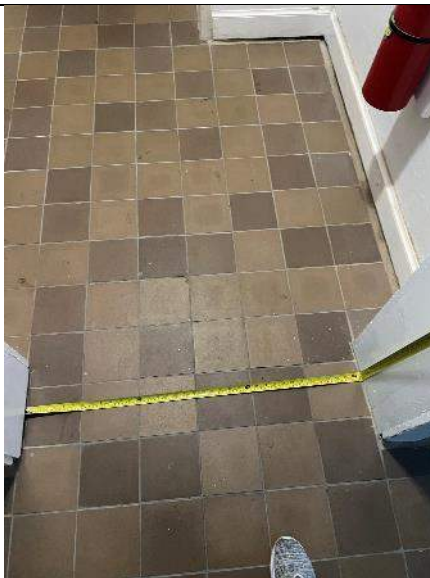
PHOTO #59: 36" opening on accessible route in building (Compliant).

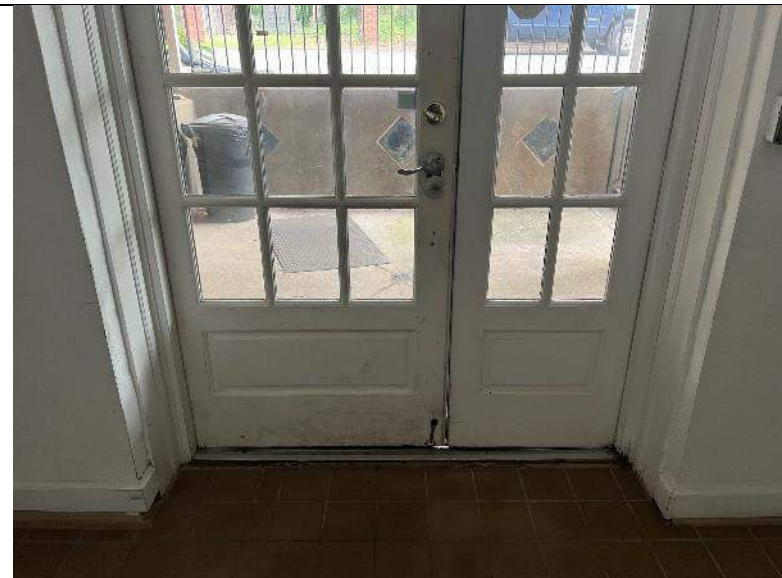
PHOTO #60: 36" opening at accessible entry, and lever handle is provided (Compliant).

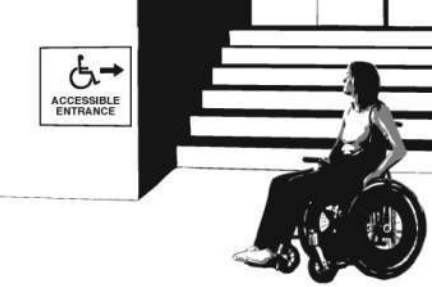
<b>1.39</b> Do all inaccessible entrances have signs indicating the location of the nearest accessible entrance?	<input type="checkbox"/> Yes <input checked="" type="checkbox"/> No

Install signs at non accessible entrances.
<b>1.40</b> If not all entrances are accessible, is there a sign at the accessible entrance with the International Symbol of Accessibility?	<input type="checkbox"/> Yes <input checked="" type="checkbox"/> No

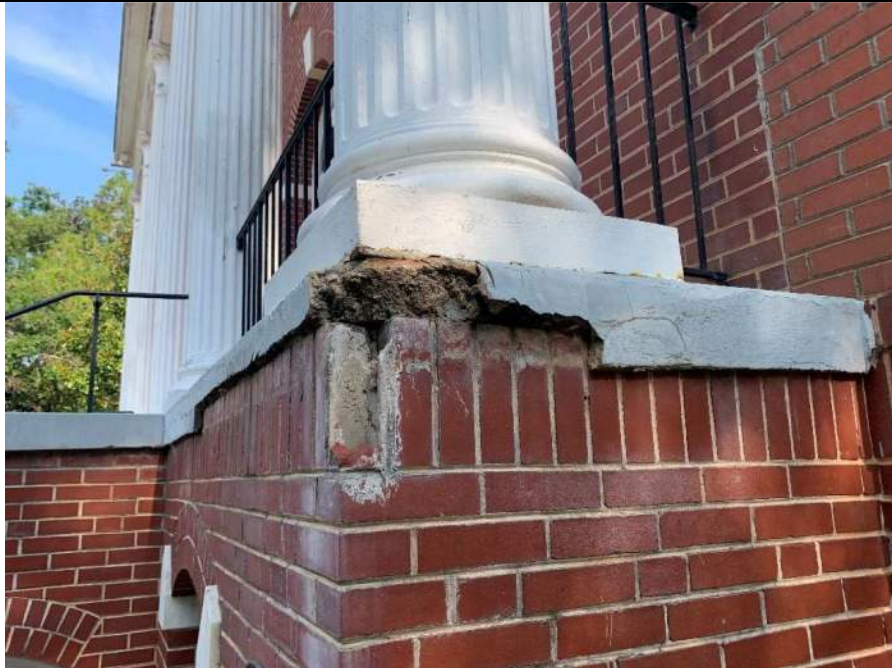
**Photo 4:** Observed missing elevated concrete slab material and brick facade near south main entrance columns.

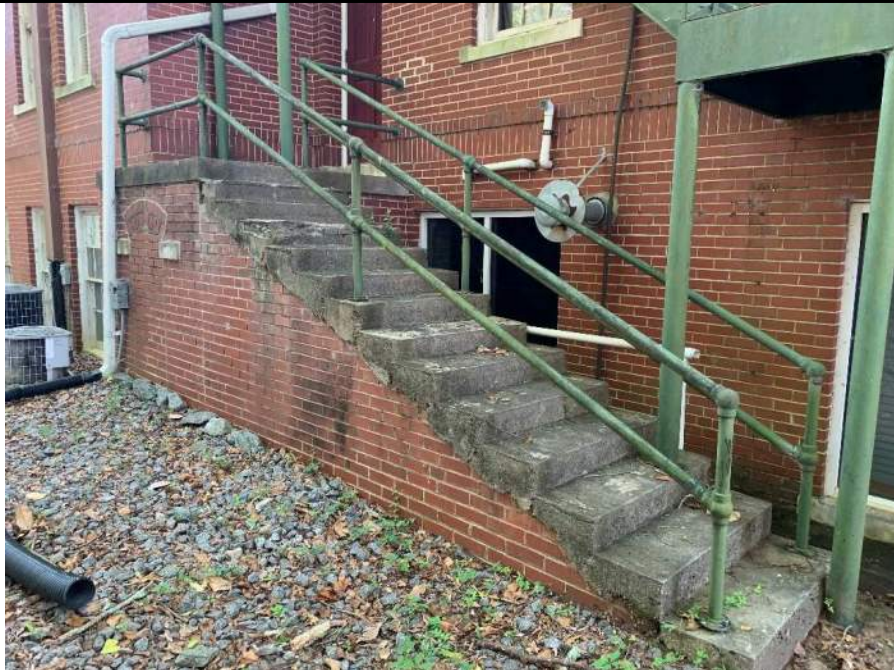
**Photo 9:** Overview of northwest corner exterior stairs emanating from first floor to grade. Note, handrail does not meet current building code requirements.

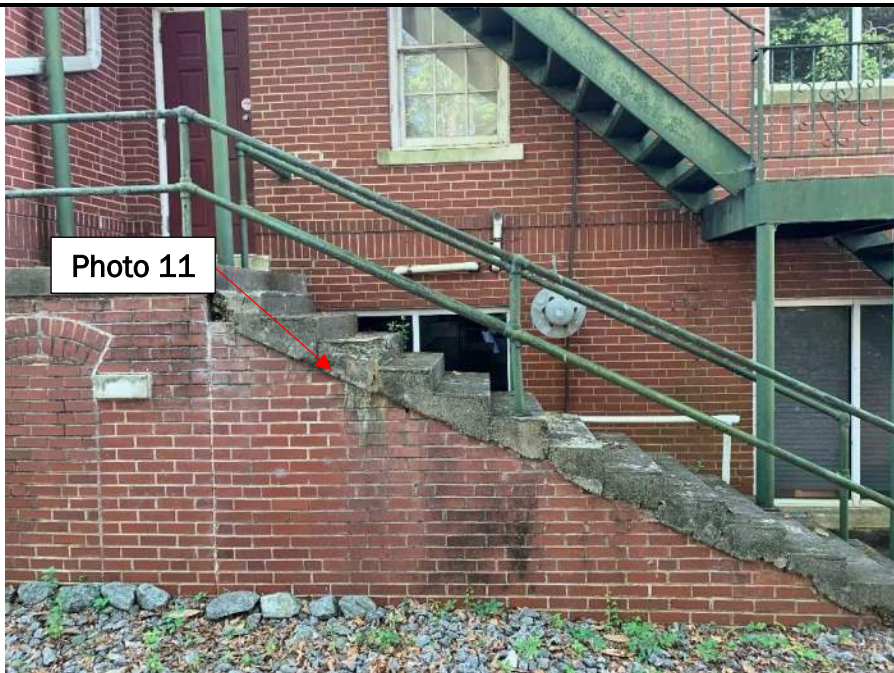
**Photo 10:** Side View of previous stair. Note brick and concrete spall distress.

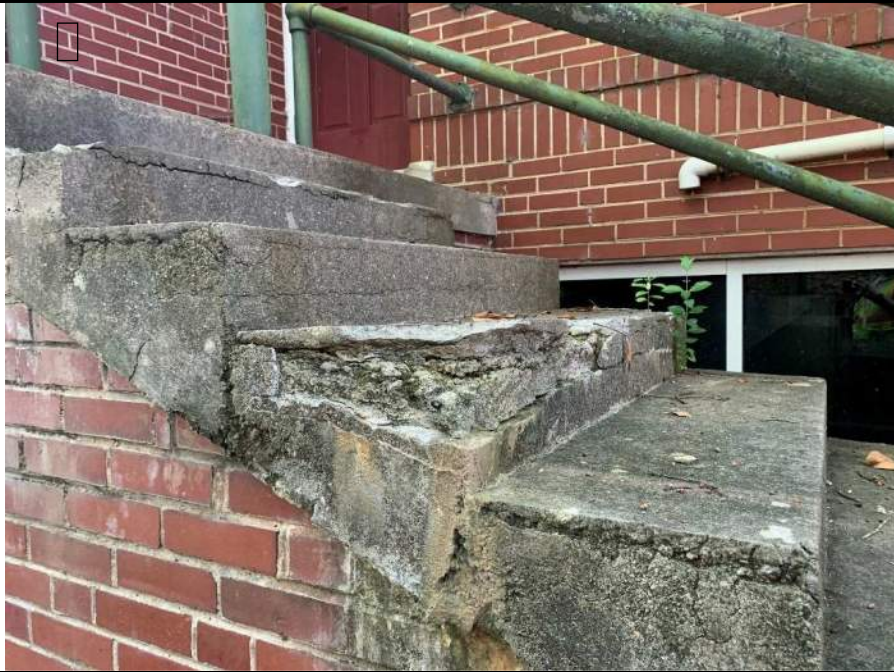
**Photo 11:** Observed severely damaged concrete stairs. Significant repair or remove and replace required.

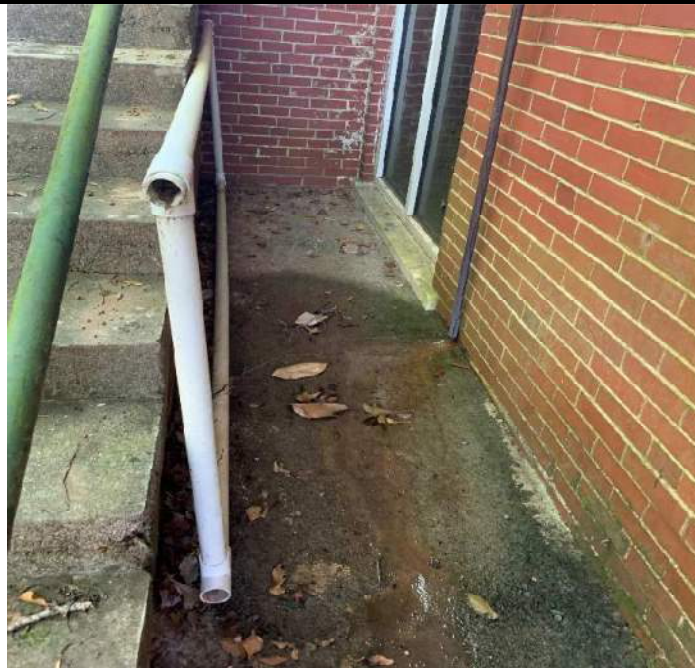
**Photo 12:** Subject structure concrete drain adjacent to concrete stairs, observed ponding of water runoff from roof drain system.

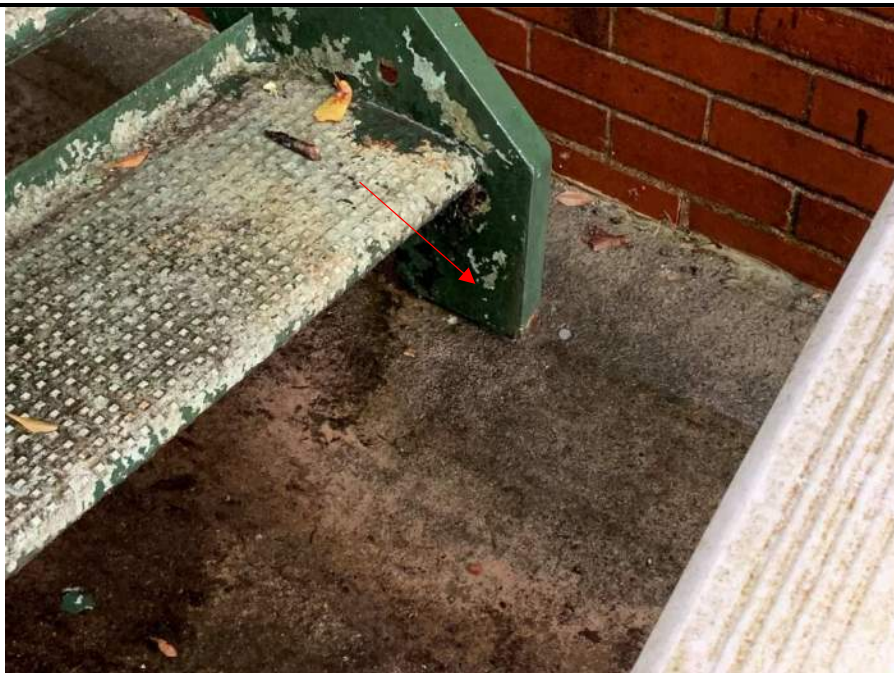
**Photo 14:** Previous steel fire escape connection to concrete slab on grade. Note, peeling paint. Recommended clean, prime, and paint steel staircase.

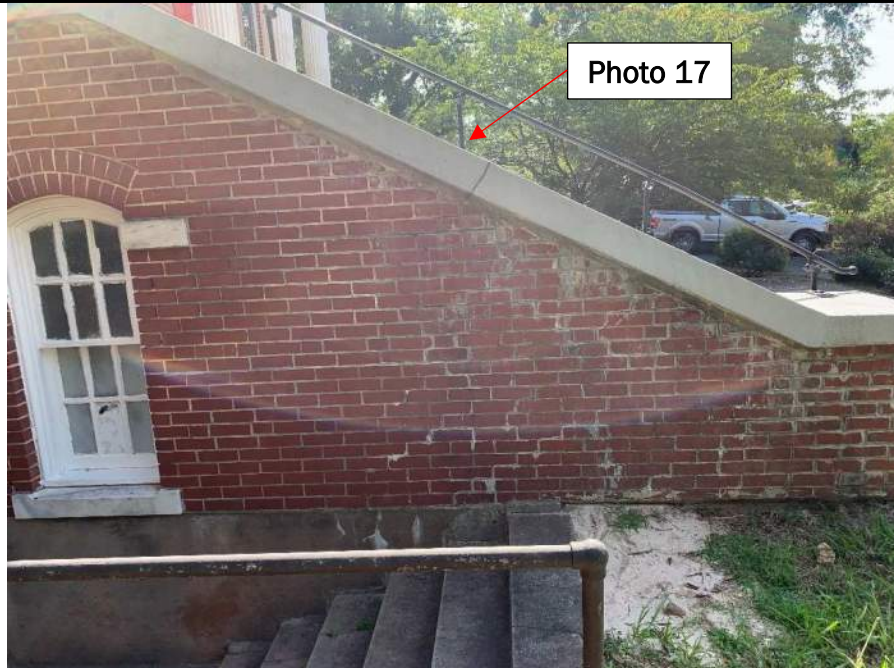
**Photo 15:** Overview of south entrance stairwell to ground floor. Recommend tuckpoint repair of exterior brick.

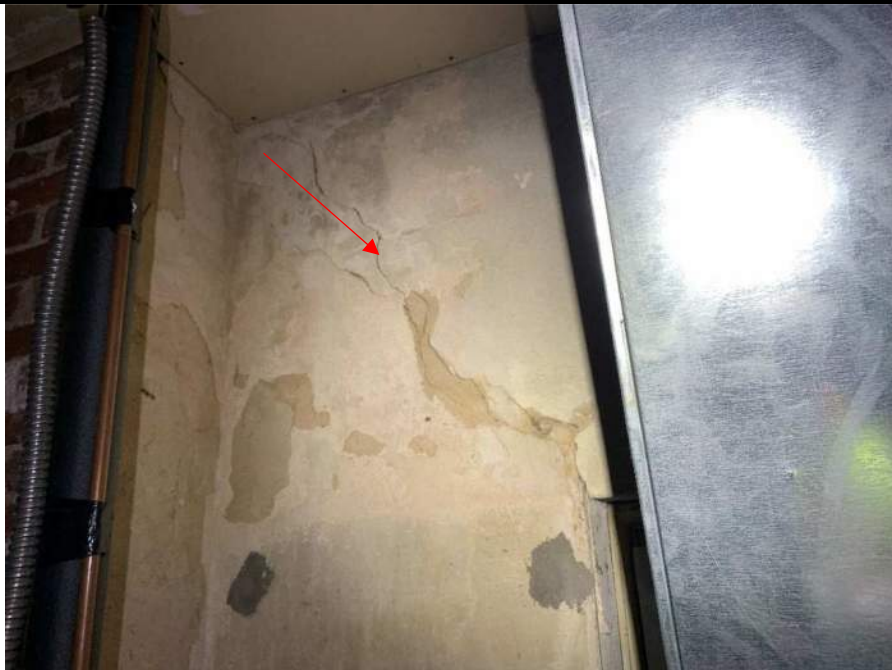
**Photo 22:** Typical cracks/separations and peeling paint in perimeter walls.

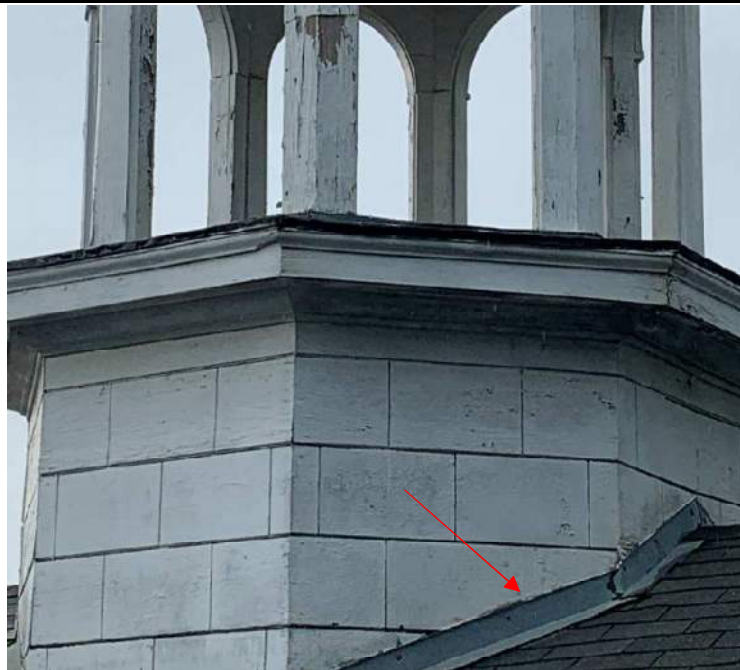
**Photo 27:** Overview of steeple near south elevation. Flashing appears to be in fair condition with slight corrosion. Recommend prime, and paint wood components. Remove and replace of rotten wood near flashing material as required.

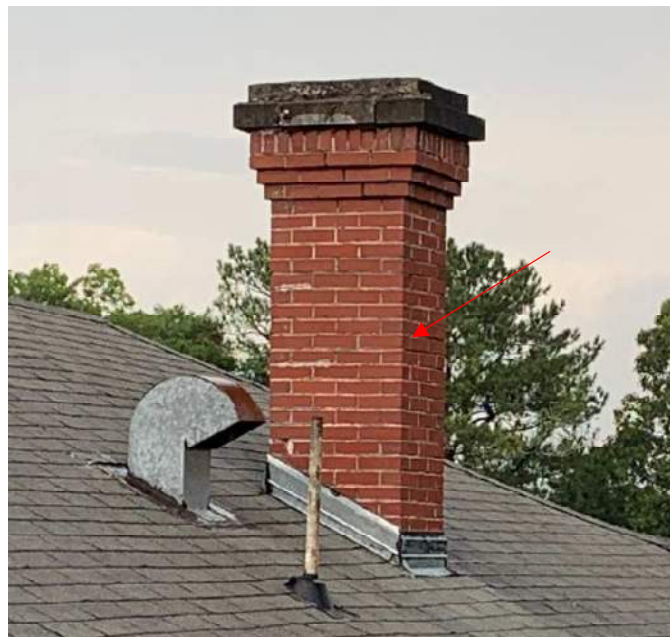
**Photo 28:** Overview of brick chimney near north portion of shingle roof. Observed spalls and separation in joints. Recommend tuckpoint repair.

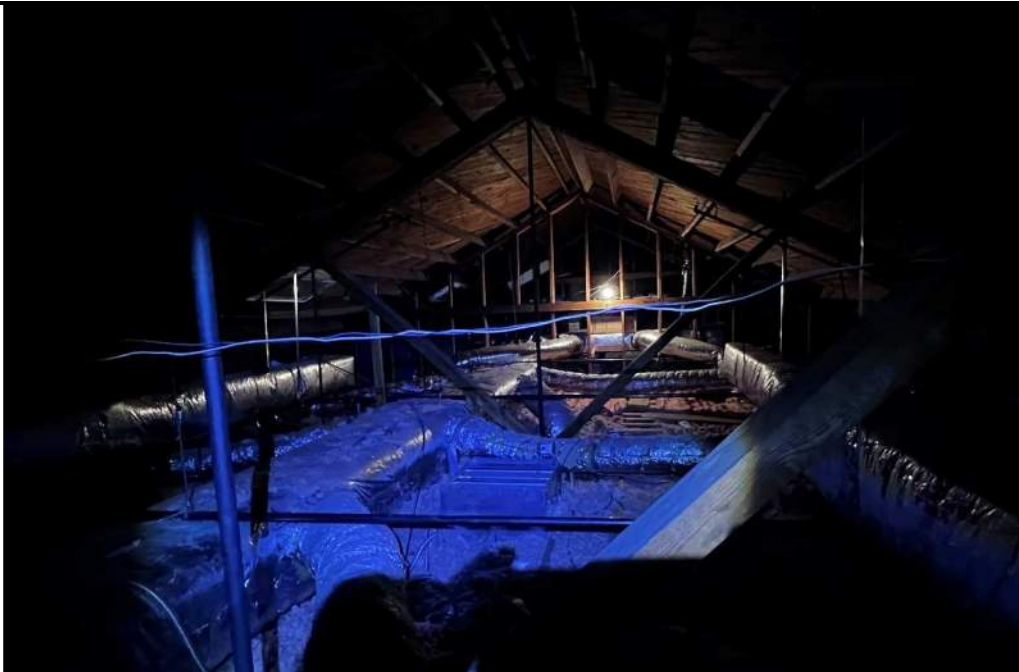
**Photo 29:** Overview of the underside of the roof deck framing, timber trusses, and wood joist. Note, truss components appear to be in good structural condition with observed signs of previous water infiltration near the steeple framing.

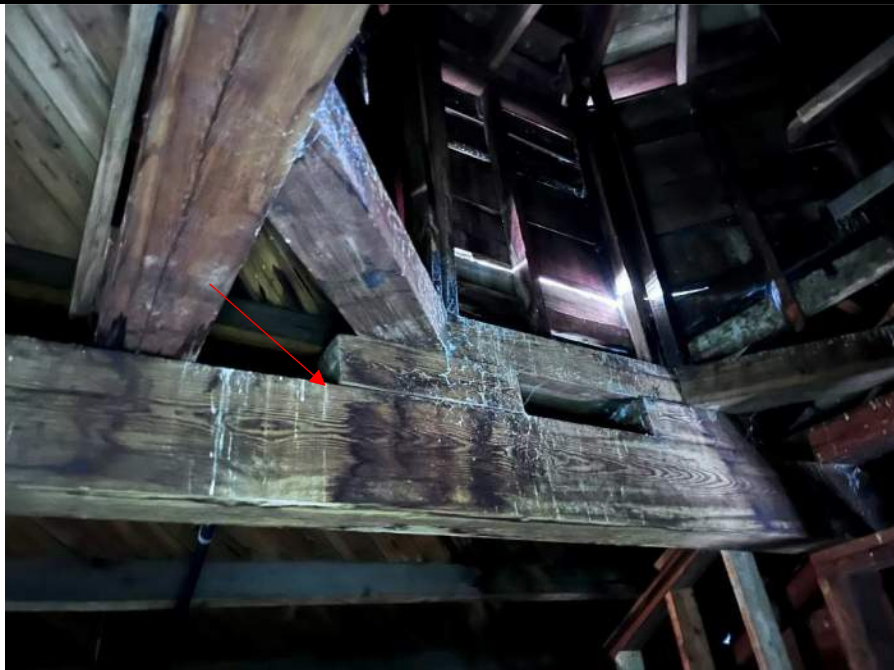
**Photo 30:** Observed signs of previous water infiltration near the steeple near the south end of the structure.

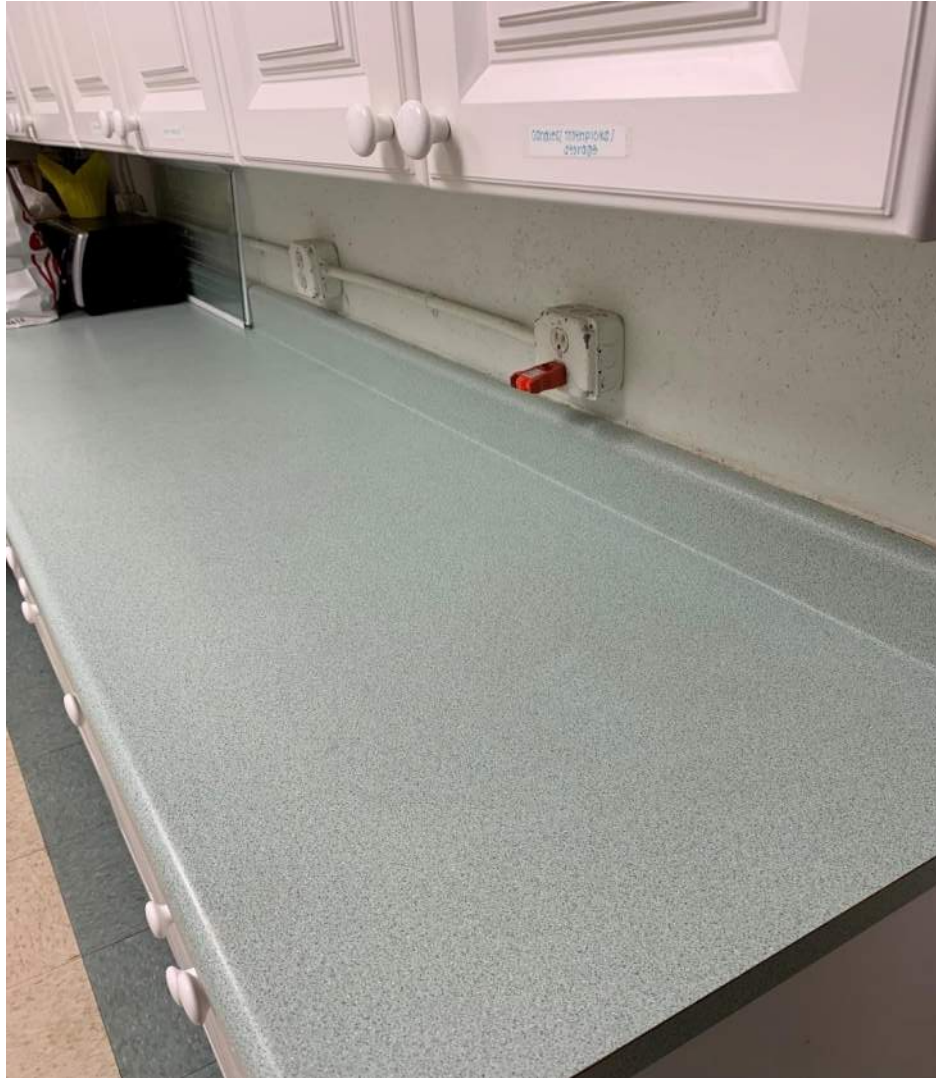
Photo 10: Countertop Receptacles

- Classroom receptacles missing protective caps, Daycare counter missing GFCI receptacles, and other above counter receptacles not GFCI protected. Receptacles should be in accordance with NFPA 70.
- Panel blocked in second floor mechanical room. Clearance should be maintained in front of panel boards in accordance with NFPA 70.
